BMW 1 HATCH: 1TBK900

Limited Technical Inspection

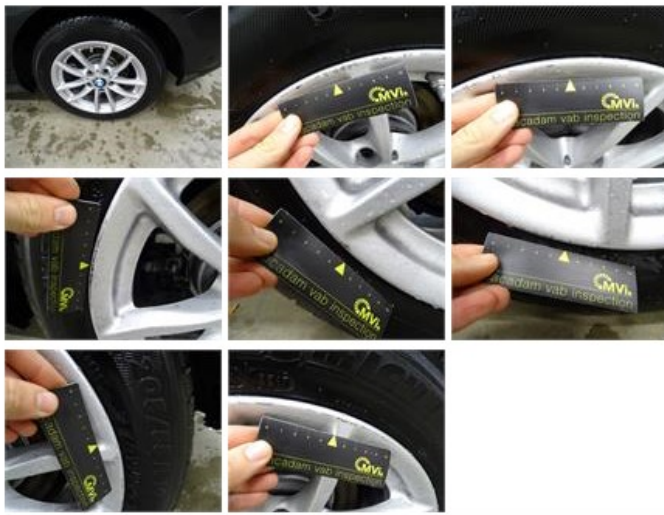
Total cost ex VAT	1016,60
Bonnet, Chemical polution, 67 - Polish	0,00
<i>No pictures to display</i>	
Alloy rim R L, Scratch(es), LI - Repair and paint (complete)	95,00

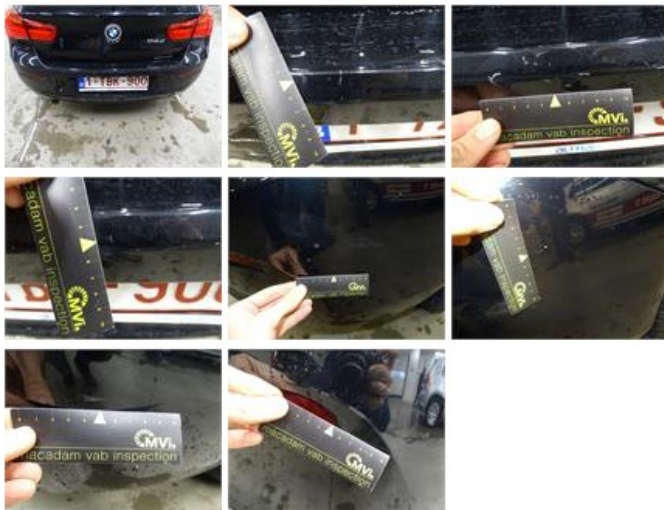
Bumper R, Scratch(es), LI - Repair and paint (complete)

211,80

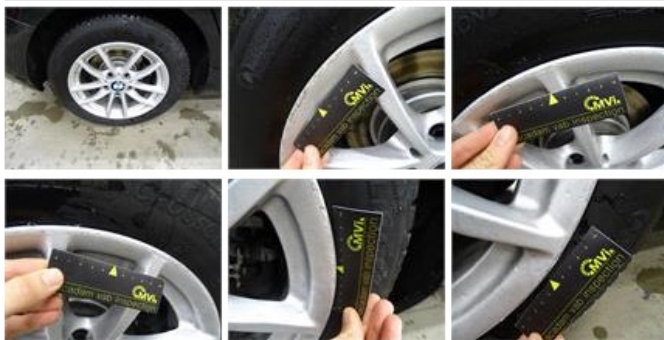
Alloy rim R R, Scratch(es), LI - Repair and paint (complete)

95,00

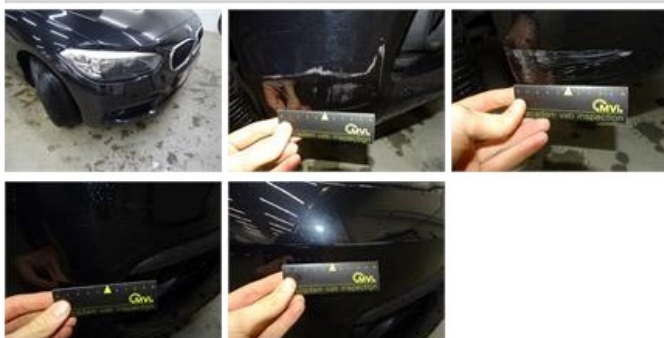
Bumper F, Scratch(es), LI - Repair and paint (complete)

211,80

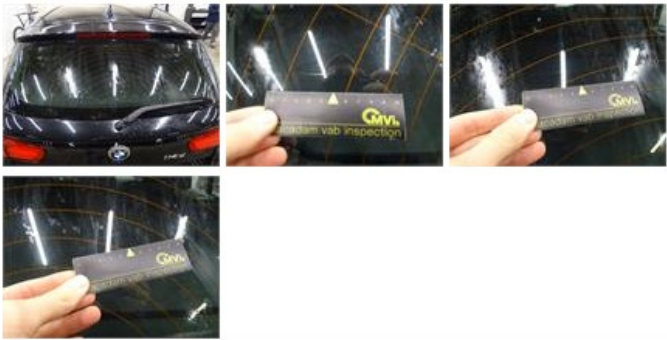
Wing(s), Dent(s), and Scratch(es), Acceptable	0,00
<i>No pictures to display</i>	
Roof, Chemical polution, 67 - Polish	0,00
<i>No pictures to display</i>	
Door F L, Scratch(es), Acceptable	0,00
<i>No pictures to display</i>	
Rear window, Scratch(es), Acceptable	0,00

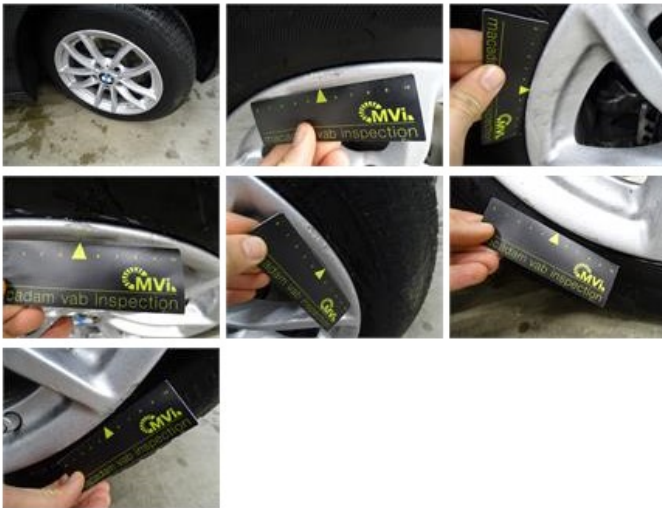
Wing F R, Scratch(es), Acceptable	0,00
<i>No pictures to display</i>	
Wing R R, Scratch(es), 67 - Polish	0,00
<i>No pictures to display</i>	
Alloy rim F R, Scratch(es), LI - Repair and paint (complete)	95,00
