BMW 5 TOURING: 1KLCL784

Vinnumber:	WBA5L11010D969412	Versionname:	2.0 518D (100KW) TOURING
First Registrationdate:	26/05/2015	Fiscalpower:	
Expertise Mileage:	145218	Power Kw:	100
Bodytype:		Body color:	Brown
Gearbox:	Automatic	Paint type:	Metalic
Transmission:	Back	Rims summer:	Aluminium
Fueltype:	Diesel	Oil level:	OK
Battery functioning:	Yes	Parking lot:	LKW2
Number of doors:	5		
Number of seats:	5		
Number head rests:	5		
Rims summer:	Aluminium		
Category:	Passenger Car		
Oil level:	OK		
Registration Certificate Car (BE):	Yes

Limited Technical Inspection

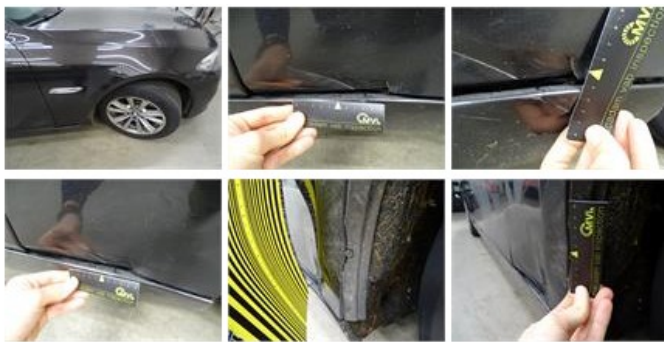
Wing F R, Crack, Le - Replace and paint 612,02

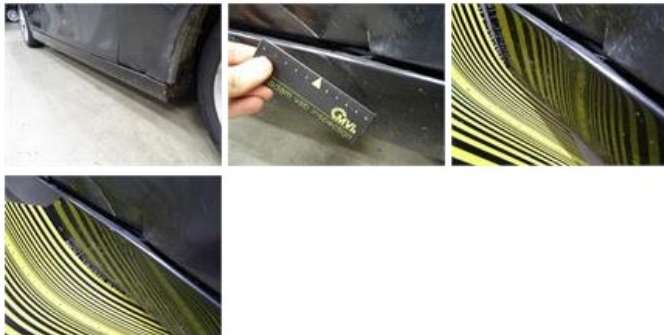
Sill outer R, Dent(s) and scratch(es), It - Spot repair 115,56

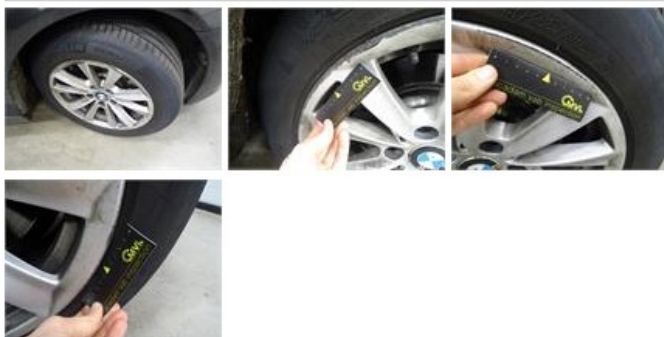
Alloy rim F R, Scratch(es), LI - Repair and paint (complete) 95,00

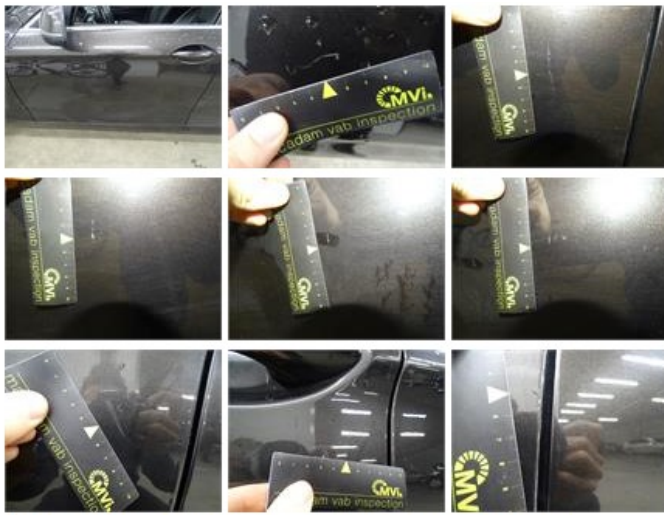
Door F L, Scratch(es), LI - Repair and paint (complete) 382,02

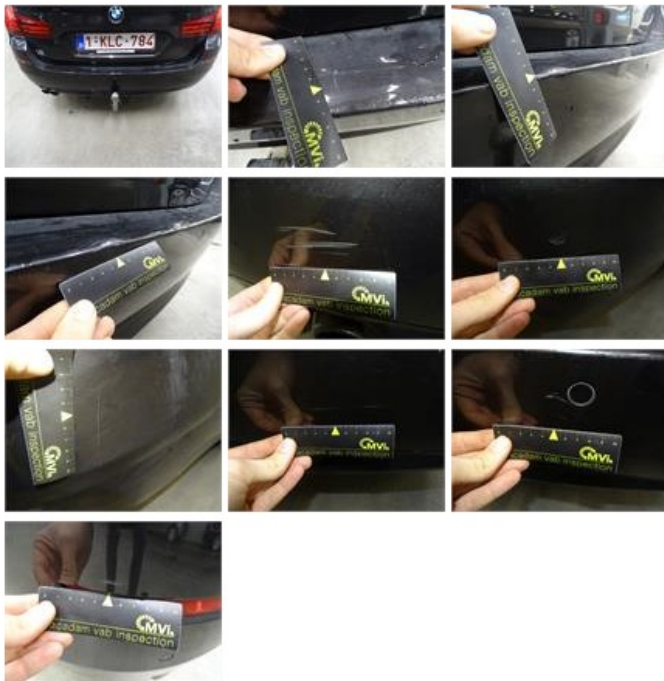
Bumper R, Dent(s) and scratch(es), LI - Repair and paint (complete)

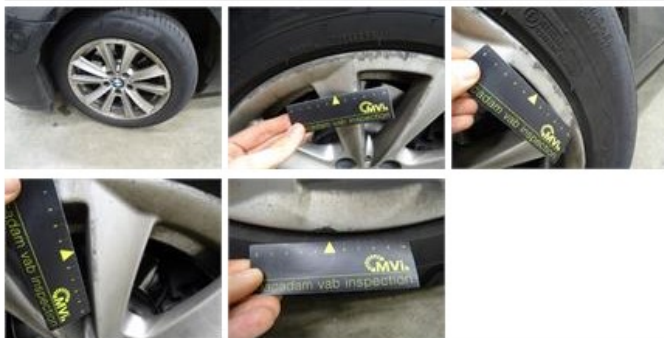
Alloy rim F L, Scratch(es), LI - Repair and paint (complete)

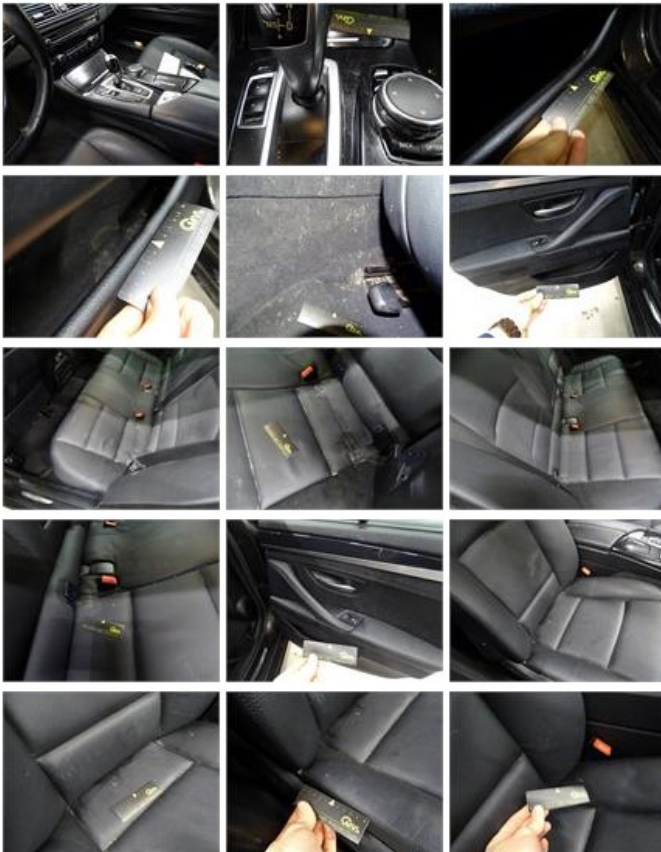
Interior, Dirty, Cleaning

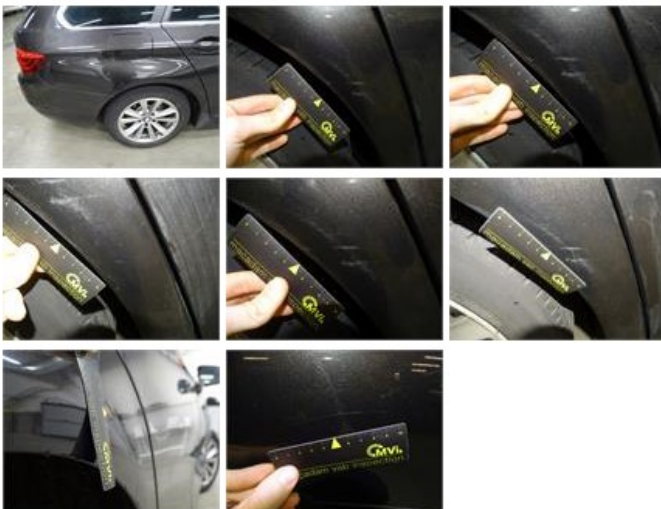
Wing R R, Dent(s) and scratch(es), LI - Repair and paint (complete)

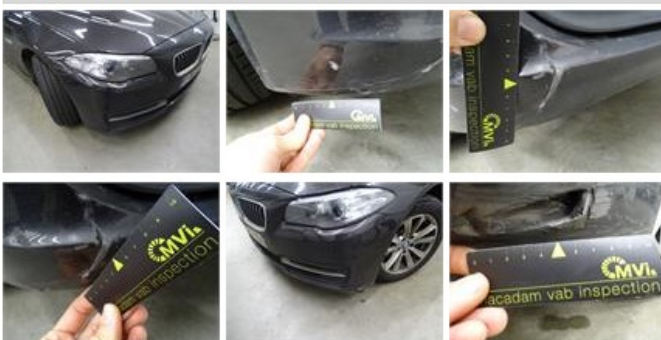
Bumper F, Broken, Le - Replace and paint
