BMW 4 GRAN COUPE: 1LXZ037

Vinnumber:	WBA4E71010G519170	Versionname:	2.0 418D (110KW) GRAN COUPE
First Registrationdate:	31/12/2015	Fiscalpower:	
Expertise Mileage:	112936	Power Kw:	110
Bodytype:		Body color:	Black
Gearbox:	Automatic	Paint type:	Metallic
Transmission:	Back	Rims summer:	Aluminium
Fueltype:	Diesel	Oil level:	OK
Battery functioning:	Yes	Parking lot:	LKW2
Number of doors:	5		
Number of seats:	5		
Number head rests:	4		
Rims summer:	Aluminium		
Category:	Passenger Car		
Oil level:	OK		
Registration Certificate Car (BE):	Yes

Limited Technical Inspection

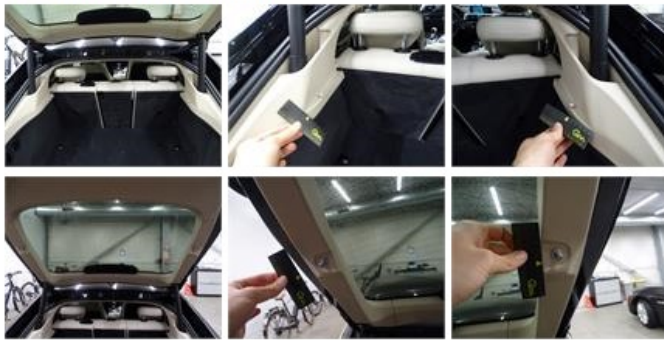
Boot cover, Missing, E - Replace 60,00

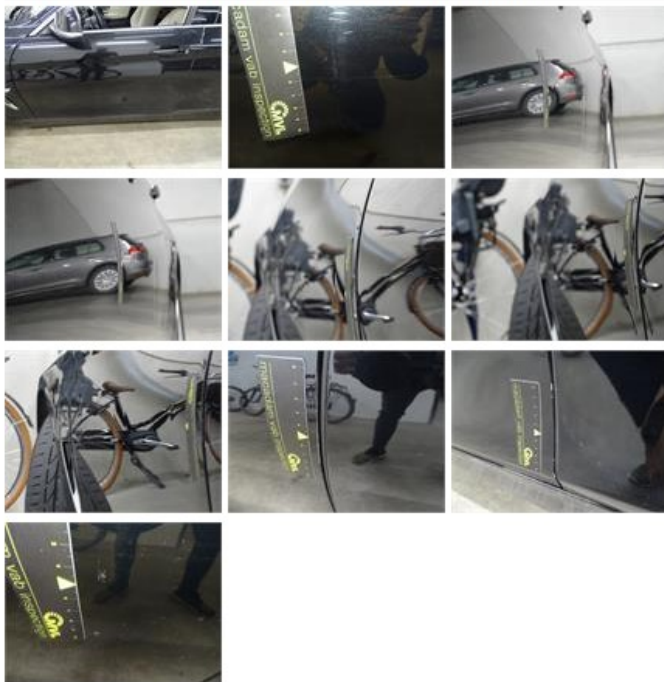
Door F L, Dent(s) and scratch(es), LI - Repair and paint (complete) 382,02

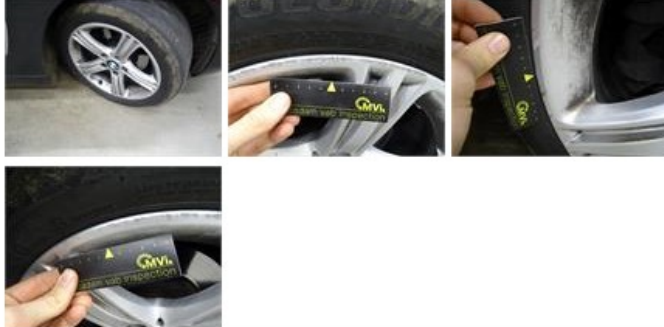
Alloy rim F R, Scratch(es), LI - Repair and paint (complete) 95,00

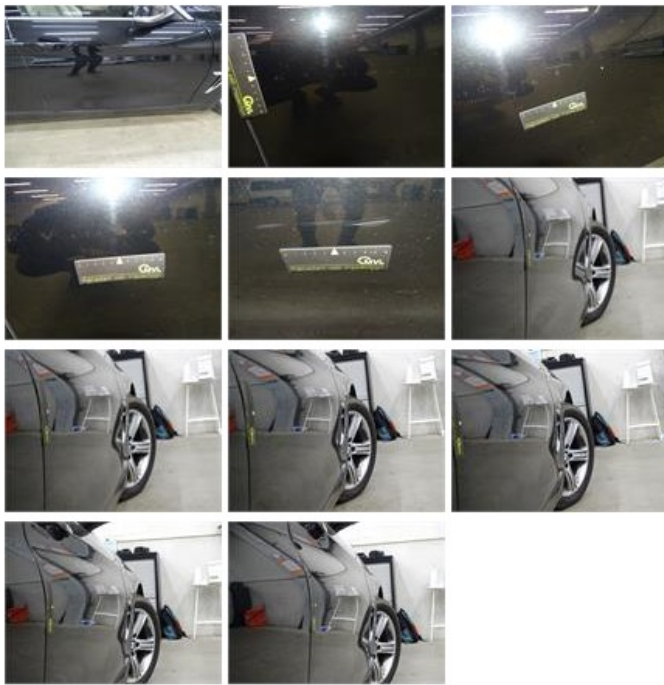
Door F R, Dent(s) and scratch(es), LI - Repair and paint (complete) 382,02

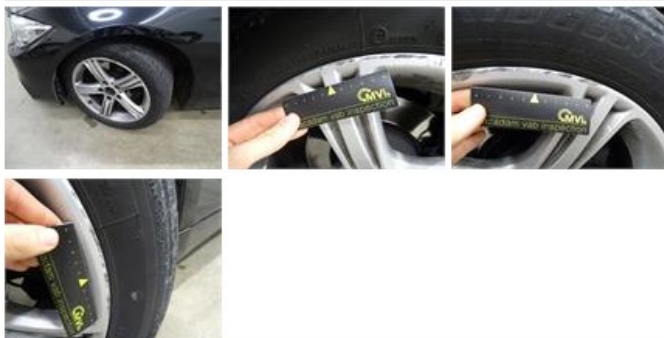
Alloy rim F L, Scratch(es), LI - Repair and paint (complete) 95,00

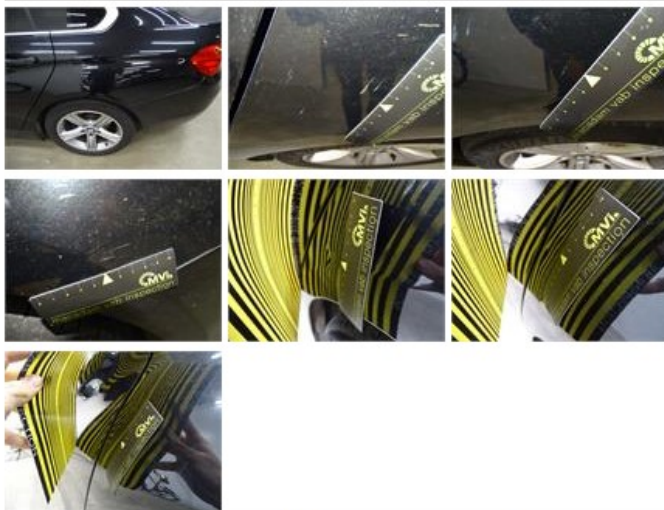
Wing R L, Dent(s) and scratch(es), LI - Repair and paint (complete) 369,84

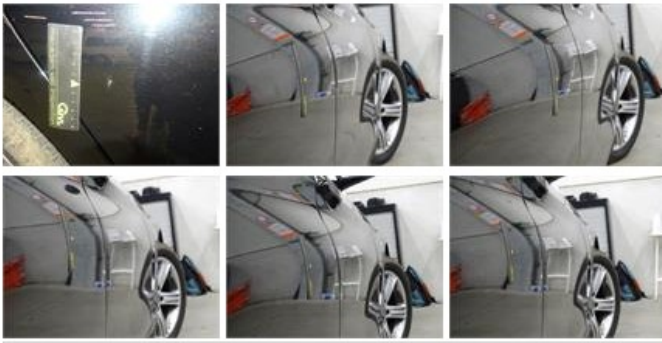
Door R R, Dent(s) and scratch(es), LI - Repair and paint (complete) 382,02
