BMW 5 BERLINE: 1KSA324

Limited Technical Inspection

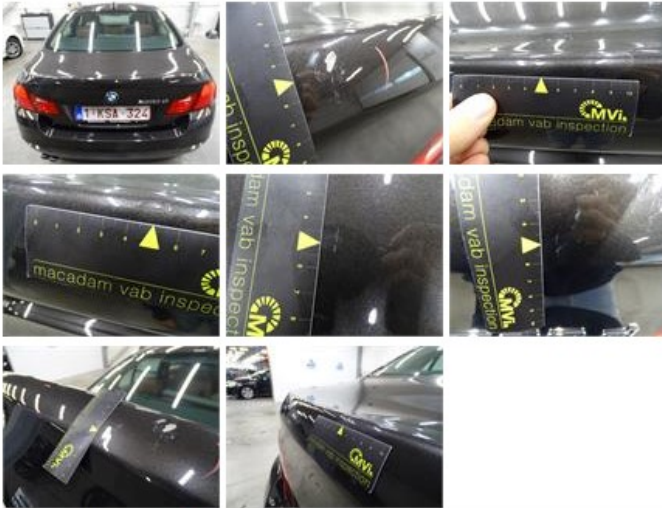
Tailgate, Dent(s) and scratch(es), LI - Repair and paint (complete) 362,02

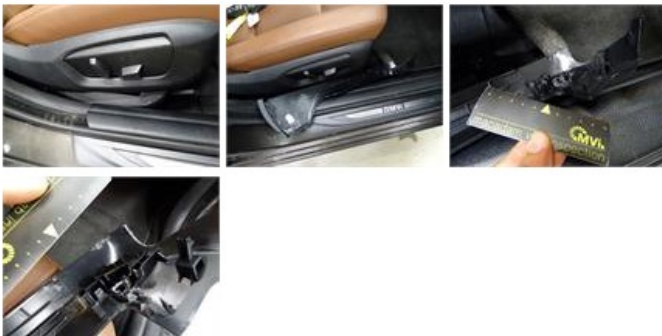
Inner seat cover R, Broken, E - Replace 54,00

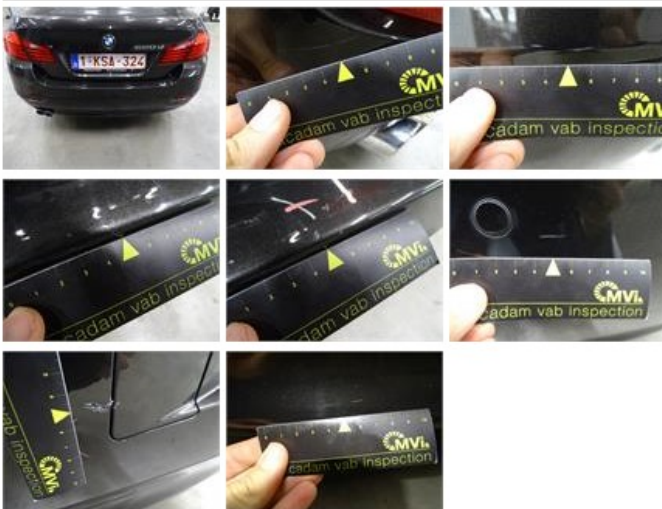
Bumper R, Scratch(es), LI - Repair and paint (complete) 254,16

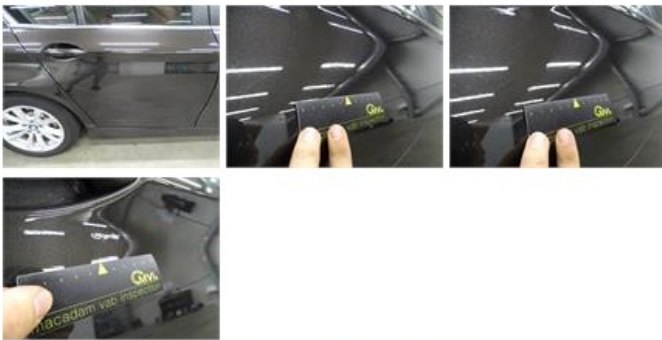
Door R R, Bad repair, Acceptable 0,00

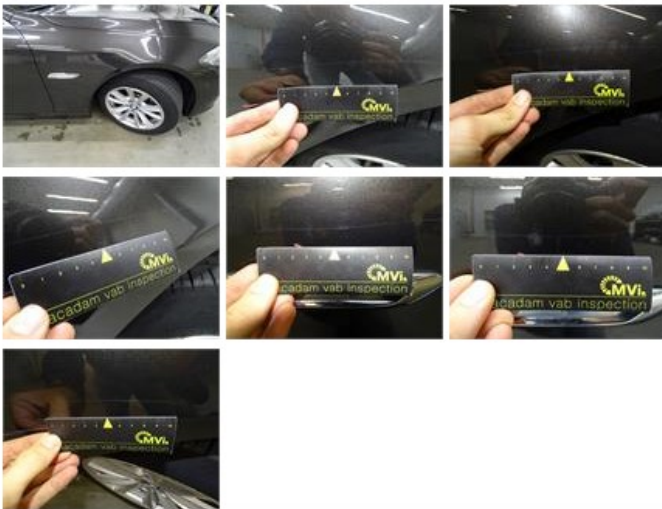
Wing F R, Scratch(es), LI - Repair and paint (complete) 264,21
