**LAND ROVER RANGE ROVER EVOQUE: 1LSF272**

**Limited Technical Inspection**

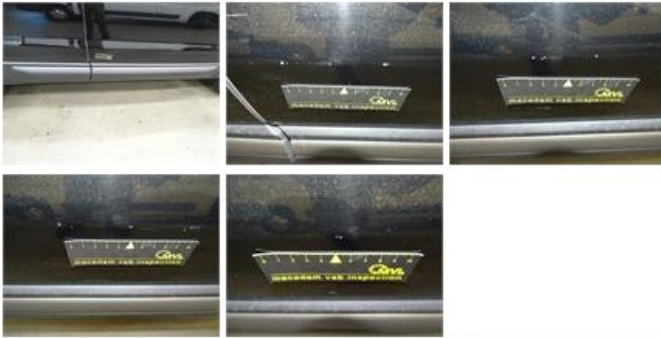
Door F R, Scratch(es), LI - Repair and paint (complete) 382,02

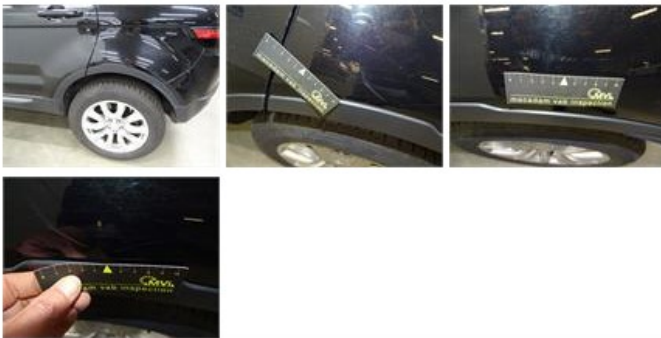
Wing R L, Scratch(es), LI - Repair and paint (complete) 369,84
