BMW X1: 1LSB612			
Vinnumber:	WBAHT71000P908678	Versionname:	2.0 SDRIVE18D (100KW)
First Registrationdate:	19/11/2015	Fiscalpower:	
Expertise Mileage:	37724	Power Kw:	100
Bodytype:		Body color:	Brown
Gearbox:	MAN 6 VIT	Paint type:	Metalic
Transmission:	Front	Rims summer:	Aluminium
Fueltype:	Diesel	Oil level:	OK
Battery functioning:	Yes	Parking lot:	1731
Number of doors:	5		
Number of seats:	5		
Number head rests:	5		
Rims summer:	Aluminium		
Category:	Passenger Car		
Oil level:	OK		
Registration Certificate Car (BE):	Yes

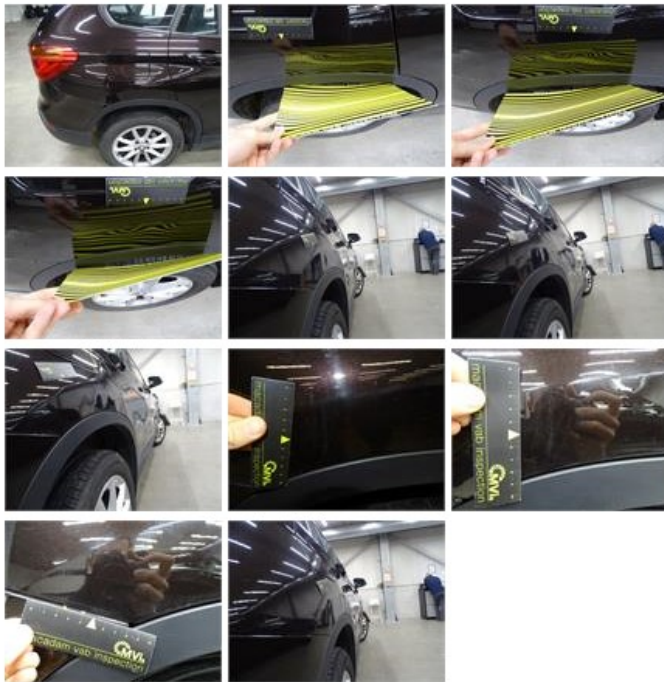
Wing R R, Deformed / Strained, LI - Repair and paint (complete) 356,20

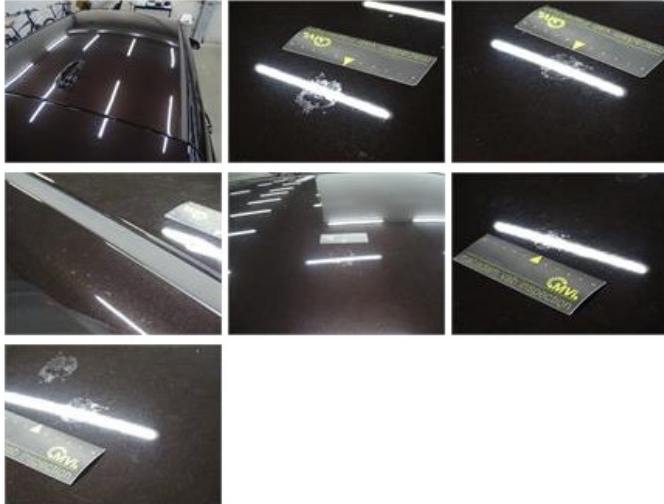
Roof, Chemical polution, LI - Repair and paint (complete) 481,50
