**BMW 5 TOURING: 1LRZ143**

Vinnumber:	<b>WBA5L11010G344961</b>	Versionname:	<b>2.0 518D (110KW) TOURING</b>
First Registrationdate:	<b>18/11/2015</b>	Fiscalpower:	
Expertise Mileage:	<b>147583</b>	Power Kw:	<b>110</b>
Bodytype:	<b>Break</b>	Body color:	<b>Gold</b>
Gearbox:	<b>MAN 6 VIT</b>	Paint type:	<b>Metalic</b>
Transmission:	<b>Back</b>	Rims summer:	<b>Aluminium</b>
Fueltype:	<b>Diesel</b>	Oil level:	<b>OK</b>
Battery functioning:	<b>Yes</b>	Parking lot:	<b>3203</b>
Number of doors:	<b>5</b>		
Number of seats:	<b>5</b>		
Number head rests:	<b>5</b>		
Rims summer:	<b>Aluminium</b>		
Category:	<b>Passenger Car</b>		
Oil level:	<b>OK</b>		
Registration Certificate Car (BE):	<b>Yes</b>

**Limited Technical Inspection**

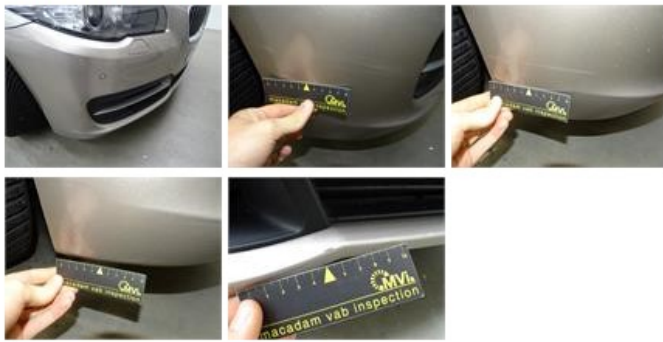
Bumper F, Scratch(es), Acceptable 0,00

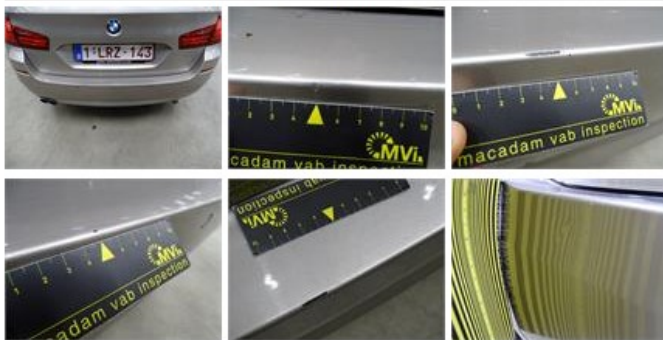
Bumper cover R M, Dent(s) and scratch(es), It - Spot repair 75,00

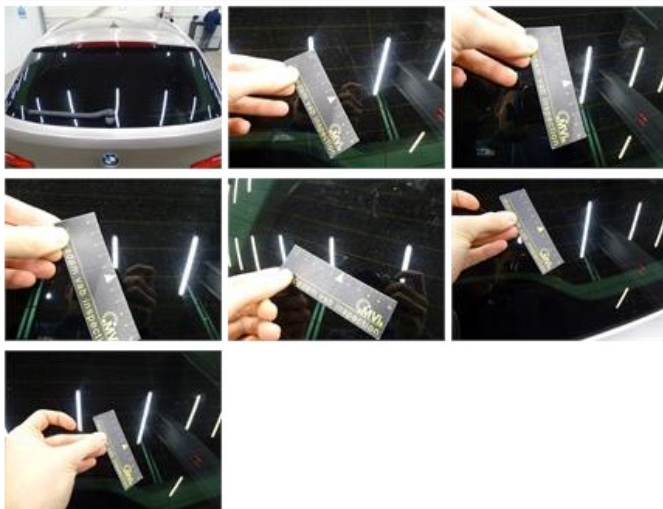
Rear window, Scratch(es), Acceptable 0,00
