**MERCEDES B: 1HSR498**

**Limited Technical Inspection**

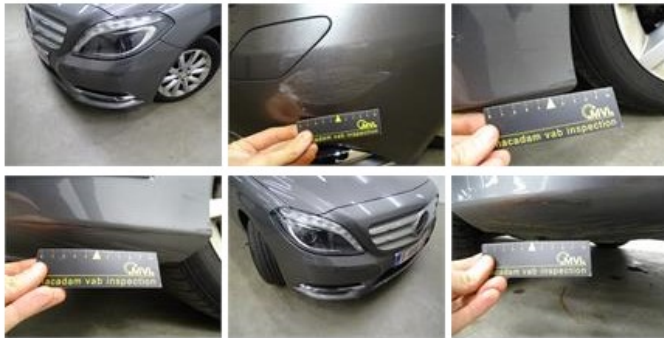
Bumper F, Scratch(es), LI - Repair and paint (complete) 211,80
