RENAULT CLIO: 1LLS283

Limited Technical Inspection

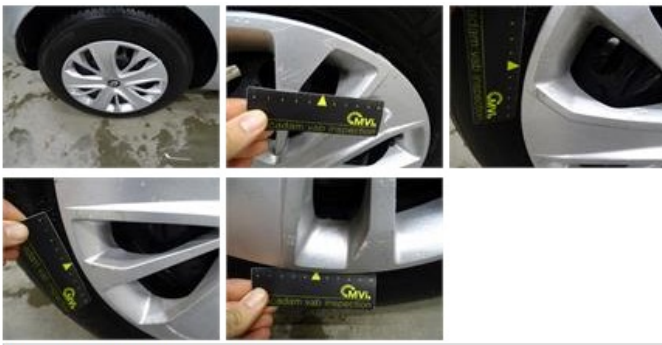
Total cost ex VAT	1343,84
Wheel cover R R, Scratch(es), E - Replace	24,00

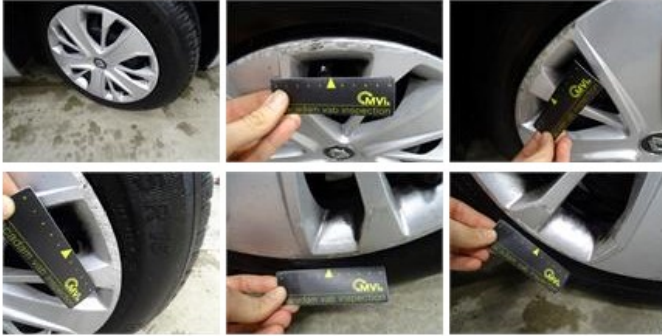
Wheel cover F R, Scratch(es), E - Replace 24,00

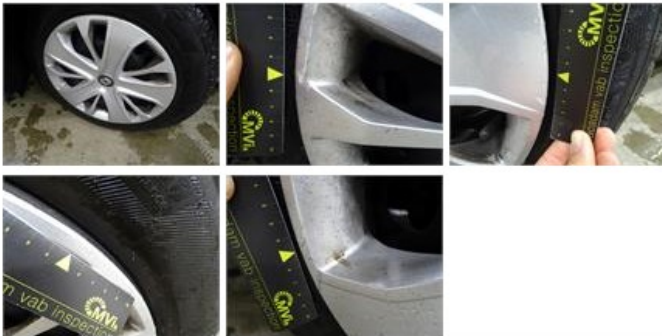
Wheel cover F L, Scratch(es), E - Replace 24,00

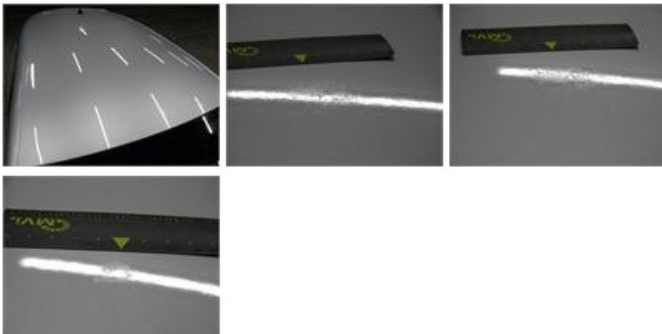
Roof, Chemical pollution, LI - Repair and paint (complete) 385,20

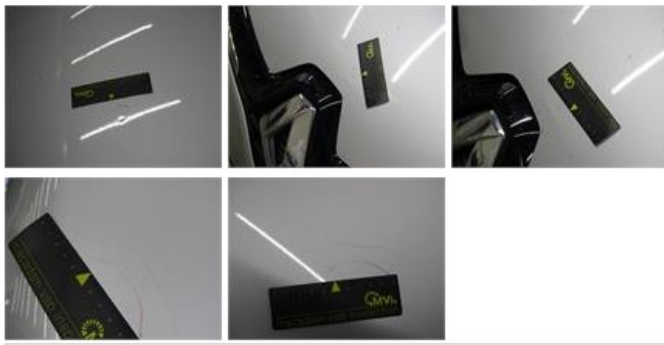
Bonnet, Dent(s) and scratch(es), LI - Repair and paint (complete) 232,06

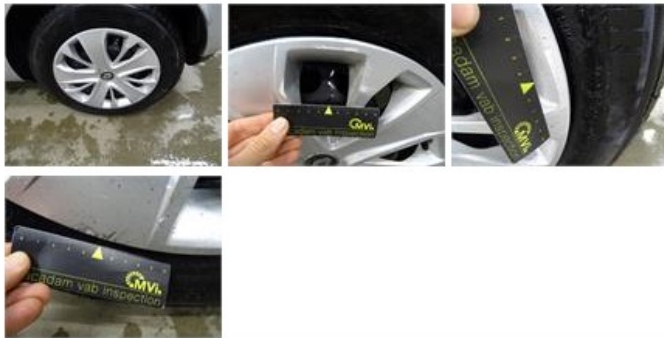
Wheel cover R L, Scratch(es), E - Replace

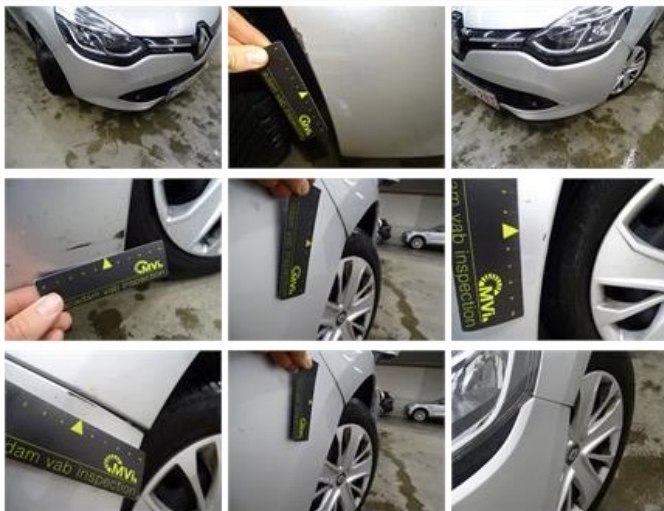
Bumper F, Dent(s) and scratch(es), LI - Repair and paint (complete)

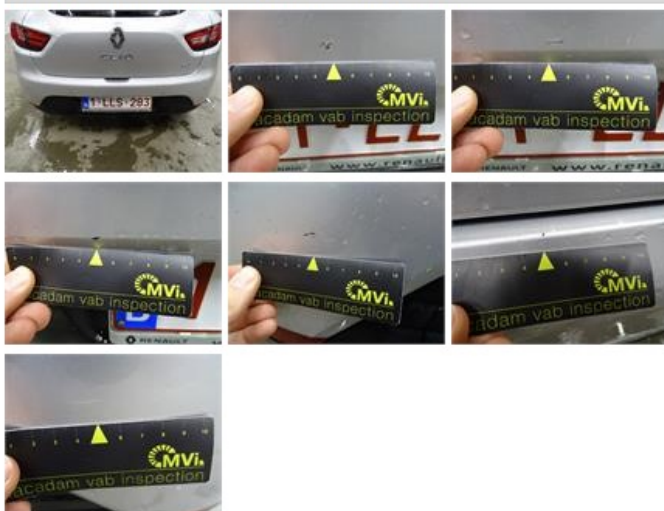
Bumper R, Scratch(es), LI - Repair and paint (complete)

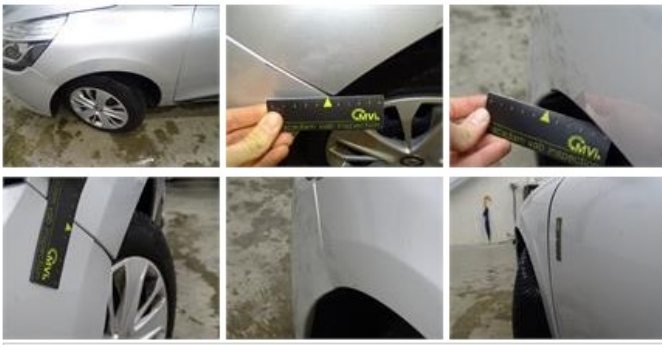
Wing F L, Deformed / Strained, LI - Repair and paint (complete)
