MINI : 1PCV169			
Vinnumber:	WMWXN110202A17178	Versionname:	1.5 ONE D
First Registrationdate:	7/06/2016	Fiscalpower:	
Expertise Mileage:	64147	Power Kw:	70
Bodytype:		Body color:	Black
Gearbox:	MAN 6 VIT	Paint type:	Metalic
Transmission:	Front	Rims summer:	Aluminium
Fueltype:	Diesel	Oil level:	OK
Battery functioning:	Yes	Parking lot:	2706
Number of doors:	3		
Number of seats:	4		
Number head rests:	4		
Rims summer:	Aluminium		
Category:	Passenger Car		
Oil level:	OK		
Registration Certificate Car (BE):	Yes

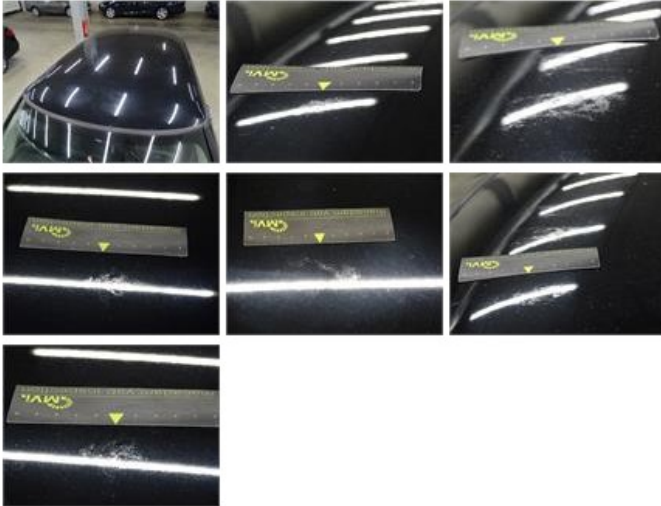
Roof, Chemical polution, LI - Repair and paint (complete) 481,50

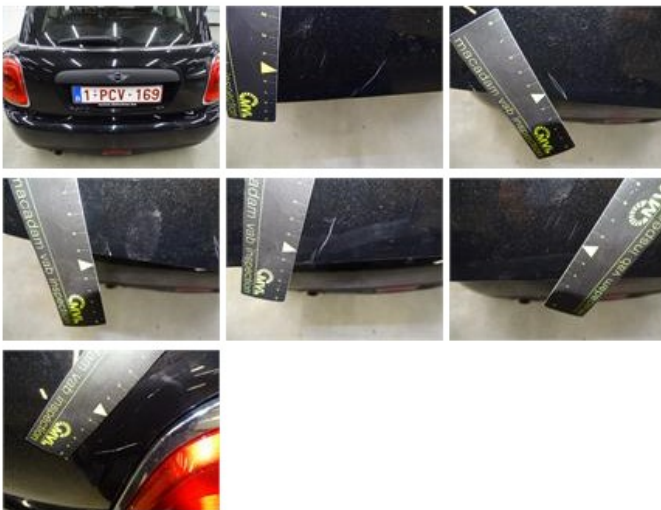
Tailgate, Scratch(es), LI - Repair and paint (complete) 301,68

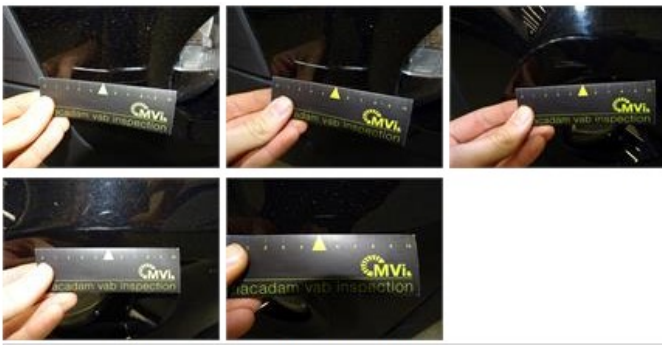
Bumper F, Scratch(es), LI - Repair and paint (complete) 211,80

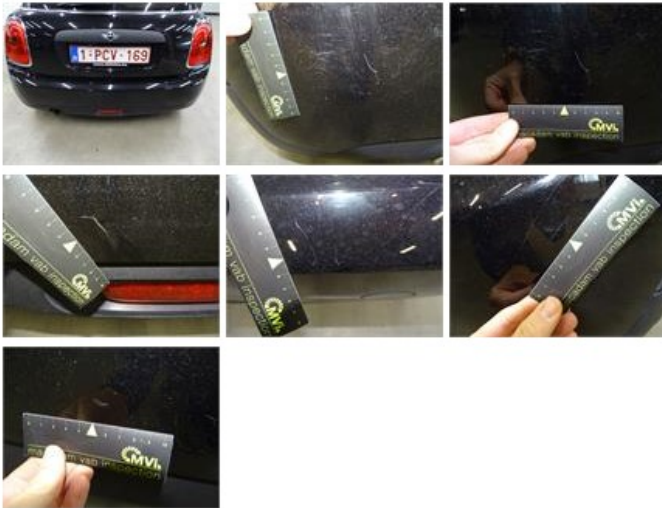
Bumper R, Scratch(es), LI - Repair and paint (complete) 211,80
