<b>MINI : 1PEN784</b>			
Vinnumber:	<b>WMWXN110303B51806</b>	Versionname:	<b>1.5 ONE D</b>
First Registrationdate:	<b>17/06/2016</b>	Fiscalpower:	
Expertise Mileage:	<b>72565</b>	Power Kw:	<b>70</b>
Bodytype:		Body color:	<b>Black</b>
Gearbox:	<b>MAN 6 VIT</b>	Paint type:	<b>Metalic</b>
Transmission:	<b>Front</b>	Rims summer:	<b>Aluminium</b>
Fueltype:	<b>Diesel</b>	Oil level:	<b>OK</b>
Battery functioning:	<b>Yes</b>	Parking lot:	<b>3111</b>
Number of doors:	<b>3</b>		
Number of seats:	<b>4</b>		
Number head rests:	<b>4</b>		
Rims summer:	<b>Aluminium</b>		
Category:	<b>Passenger Car</b>		
Oil level:	<b>OK</b>		
Registration Certificate Car (BE):	<b>Yes</b>

<b>Limited Technical Inspection</b>			
Airco functioning	<b>OK</b>	Battery functioning	<b>Yes</b>
Tires wear profile	<b>OK</b>	Power steering	<b>Yes</b>
Idle position	<b>OK</b>	Sound engine	<b>OK</b>
Engine startingtime	<b>OK</b>	Clutch test	<b>OK</b>
Exhaust gass	<b>OK</b>	Wiper fluid level	<b>OK</b>
Handbrake	<b>OK</b>	Transmission	<b>OK</b>
		Lighting	<b>OK</b>
		Wiperblades	<b>OK</b>

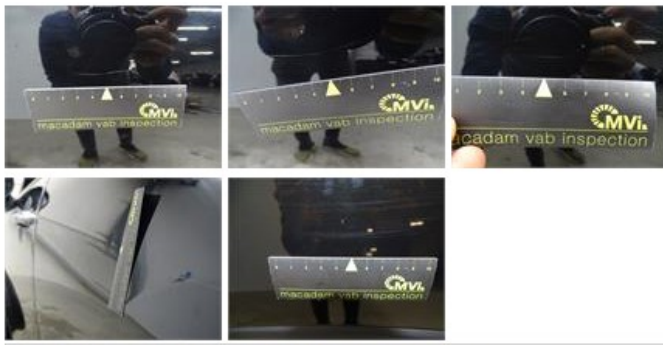
<b>Total cost ex VAT</b>	<b>1124,68</b>
<b>Wing R L, Dent(s) and scratch(es), LI - Repair and paint (complete)</b>	<b>308,20</b>

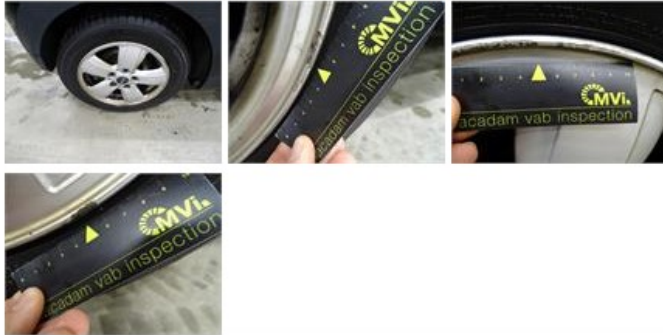
Alloy rim R R, Scratch(es), LI - Repair and paint (complete)

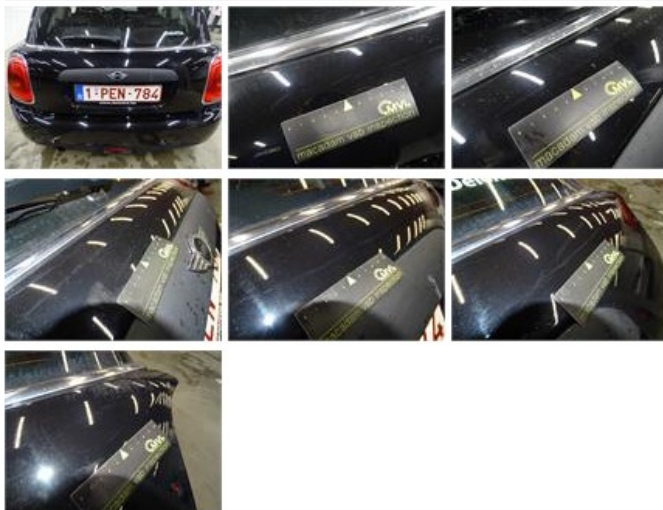
Tailgate, Scratch(es), LI - Repair and paint (complete)

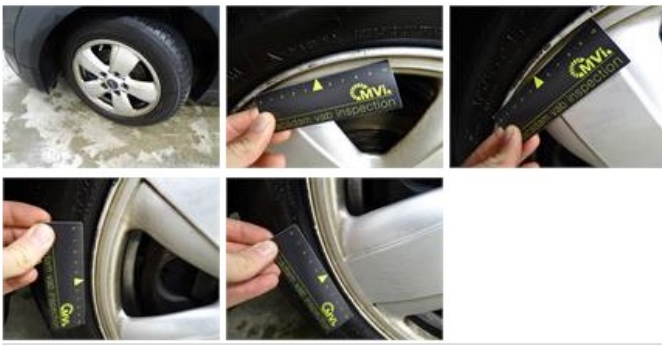
Alloy rim F L, Scratch(es), LI - Repair and paint (complete)

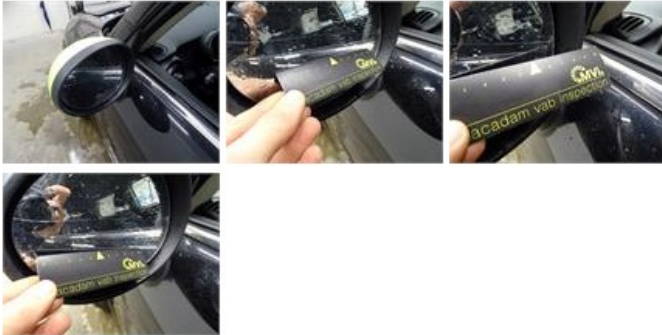
Rearview mirror glass L, Broken, E - Replace 18,00

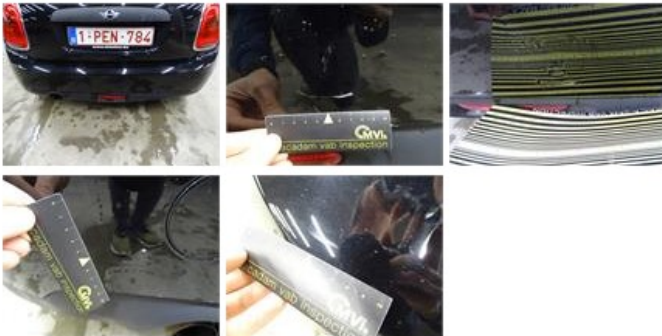
Bumper R, Dent(s) and scratch(es), LI - Repair and paint (complete) 211,80
