PEUGEOT 308: 1GCX758

| Vinnumber: | VF3LB9HCGDS248080 | Versionname: | 308 BER e-HDi Active STT 115PK |

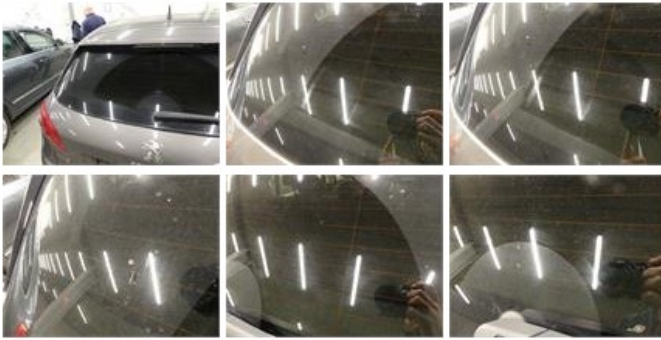
Rear window, Scratch(es), E - Replace 370,00

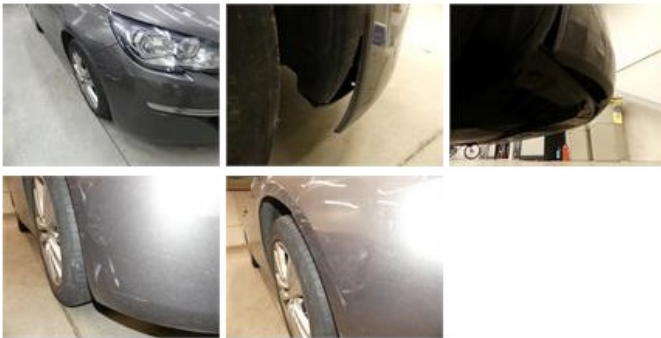
Bumper F, Deformed / Strained, Le - Replace and paint 735,00
