RENAULT CLIO: 1LRG464

Limited Technical Inspection

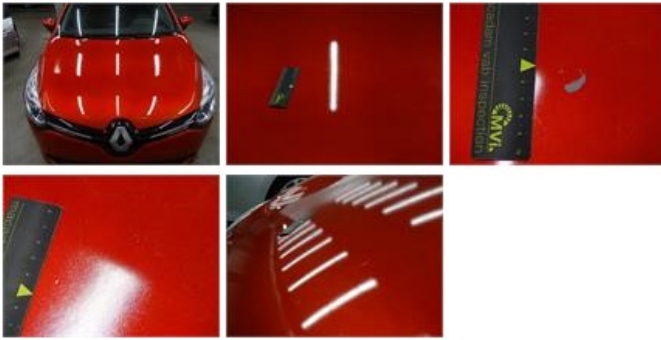
Bonnet, Bad repair, Acceptable 0,00

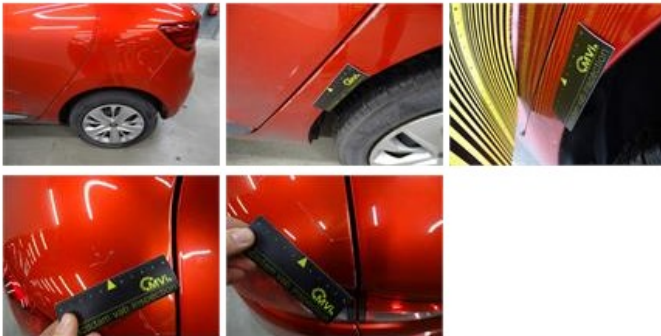
Wing R L, Dent(s) and scratch(es), LI - Repair and paint (complete) 246,56

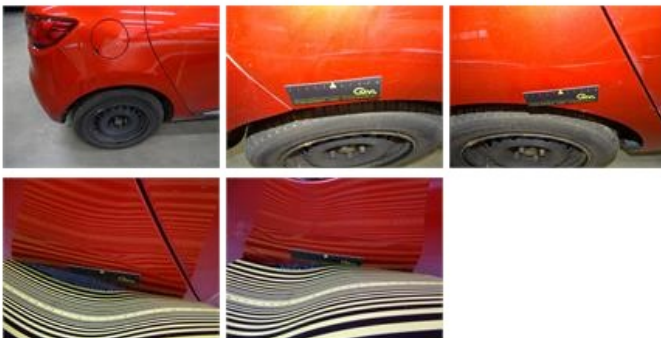
Wing R R, Dent(s) and scratch(es), LI - Repair and paint (complete) 246,56

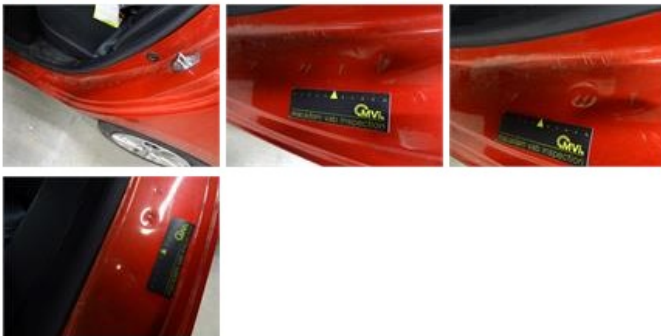
Rocker panel inner R L, Dent(s), LI - Repair and paint (complete) 115,56

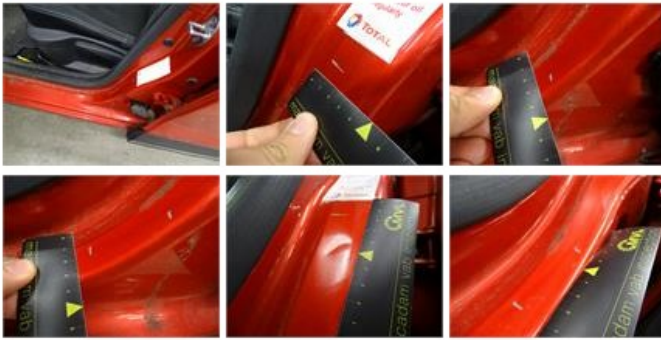
Rocker panel inner F L, Dent(s), LI - Repair and paint (complete)

115,56

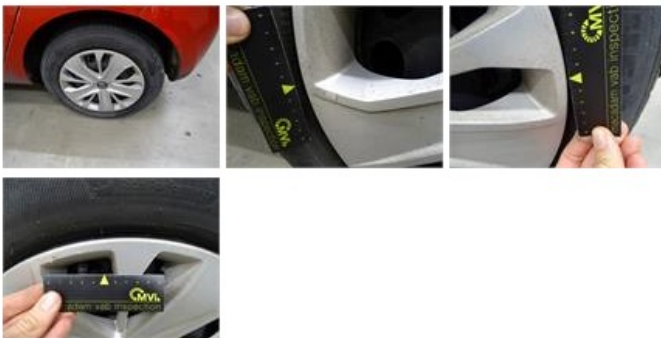
Wheel cover R L, Scratch(es), E - Replace

24,00

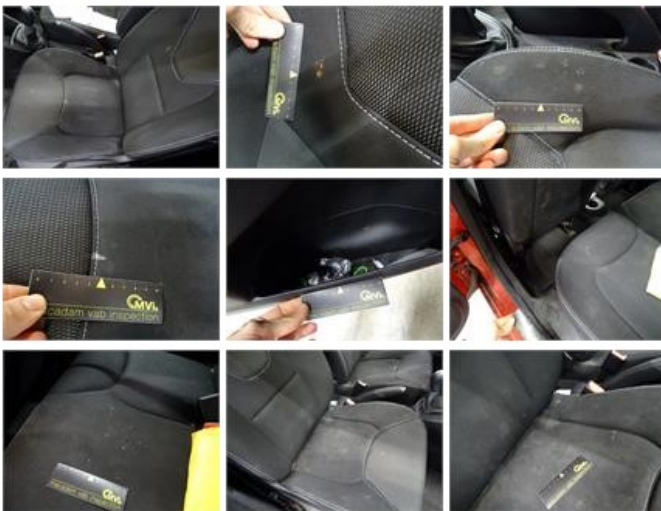
Interior, Dirty, Cleaning

50,00

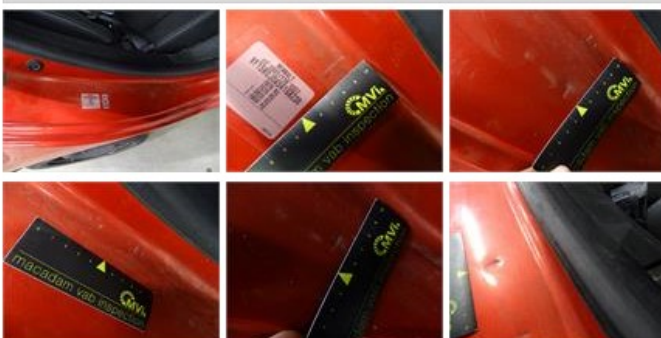
Rocker panel inner R R, Dent(s), LI - Repair and paint (complete)

115,56

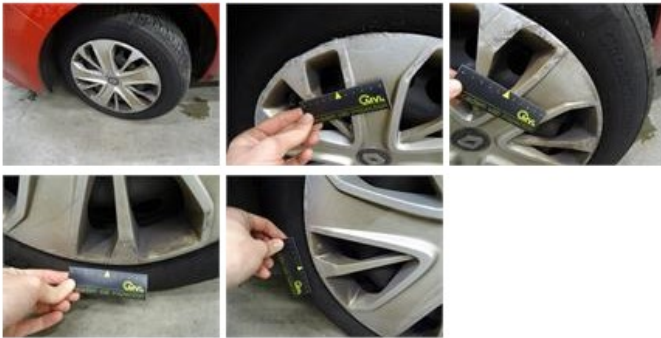
Wheel cover F L, Scratch(es), E - Replace

24,00

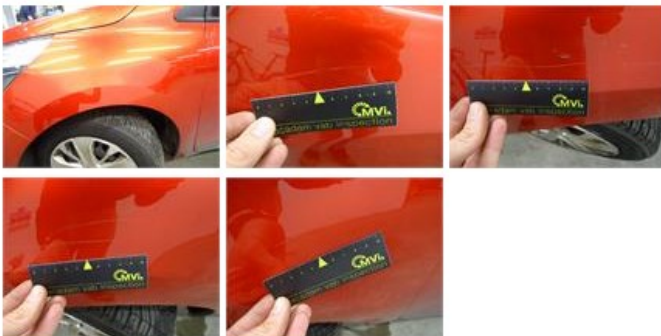
Wing F L, Scratch(es), LI - Repair and paint (complete)

176,14

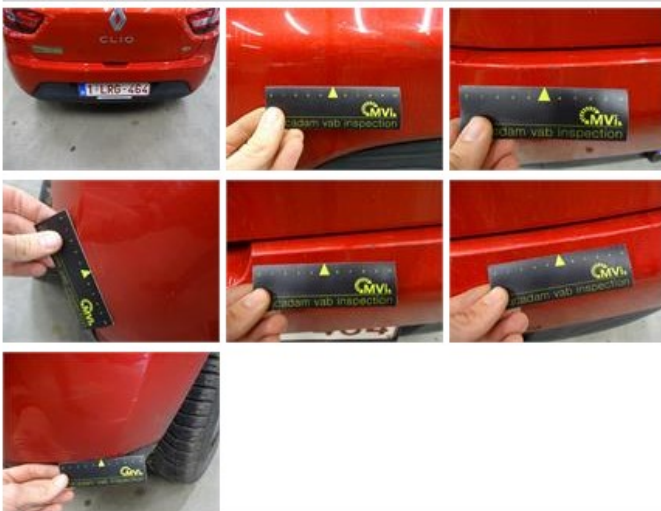
Bumper R, Scratch(es), LI - Repair and paint (complete)

169,44

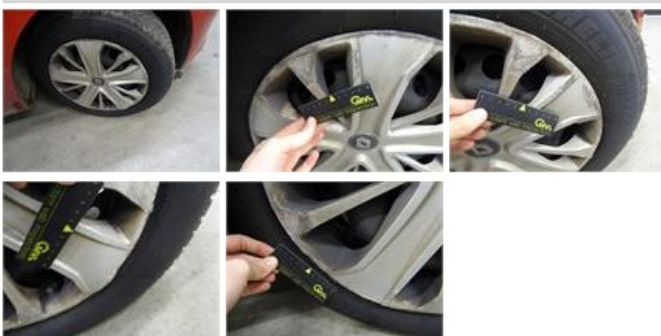
Wheel cover F R, Scratch(es), E - Replace

24,00

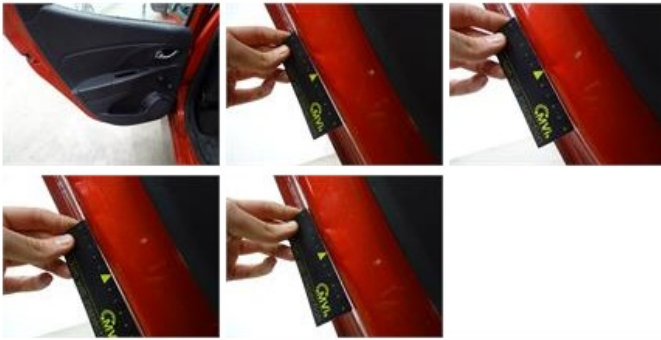
Door frame R L, Dent(s), It - Spot repair

115,56

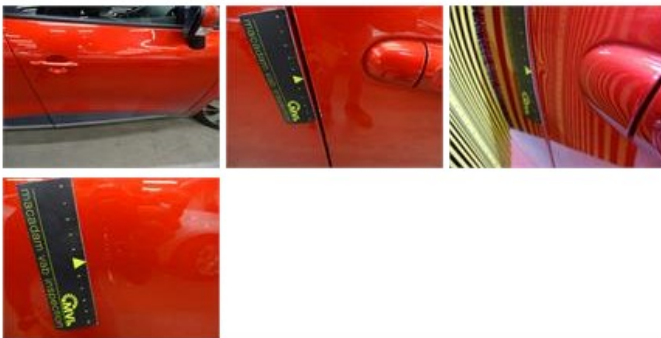
Door F R, Dent(s) and scratch(es), LI - Repair and paint (complete)

254,68

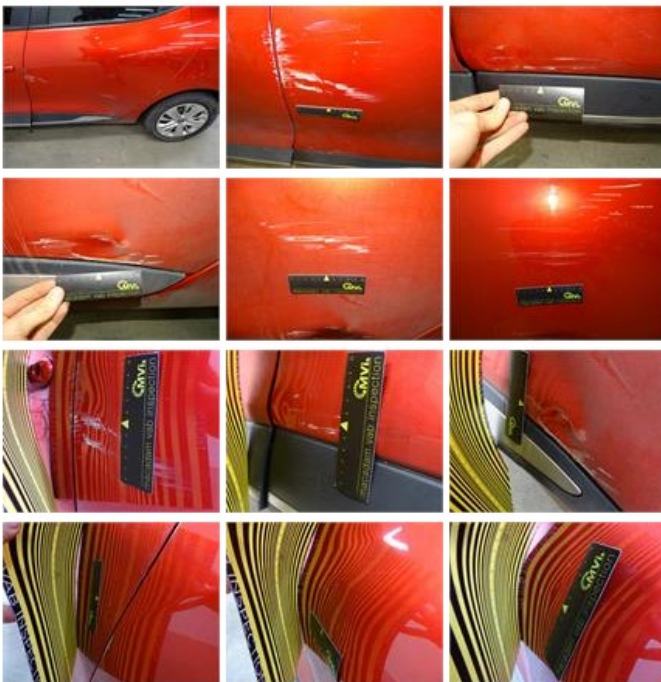
Door R L, Dent(s) and scratch(es), LI - Repair and paint (complete)

398,68

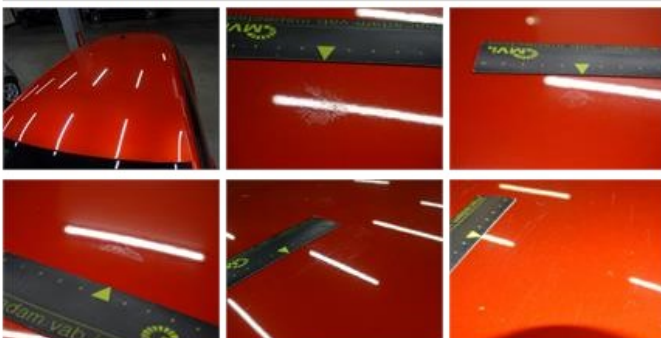
Roof, Chemical pollution, LI - Repair and paint (complete)

385,20

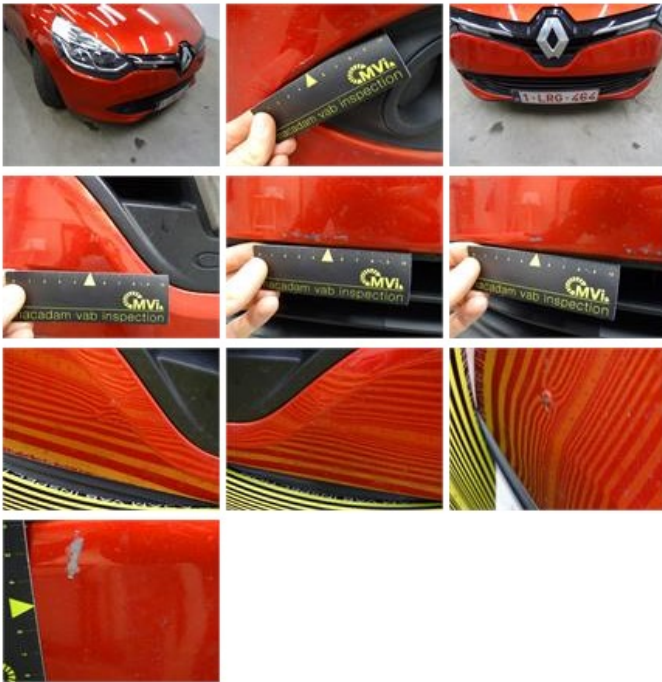
Bumper F, Dent(s) and scratch(es), LI - Repair and paint (complete)

169,44

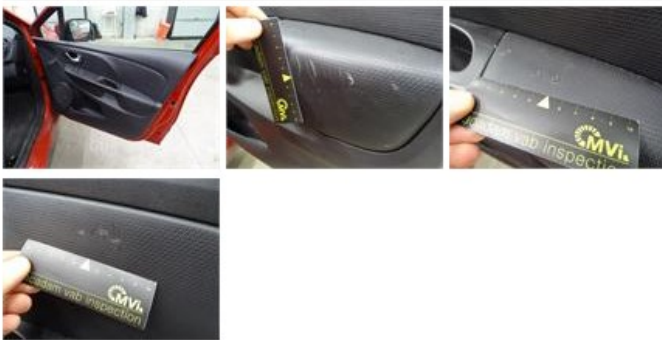
Door panel F R, Tear, E - Replace

96,00
