SKODA OCTAVIA COMBI: 1PSY881

Limited Technical Inspection

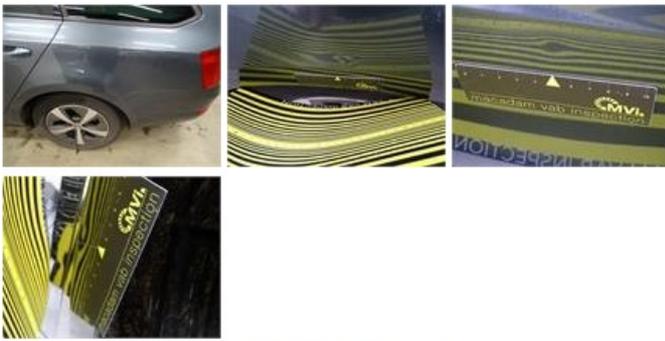
Total cost ex VAT	4278,36
Wing R L, Dent(s), PDR - Paintless dent repair	102,60

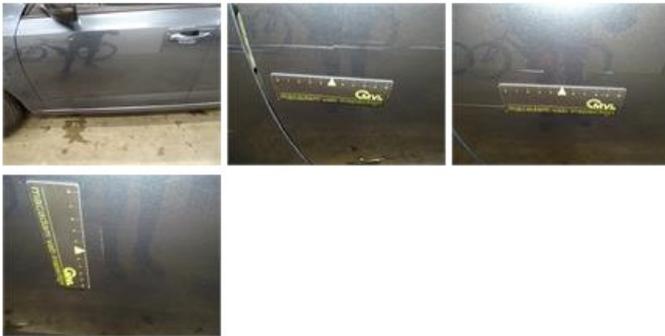
Door F L, Scratch(es), LI - Repair and paint (complete) 318,35

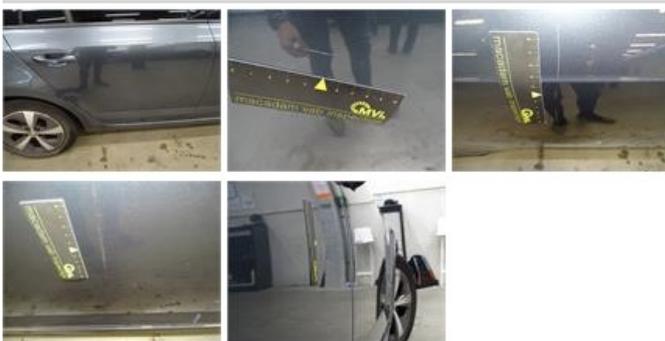
Door R R, Dent(s) and scratch(es), LI - Repair and paint (complete) 318,35

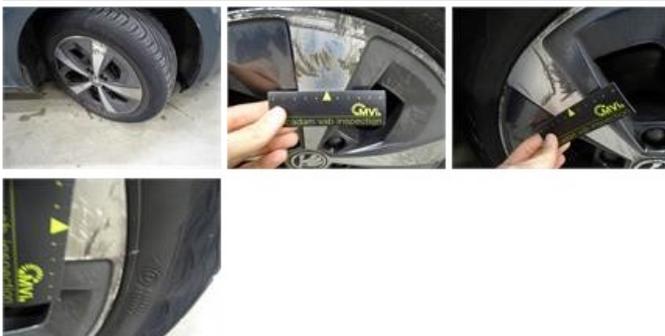
Alloy rim F R polished, Scratch(es), LI - Repair and paint (complete) 95,00

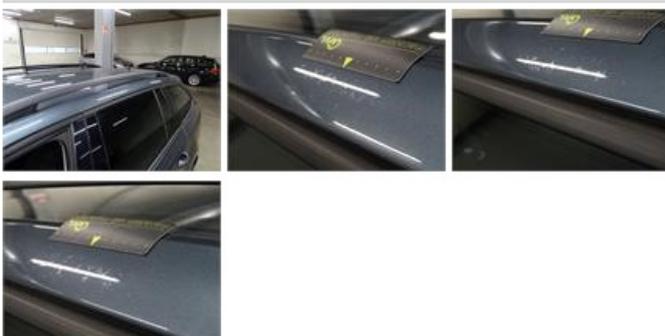
Roof pillar L, Chemical polution, LI - Repair and paint (complete) 220,18

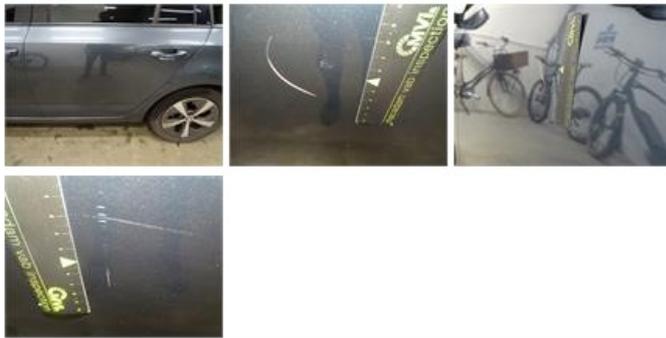
Door R L, Dent(s) and scratch(es), LI - Repair and paint (complete)

318,35

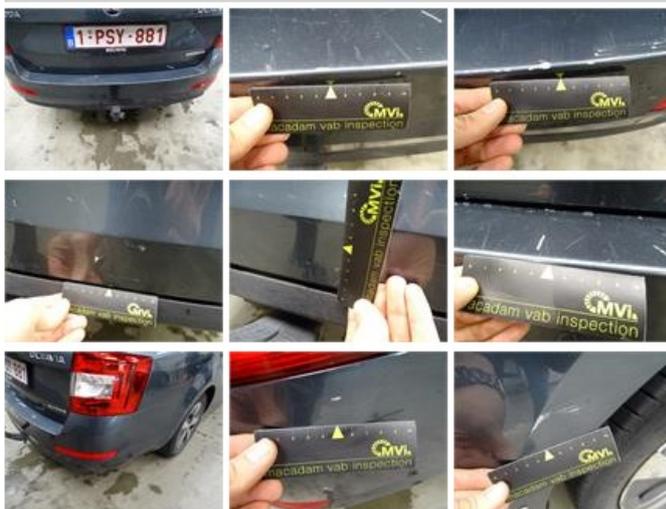
Bumper R, Scratch(es), LI - Repair and paint (complete)

211,80

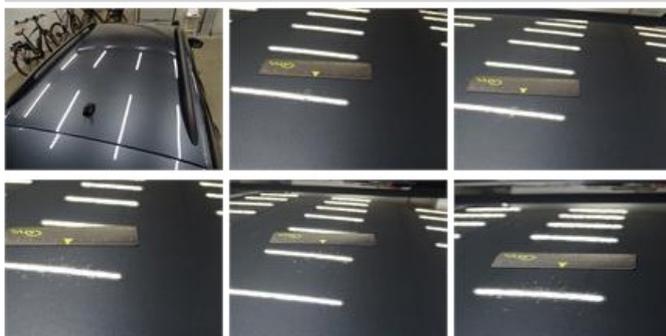
Roof, Chemical pollution, LI - Repair and paint (complete)

481,50

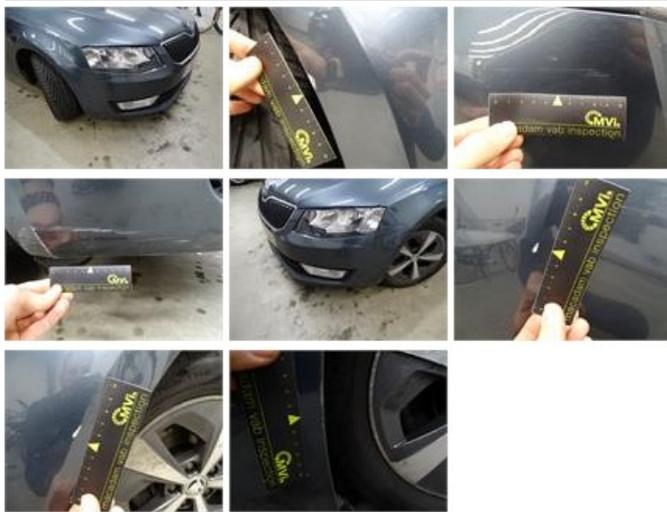
Bumper F, Scratch(es), LI - Repair and paint (complete)

211,80

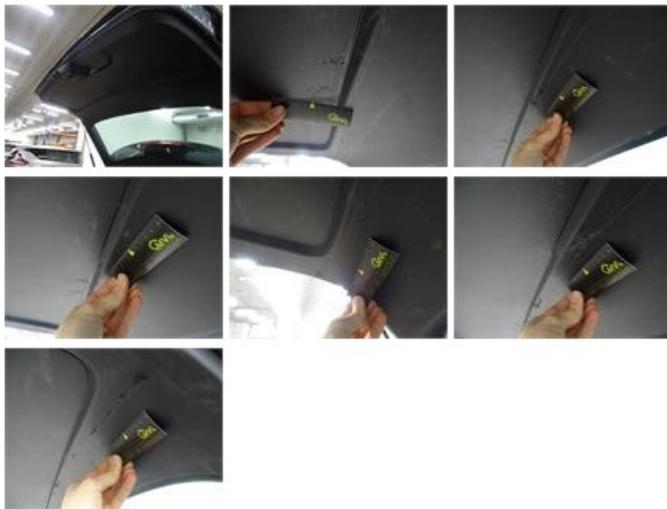
Trunk lid covering R, Scratch(es), Smart repair

110,64

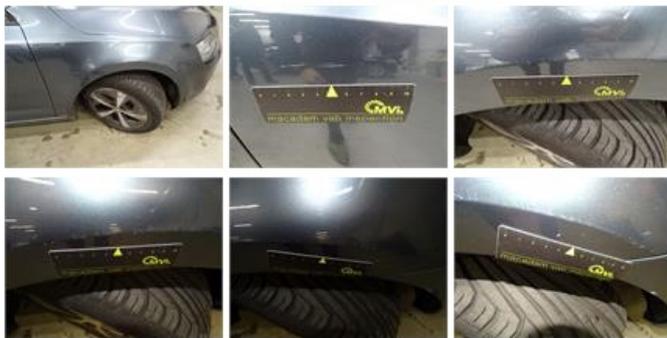
Wing F R, Scratch(es), LI - Repair and paint (complete)

220,18

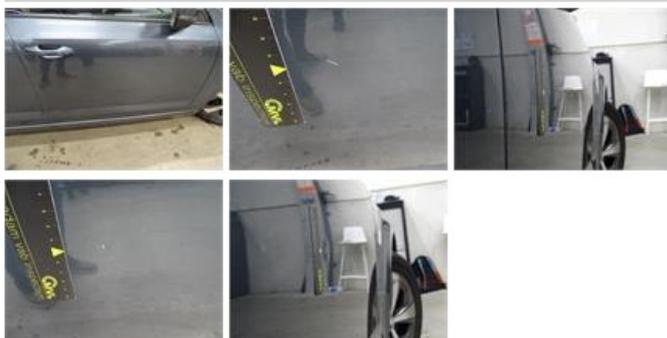
Door F R, Dent(s) and scratch(es), LI - Repair and paint (complete)

318,35

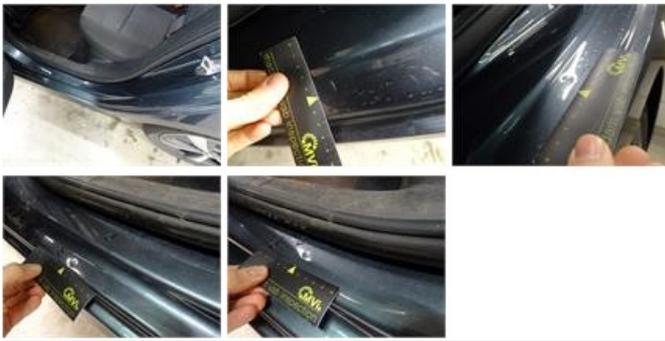
Rocker panel inner R L, Dent(s), LI - Repair and paint (complete)

115,56

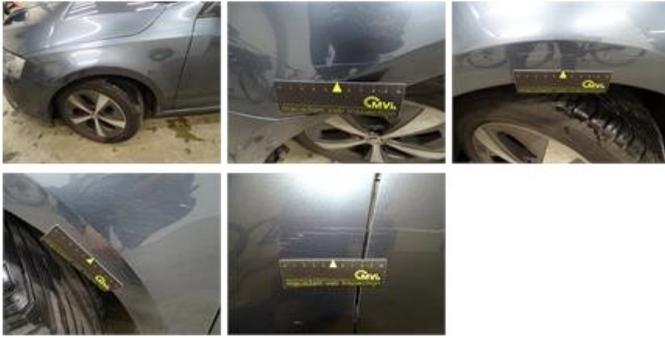
Wing F L, Scratch(es), LI - Repair and paint (complete)

220,18
