VOLKSWAGEN GOLF VII: 1KH636

Limited Technical Inspection

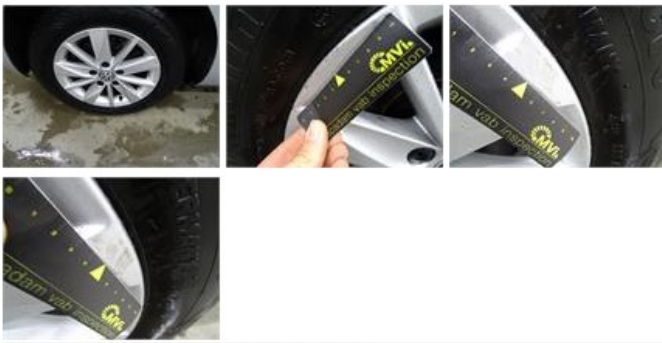
Total cost ex VAT	1124,68
Alloy rim R R, Scratch(es), LI - Repair and paint (complete)	95,00

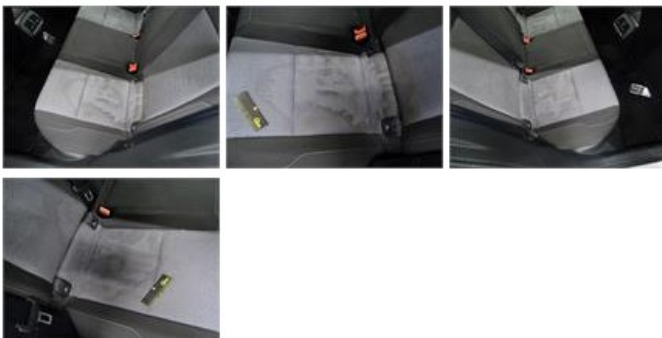
Seat cover R, Stain, Cleaning 50,00

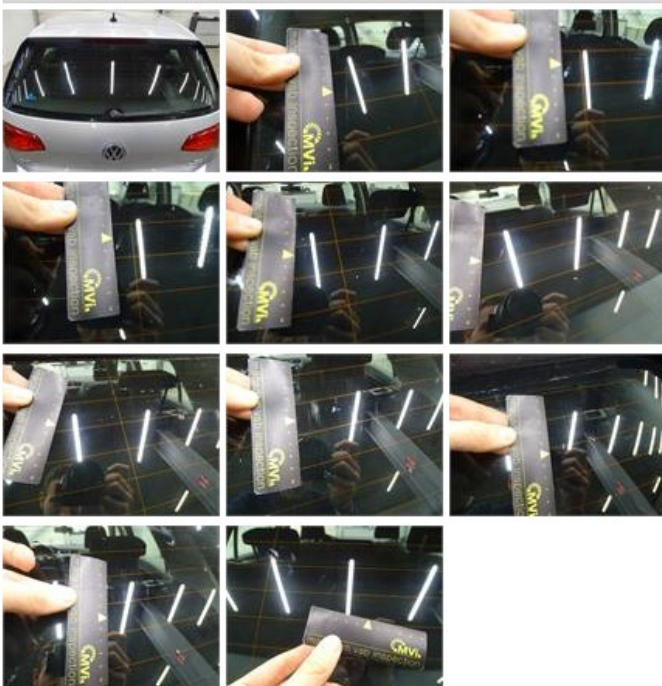
Rear window, Scratch(es), E - Replace 0,00

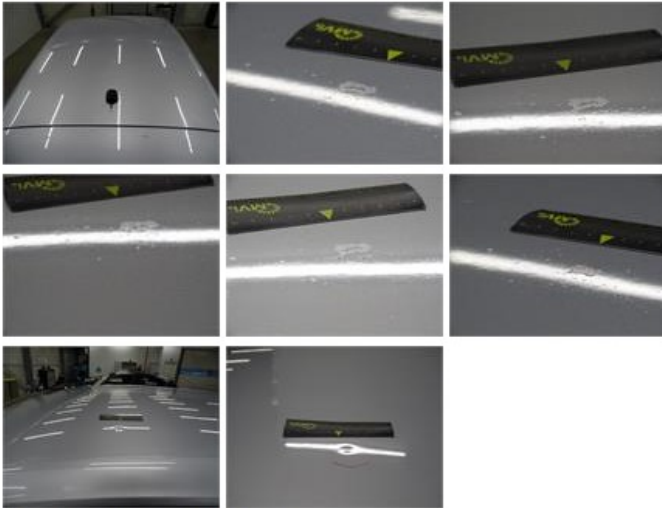
Roof, Chemical polution, LI - Repair and paint (complete) 481,50

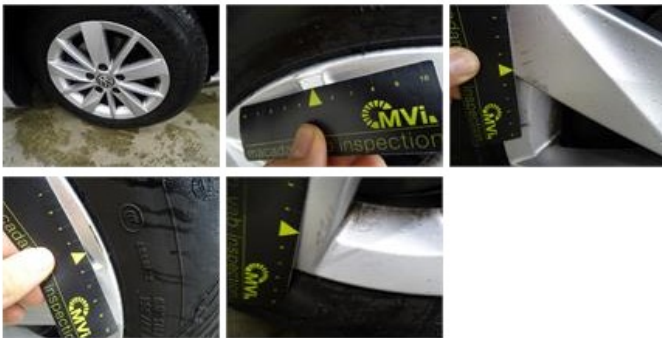
Alloy rim F L, Scratch(es), LI - Repair and paint (complete) 95,00

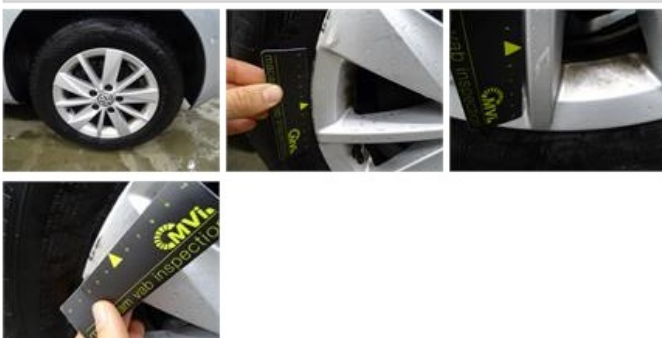
Alloy rim R L, Scratch(es), LI - Repair and paint (complete) 95,00
