SKODA Superb: 1GWX963

Limited Technical Inspection

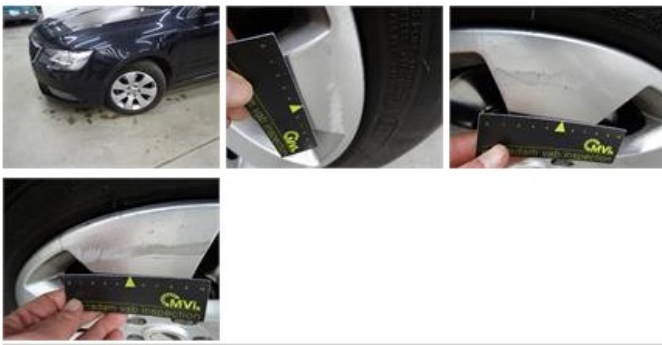
Total cost ex VAT	1570,22
Rear window, Scratch(es), Acceptable	0,00
<i>No pictures to display</i>	
Alloy rim F L, Scratch(es), LI - Repair and paint (complete)	95,00

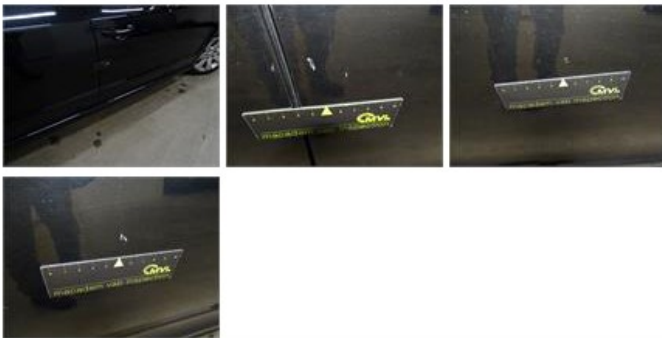
Door F R, Scratch(es), LI - Repair and paint (complete) 382,02

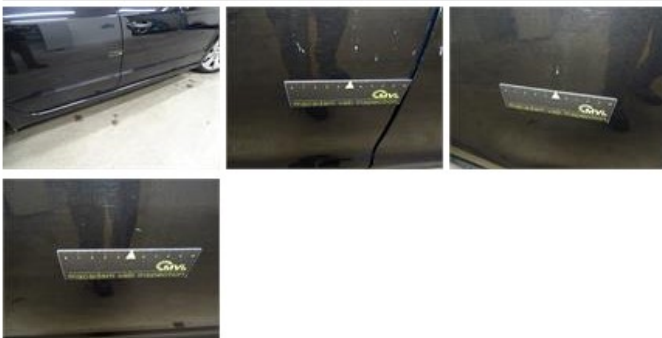
Door R R, Scratch(es), LI - Repair and paint (complete) 382,02
