VOLKSWAGEN TOURAN: 1KPD257

Vinnumber:	WVGZZZ1TZFW081887	Versionname:	1.6 CR TDI TRENDLINE BLUEMOTION TECH
First Registrationdate:	8/06/2015	Fiscalpower:	
Expertise Mileage:	95915	Power Kw:	77
Bodytype:		Body color:	Blue
Gearbox:	MAN 6 VIT	Paint type:	Metalic
Transmission:	Front	Rims summer:	Aluminium
Fueltype:	Diesel	Oil level:	OK
Battery functioning:	Yes	Parking lot:	3413
Number of doors:	5		
Number of seats:	7		
Number head rests:	7		
Rims summer:	Aluminium		
Category:	Passenger Car		
Oil level:	OK		
Registration Certificate Car (BE):	Yes

Limited Technical Inspection

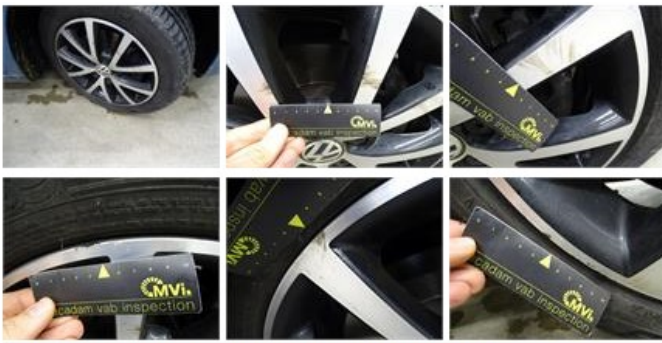
Total cost ex VAT	869,24
Alloy rim F R polished, Scratch(es), LI - Repair and paint (complete)	95,00

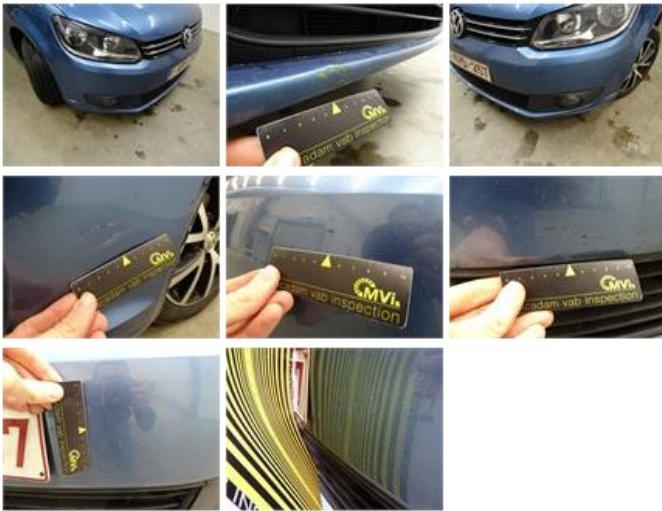
Bumper F, Dent(s) and scratch(es), LI - Repair and paint (complete)

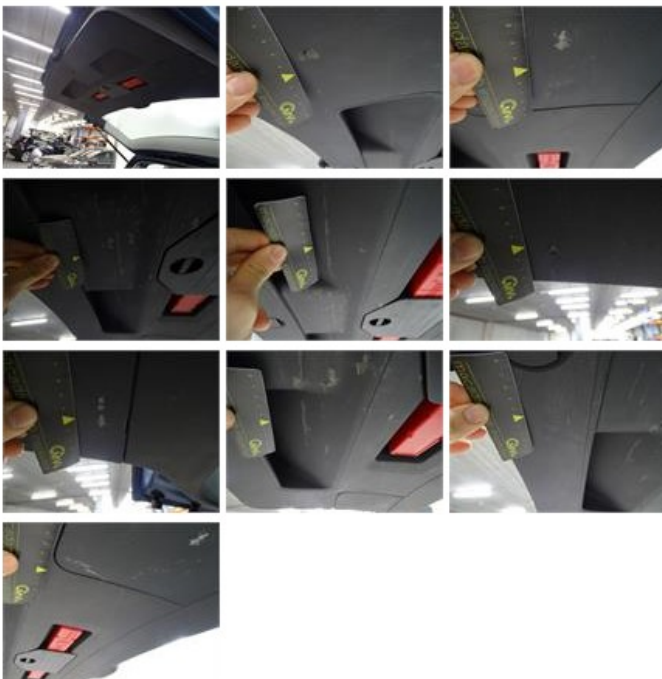
Trunk lid covering R, Scratch(es), Smart repair

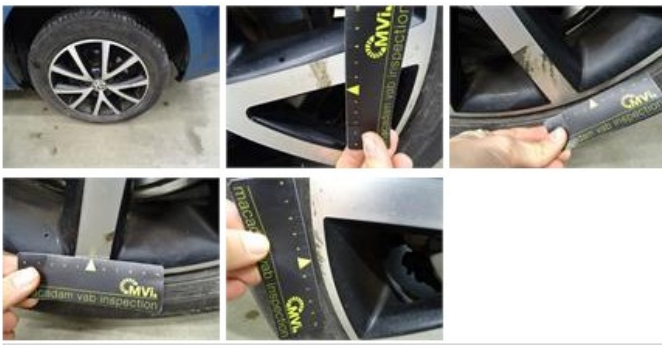
Alloy rim R L polished, Scratch(es), LI - Repair and paint (complete)

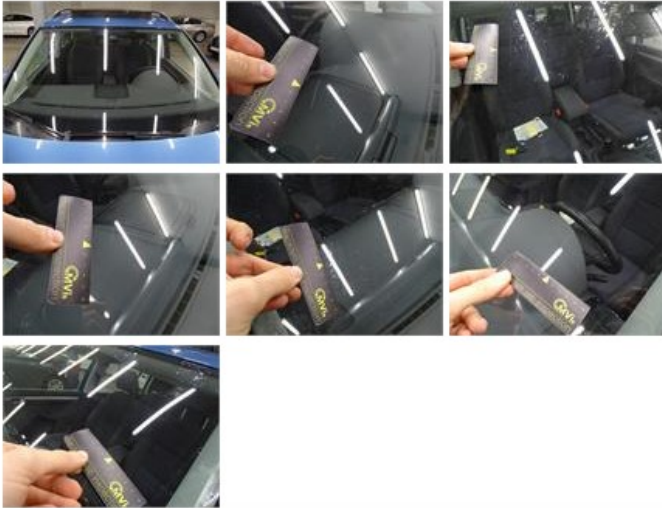
Windscreen, Scratch(es), Acceptable 0,00

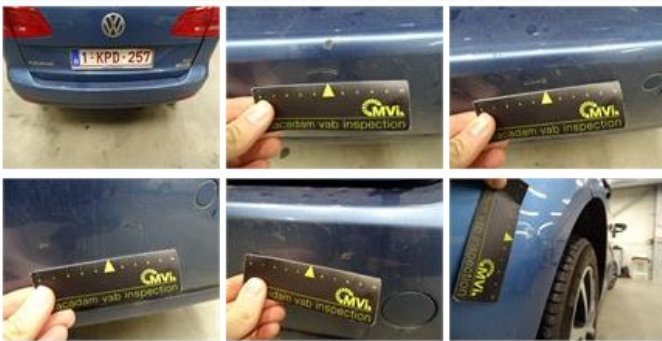
Bumper R, Scratch(es), LI - Repair and paint (complete) 211,80

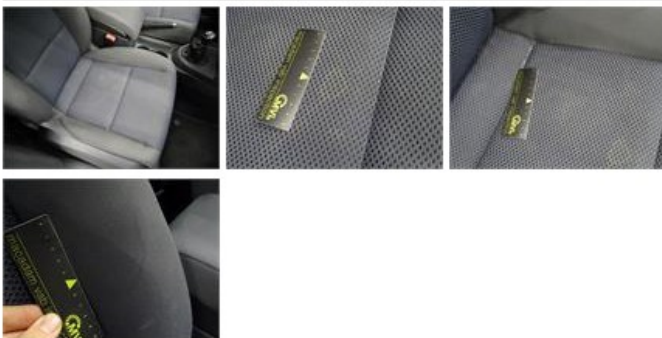
Seat cover F R, Stain, Cleaning 25,00
