**VOLVO V40: 1HLU584**

**Limited Technical Inspection**

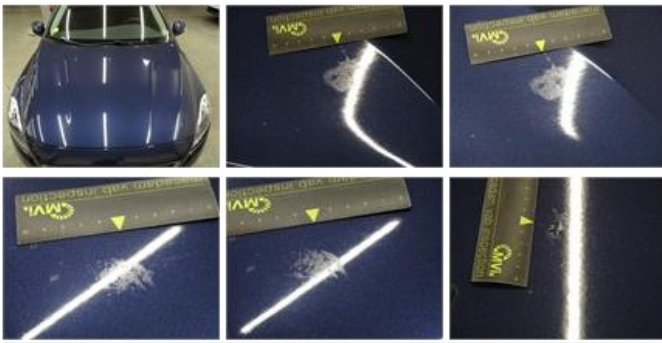
<b>Total cost ex VAT</b>	<b>3603,01</b>
<b>Bonnet, Chemical polution, LI - Repair and paint (complete)</b>	<b>290,08</b>

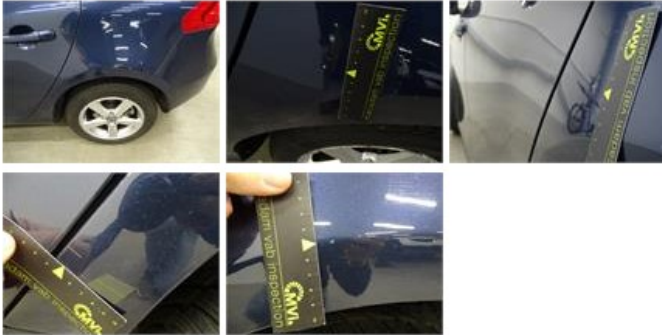
Wing R L, Dent(s) and scratch(es), LI - Repair and paint (complete) 308,20

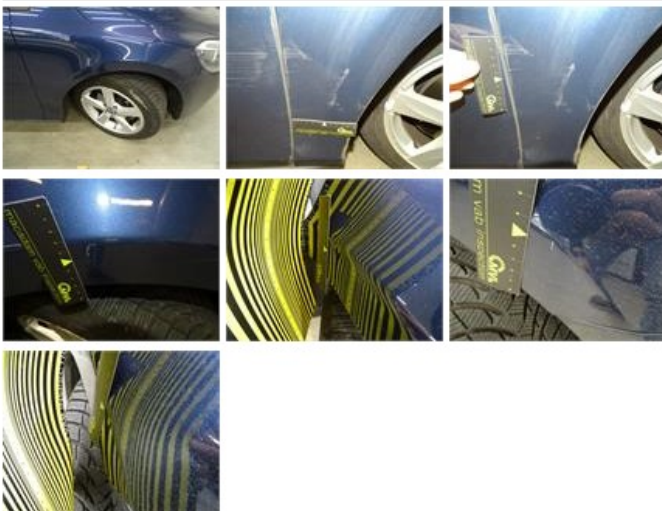
Wing F R, Dent(s) and scratch(es), LI - Repair and paint (complete) 220,18

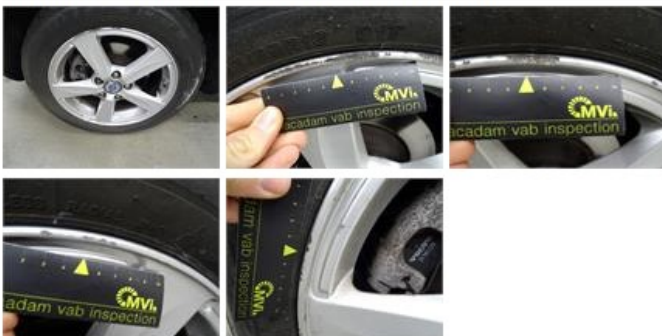
Alloy rim R R, Scratch(es), LI - Repair and paint (complete) 95,00

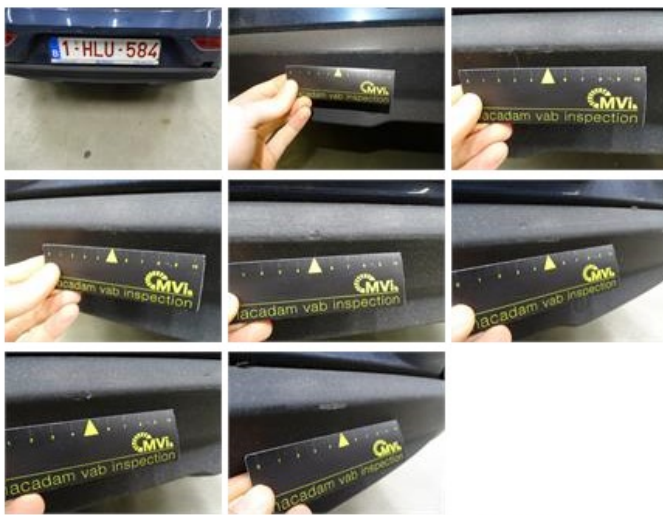
Bumper cover R M, Scratch(es), Smart repair 110,64

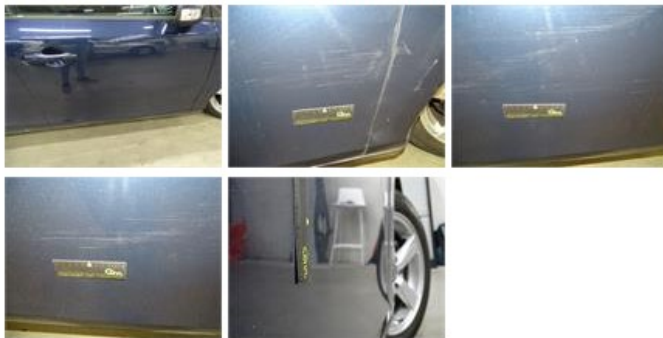
Door F R, Dent(s) and scratch(es), LI - Repair and paint (complete)

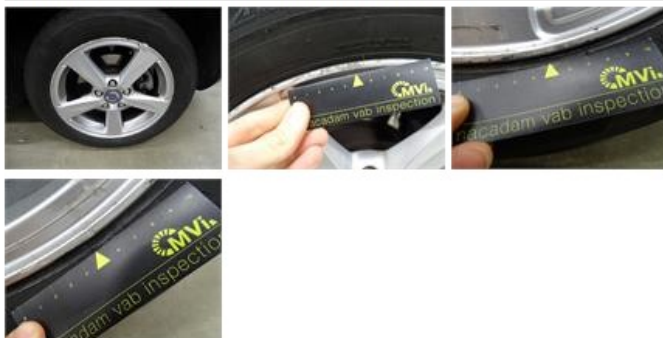
Alloy rim R L, Scratch(es), LI - Repair and paint (complete)

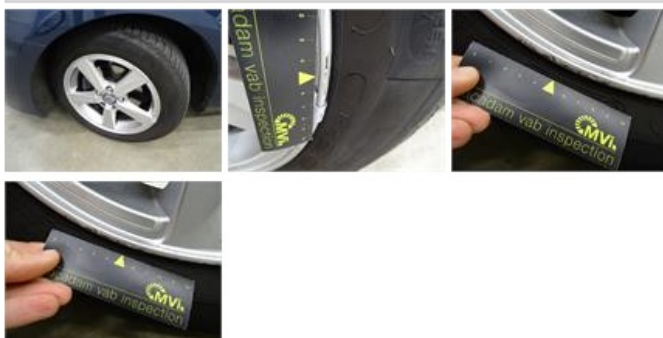
Alloy rim F L, Scratch(es), LI - Repair and paint (complete)

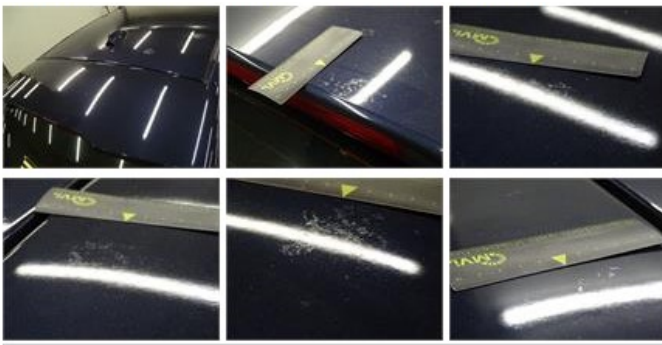
Rear spoiler, Chemical polution, LI - Repair and paint (complete)

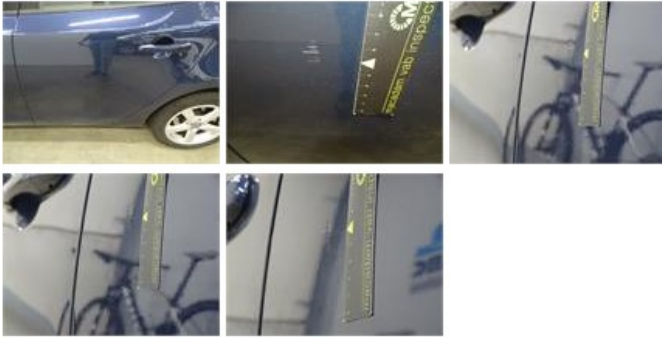
Door R L, Dent(s) and scratch(es), LI - Repair and paint (complete) 318,35

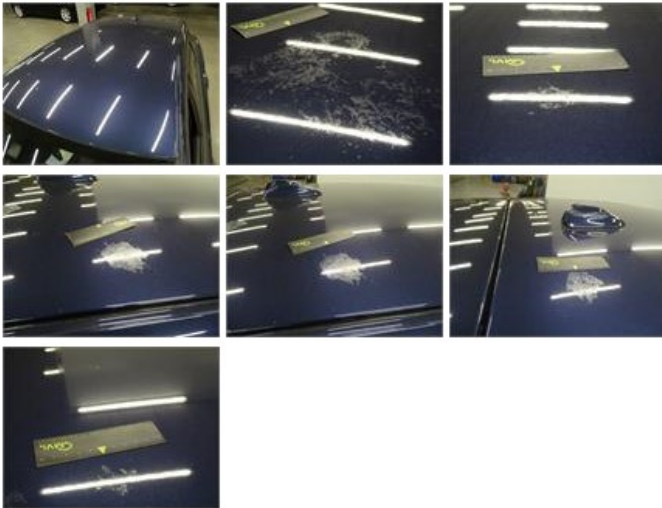
Roof, Chemical polution, LI - Repair and paint (complete) 481,50

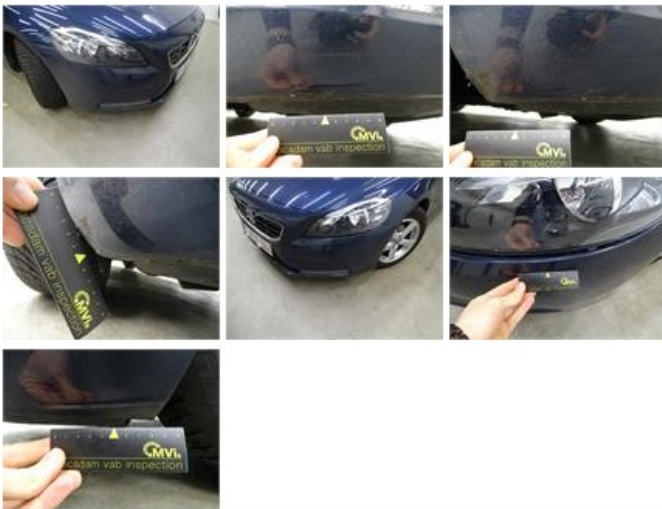
Bumper F, Scratch(es), LI - Repair and paint (complete) 211,80

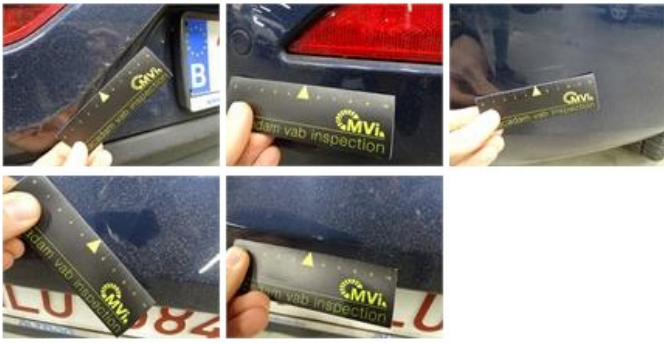
Bumper R, Scratch(es), LI - Repair and paint (complete) 211,80
