VOLVO XC60: 1LNY618

Limited Technical Inspection

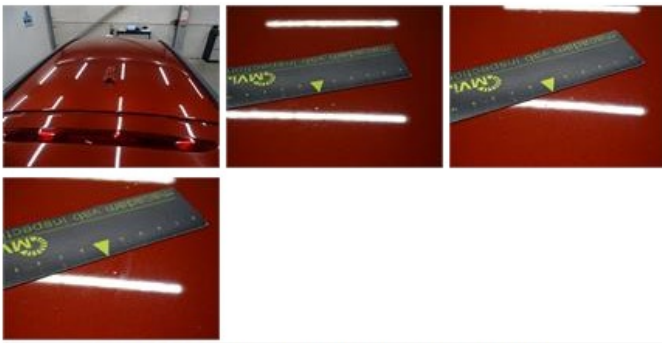
Total cost ex VAT	2598,63
Roof, Bad repair, Acceptable	0,00

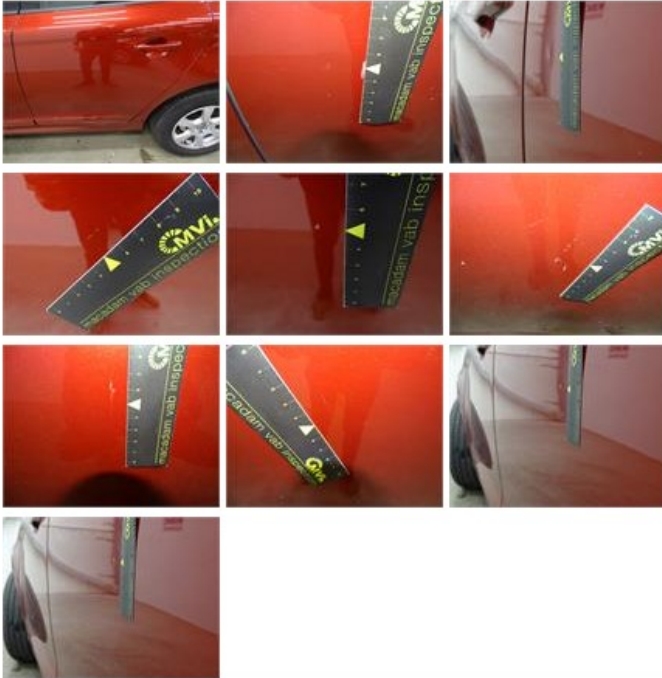
Door R L, Dent(s) and scratch(es), LI - Repair and paint (complete) 382,02

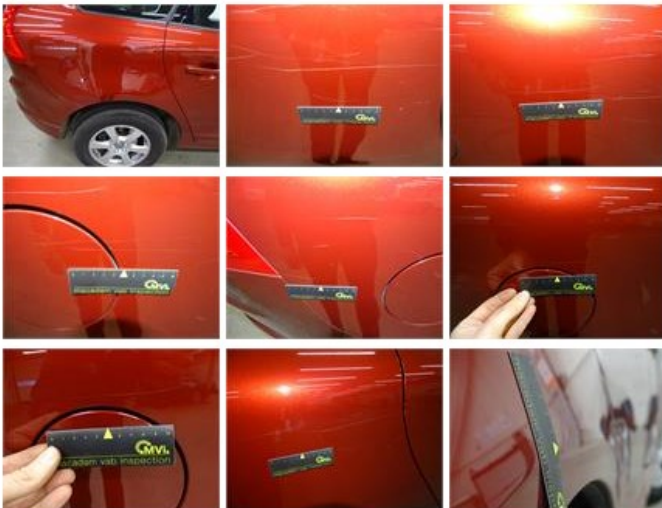
Wing R R, Dent(s) and scratch(es), LI - Repair and paint (complete) 369,84

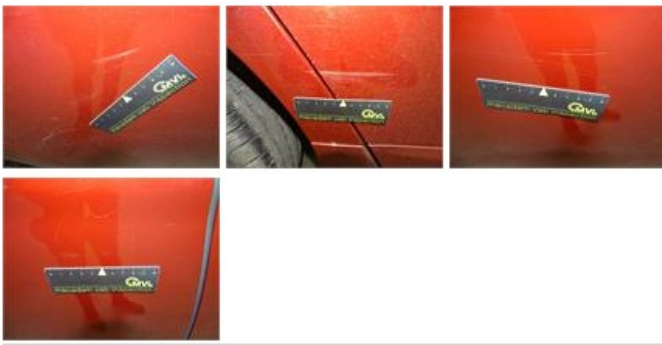
Door R R, Scratch(es), LI - Repair and paint (complete) 382,02

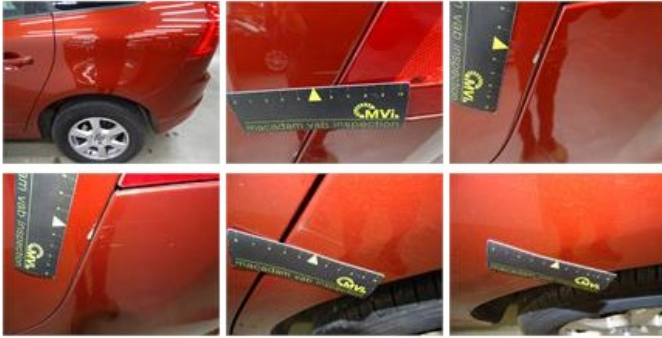
Wing R L, Scratch(es), LI - Repair and paint (complete) 369,84

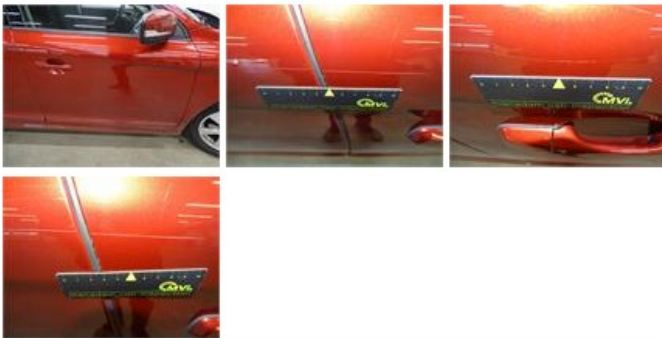
Door F R, Scratch(es), LI - Repair and paint (complete) 382,02

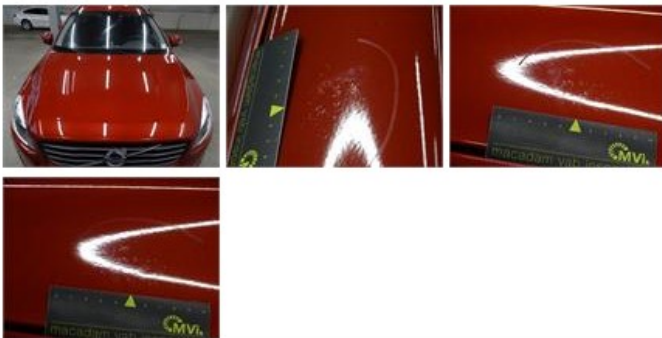
Bonnet, Chemical polution, LI - Repair and paint (complete) 348,09

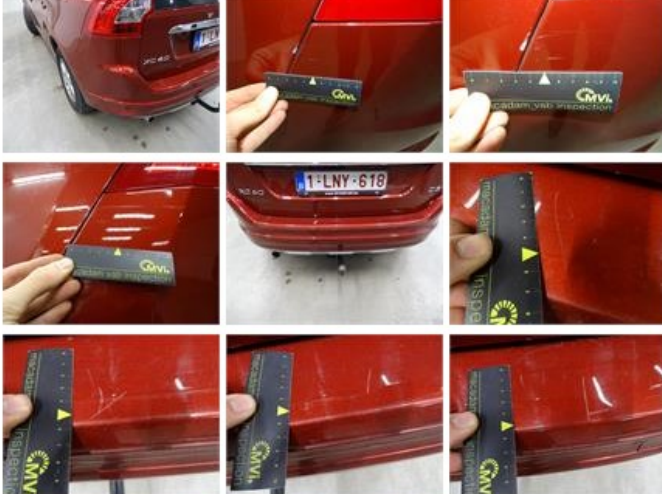
Bumper R, Dent(s) and scratch(es), LI - Repair and paint (complete) 254,16

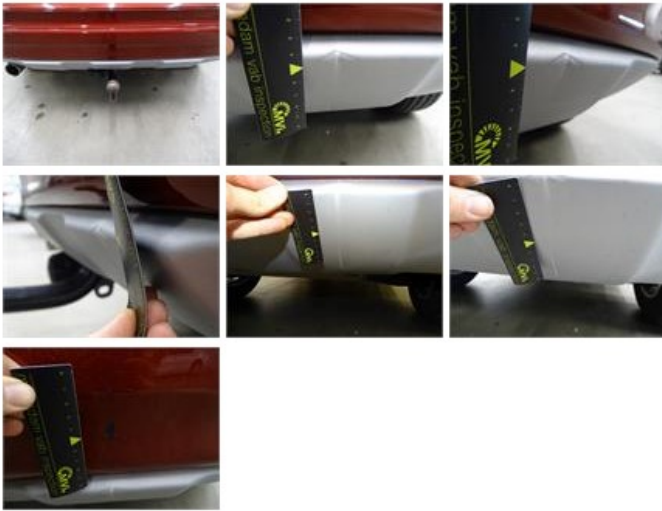
Bumper cover R M, Dent(s) and scratch(es), Smart repair
