VOLVO V60: 1HRN631

Limited Technical Inspection

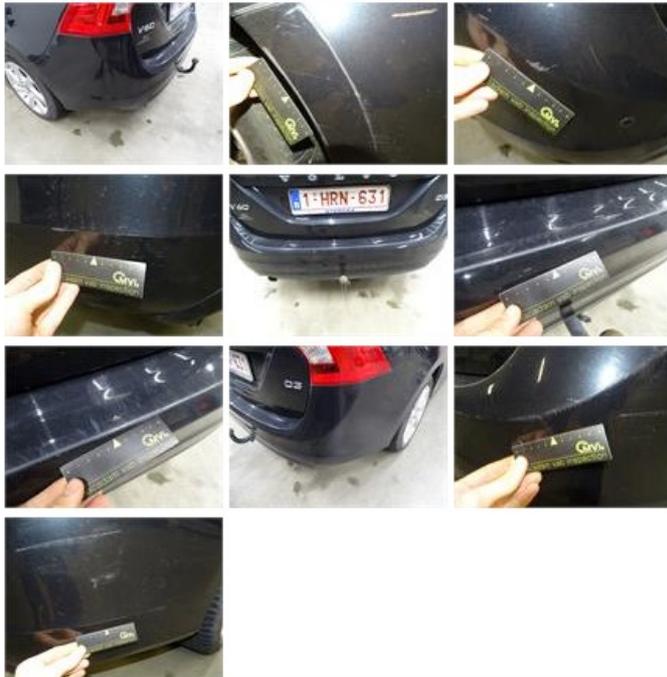
Bumper R, Scratch(es), LI - Repair and paint (complete) 211,80

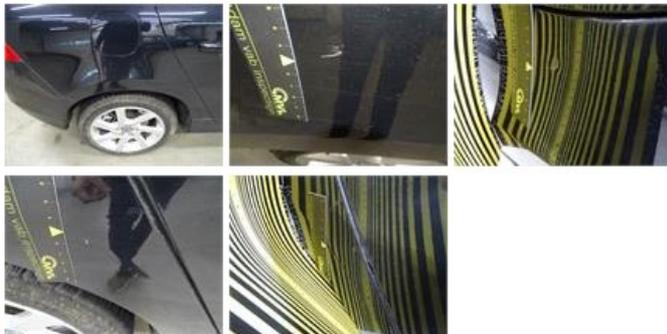
Wing R R, Dent(s) and scratch(es), LI - Repair and paint (complete) 308,20

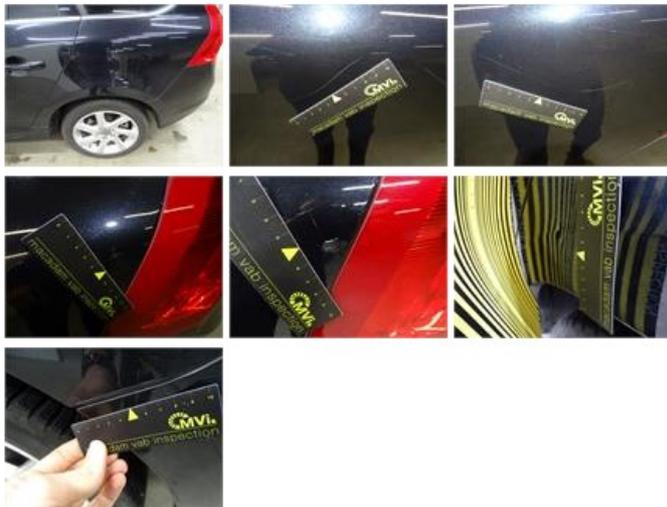
Wing R L, Dent(s) and scratch(es), LI - Repair and paint (complete) 308,20

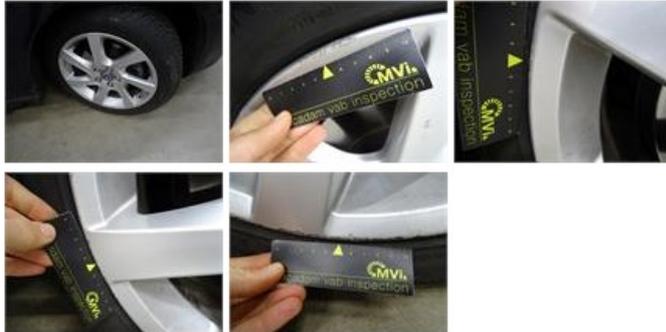
Alloy rim F R, Scratch(es), LI - Repair and paint (complete) 95,00

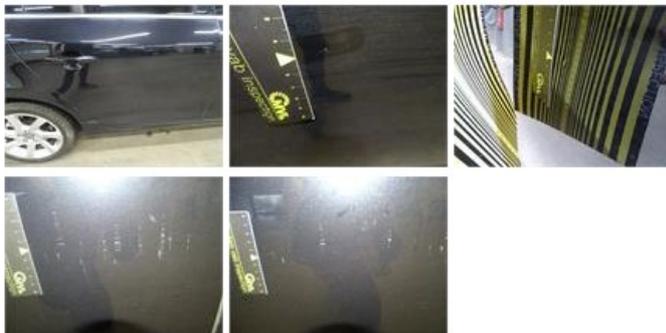
Door R R, Dent(s) and scratch(es), LI - Repair and paint (complete) 318,35

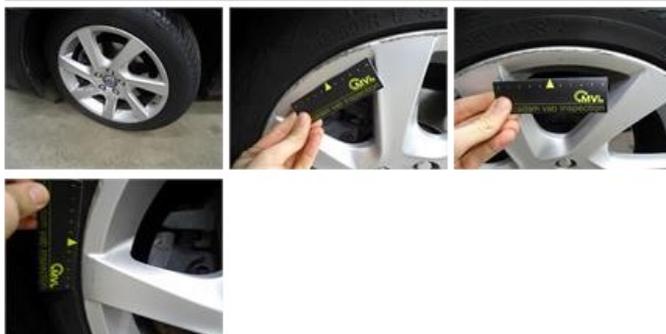
Alloy rim F L, Scratch(es), LI - Repair and paint (complete) 95,00

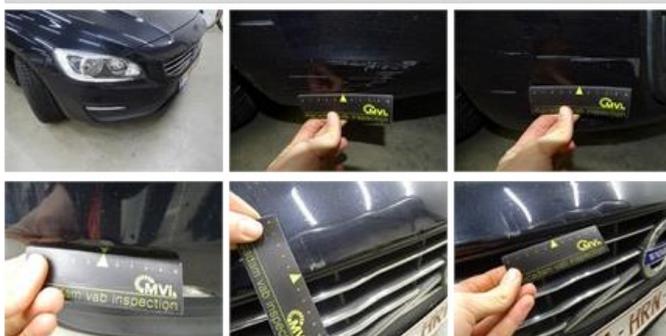
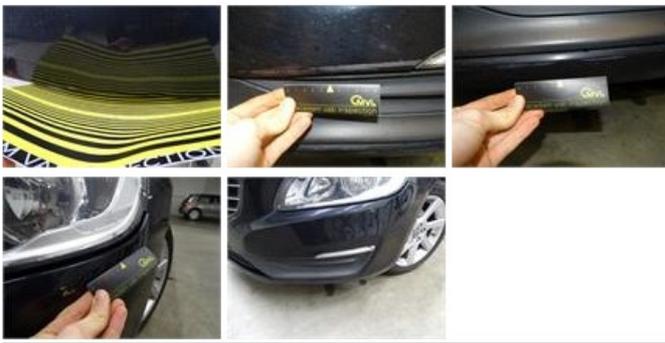
Bumper F, Dent(s) and scratch(es), LI - Repair and paint (complete) 211,80

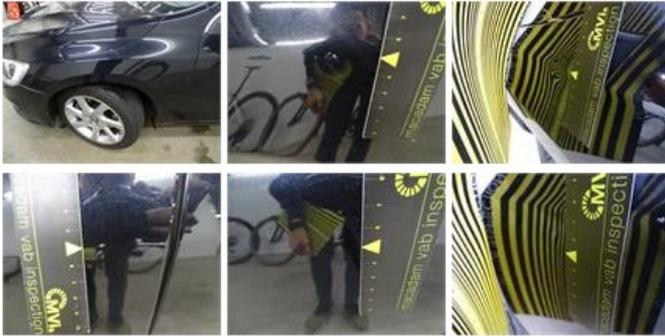
Wing F L, Dent(s) and scratch(es), LI - Repair and paint (complete) 220,18

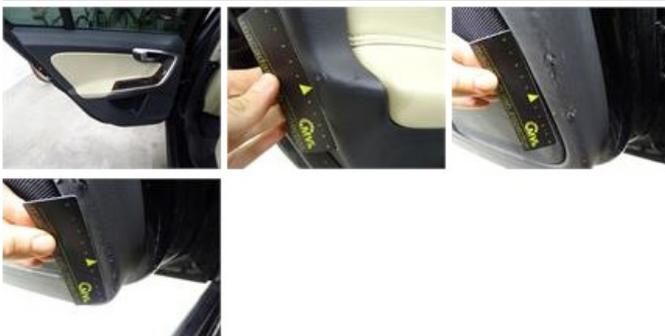
Door panel R L, Tear, Smart repair 110,64
