VOLVO V40: 1LSY771

Limited Technical Inspection

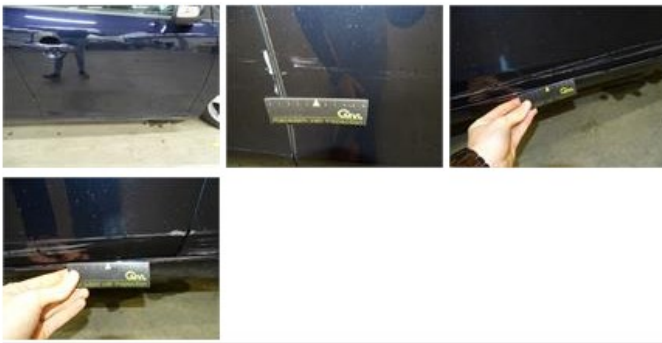
Door F R, Scratch(es), LI - Repair and paint (complete) 318,35

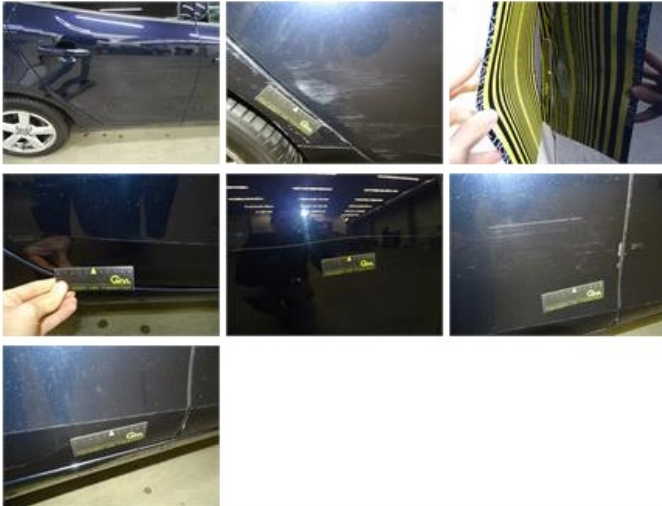
Door R R, Dent(s) and scratch(es), LI - Repair and paint (complete) 318,35

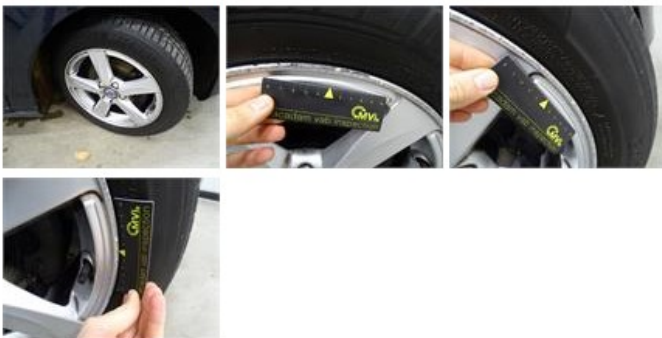
Alloy rim F R, Scratch(es), LI - Repair and paint (complete) 95,00

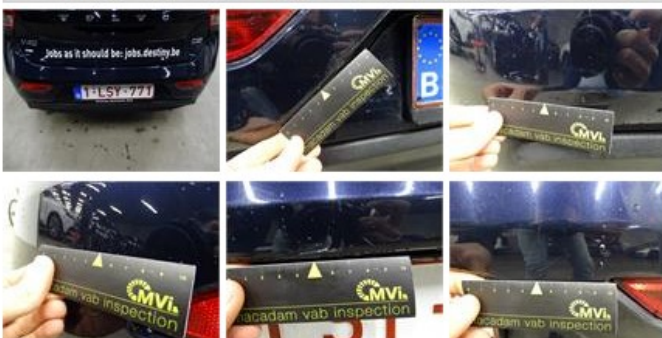
Bumper R, Scratch(es), LI - Repair and paint (complete) 211,80
