**VOLVO V60: 1HZR612**

**Limited Technical Inspection**

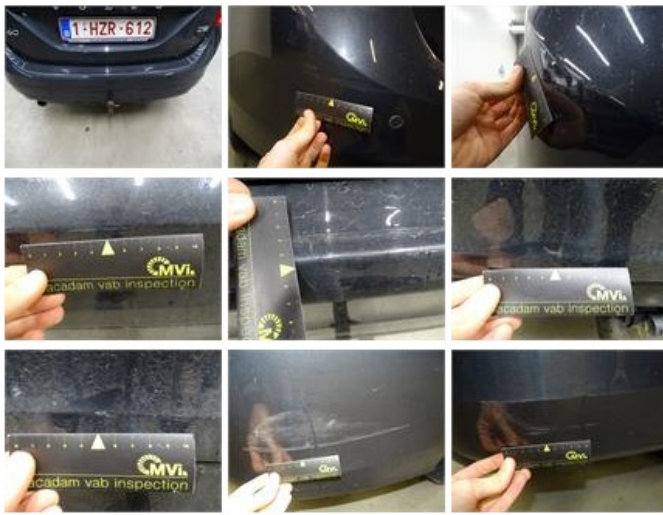
Total cost ex VAT	496,80
Bumper R, Dent(s) and scratch(es), LI - Repair and paint (complete)	211,80

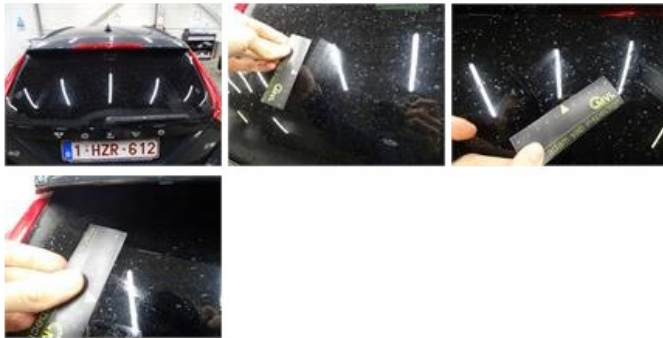
Bumper F, Scratch(es), Acceptable	0,00
<i>No pictures to display</i>	
Wing F R, Scratch(es), Acceptable	0,00
<i>No pictures to display</i>	
Door R L, Scratch(es), Acceptable	0,00
<i>No pictures to display</i>	
Rear window, Scratch(es), Acceptable	0,00

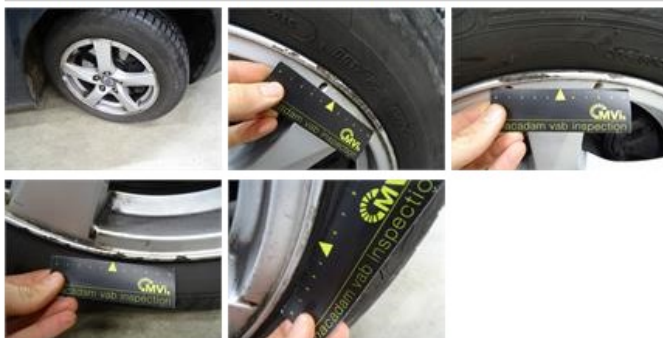
Door F R, Scratch(es), Acceptable	0,00
<i>No pictures to display</i>	
Alloy rim F R, Scratch(es), LI - Repair and paint (complete)	95,00
