## AUDI A1: 1HCL452

| Vinnumber: | WAUZZZ8X7EB119904 | Versionname: | A1 SB Attraction 90PK |

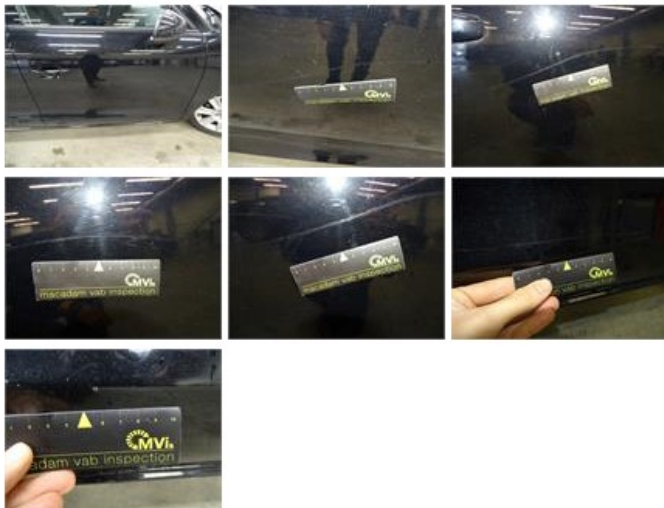
Door F R, Scratch(es), LI - Repair and paint (complete)

254,68

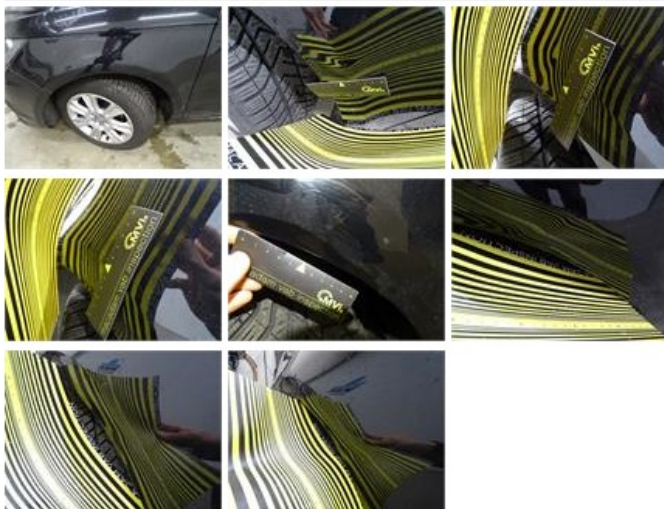
Wing F L, Dent(s) and scratch(es), LI - Repair and paint (complete)

176,14

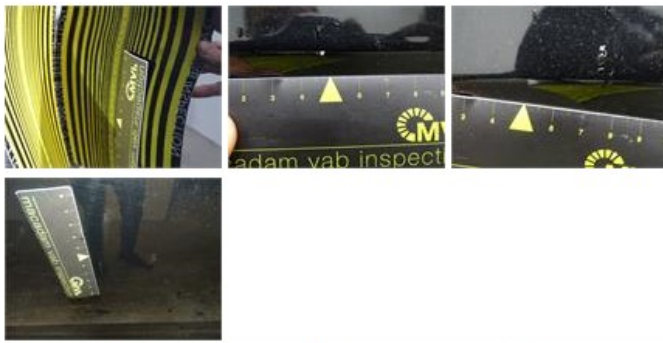
Door F L, Dent(s) and scratch(es), LI - Repair and paint (complete)

254,68

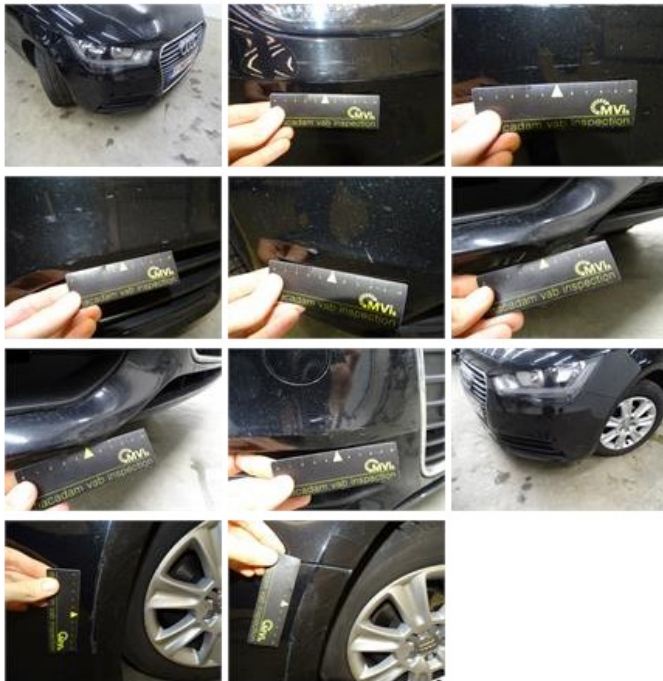
Bumper F, Dent(s) and scratch(es), LI - Repair and paint (complete)

169,44

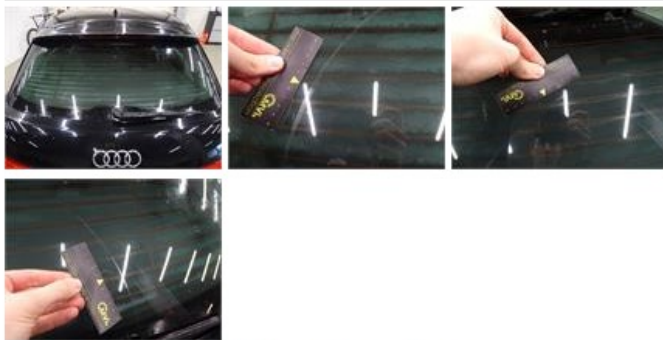
Rear window, Scratch(es), E - Replace

320,00

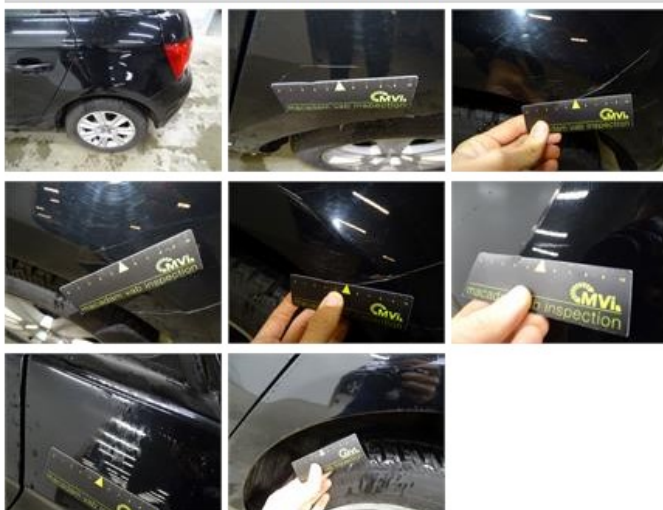
Wing R L, Scratch(es), LI - Repair and paint (complete)

246,56

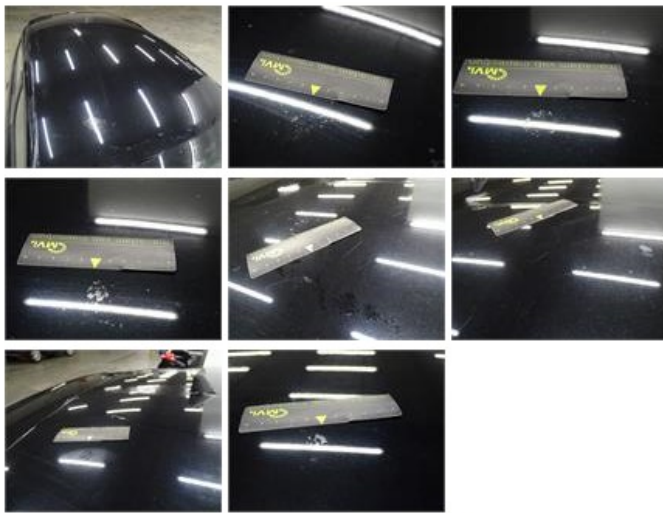
Roof, Chemical polution, LI - Repair and paint (complete)

385,20

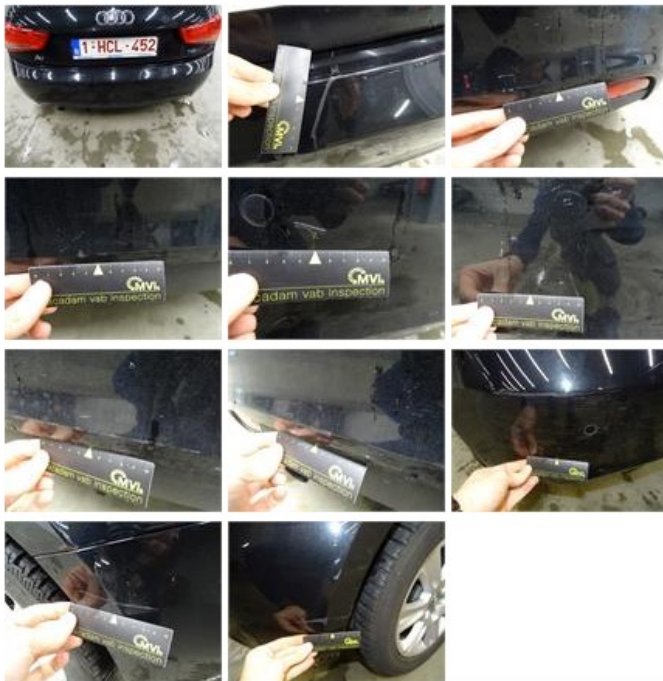
Bumper R, Scratch(es), LI - Repair and paint (complete)

169,44

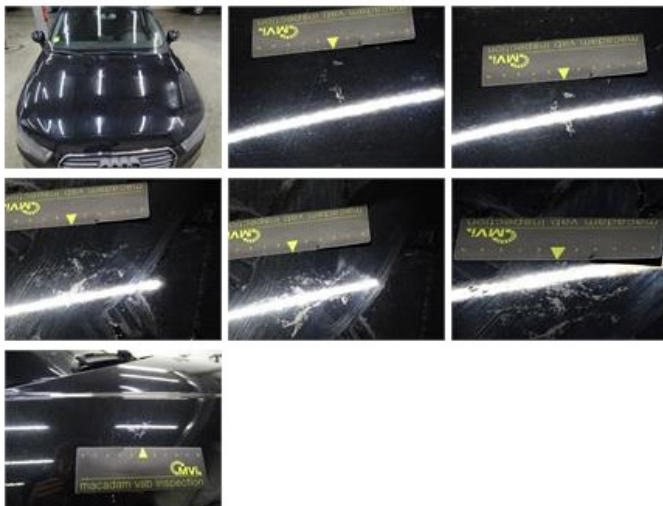
Bonnet, Chemical polution, LI - Repair and paint (complete)

232,06

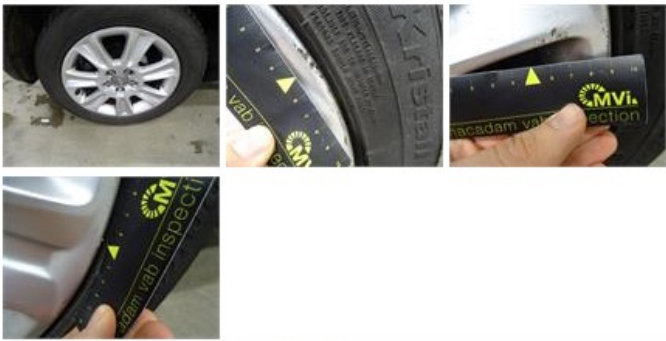
Alloy rim R R, Scratch(es), LI - Repair and paint (complete)

95,00
