BMW 1 HATCH: 1N1B178

| Vinnumber: | WBA1V91030V736973 | Versionname: | 1.5 116D EFFICIENTDYNAMICS EDIT. (85KW) |

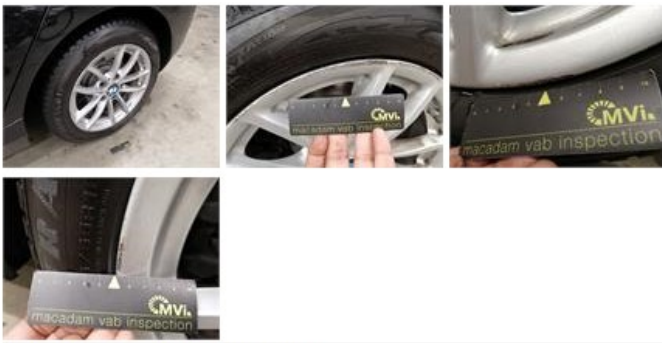
| Alloy rim R L, Scratch(es), LI - Repair and paint (complete) | | | 95,00 |

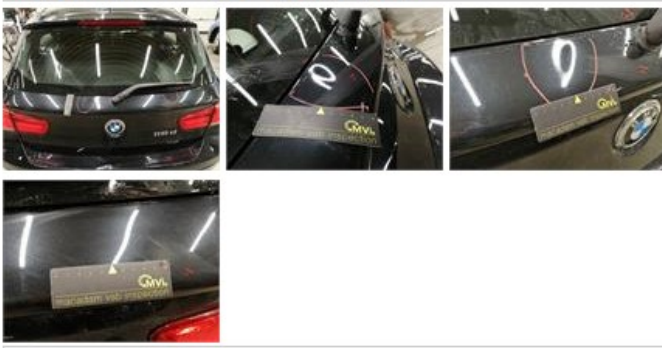
Tailgate, Dent(s), LI - Repair and paint (complete) 301,68

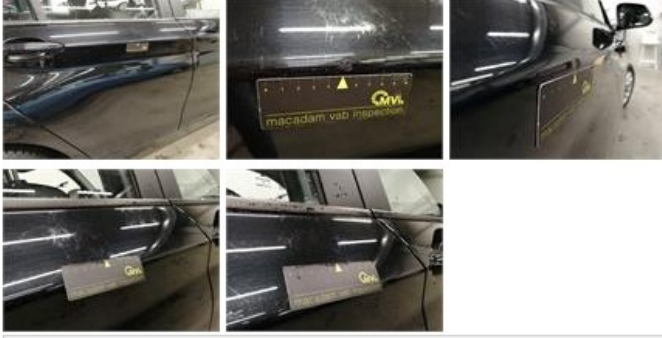
Door R R, Dent(s) and scratch(es), Acceptable 0,00
