**BMW 1: 1HVS875**

**Limited Technical Inspection**

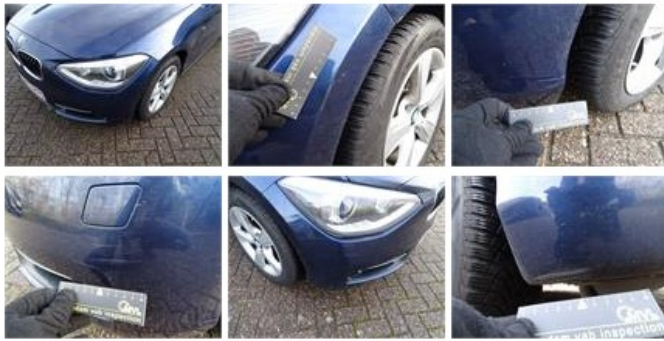
Bumper F, Scratch(es), LI - Repair and paint (complete) 211,80

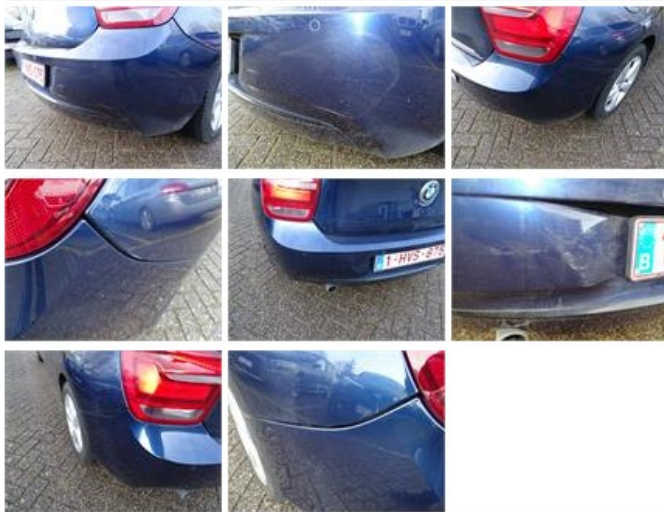
Bumper R, Deformed / Strained, Le - Replace and paint 651,00

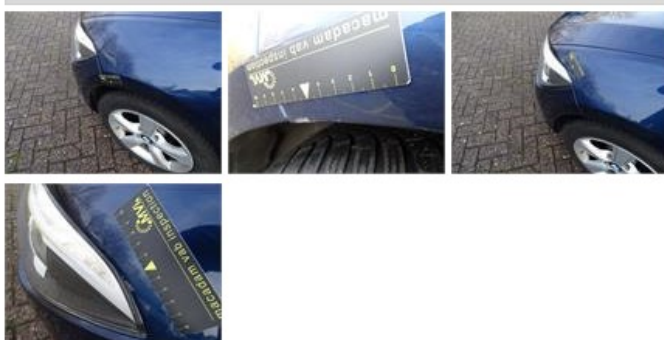
Wing F L, Rust, LI - Repair and paint (complete) 220,18
