**AUDI A5 SPORTBACK: 1KCG288**

**Limited Technical Inspection**

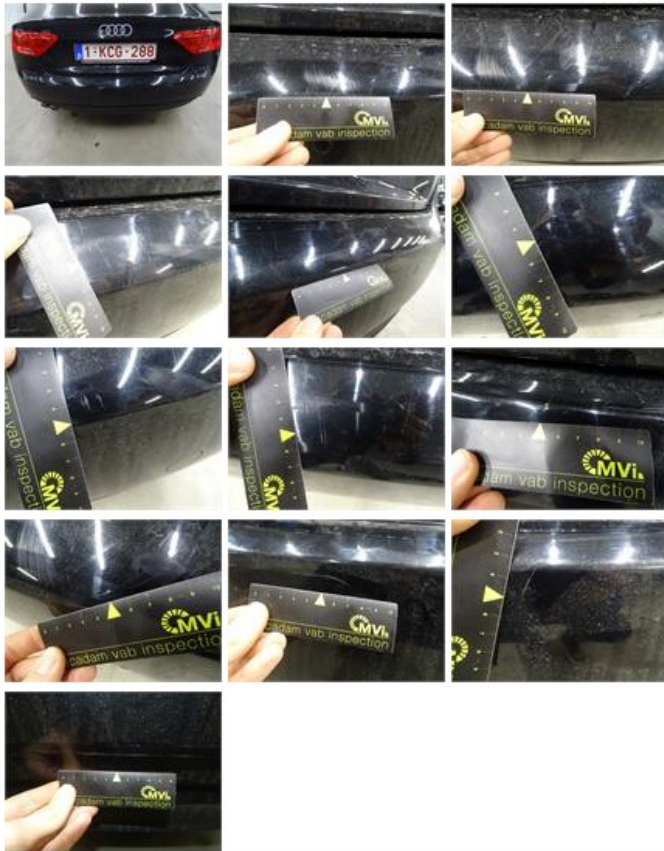
Bumper R, Scratch(es), LI - Repair and paint (complete) 254,16

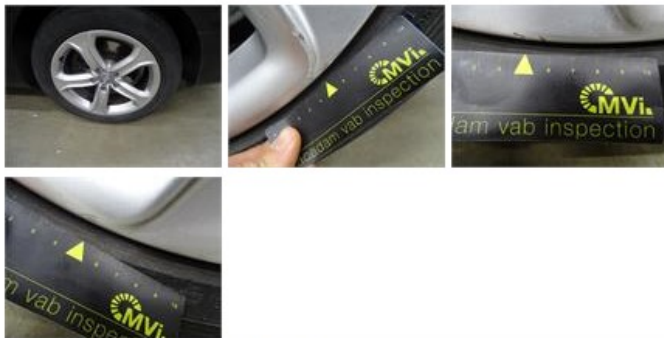
Alloy rim R L, Scratch(es), LI - Repair and paint (complete) 95,00

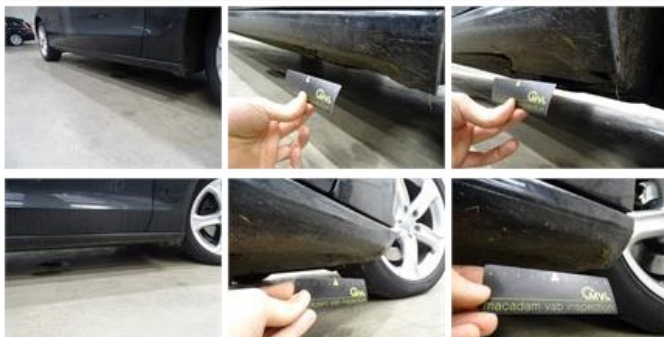
Sill outer R, Dent(s), LI - Repair and paint (complete) 372,60

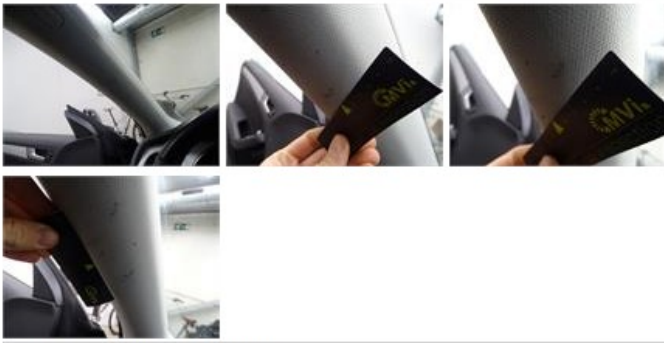
Language, Scratch(es), Acceptable		0,00
<i>No pictures to display</i>		
Bumper F, Dent(s) and scratch(es), LI - Repair and paint (complete)		254,16
Rearview mirror housing L, Scratch(es), Acceptable		0,00
<i>No pictures to display</i>		
Door F L, Dent(s) and scratch(es), Acceptable		0,00
<i>No pictures to display</i>		
Door R R, Scratch(es), Acceptable		0,00
<i>No pictures to display</i>		
Wing R R, Dent(s) and scratch(es), LI - Repair and paint (complete)		369,84
Floor covering F L, Hole, Smart repair		64,32
Alloy rim F L, Scratch(es), LI - Repair and paint (complete)		95,00
Windscreen, Stone chip(s), Acceptable		0,00
Wing F R, Scratch(es), Acceptable		0,00
<i>No pictures to display</i>		
Door F R, Dent(s) and scratch(es), Acceptable		0,00
<i>No pictures to display</i>		
Covering interior A pillar L, Hole, Smart repair		110,64
