BMW 1 HATCH: TU4603

Limited Technical Inspection

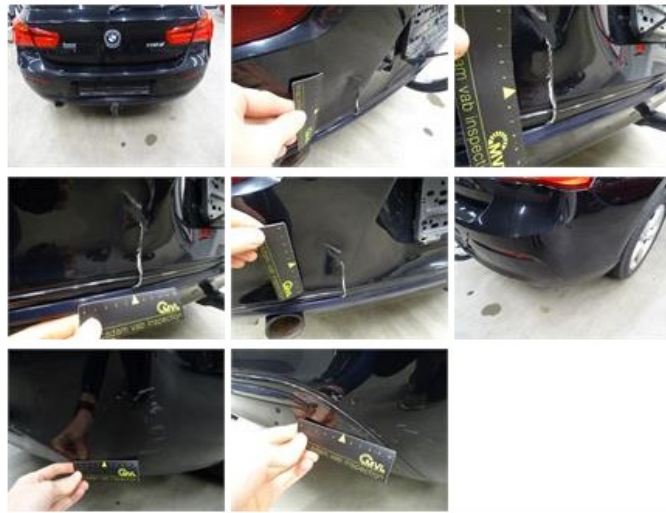
Bumper R, Broken, Le - Replace and paint 651,00

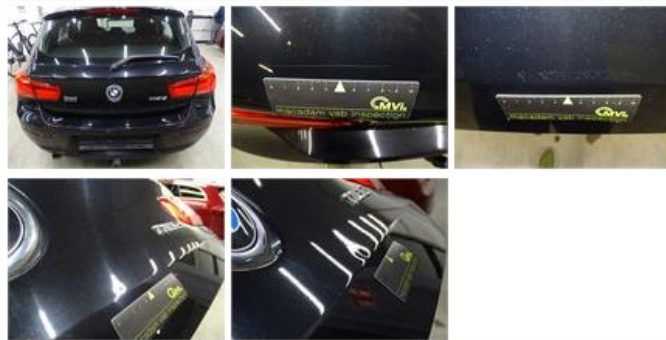
Tailgate, Dent(s) and scratch(es), LI - Repair and paint (complete) 301,68
