**LU Audi q5: GP4162**

**Limited Technical Inspection**

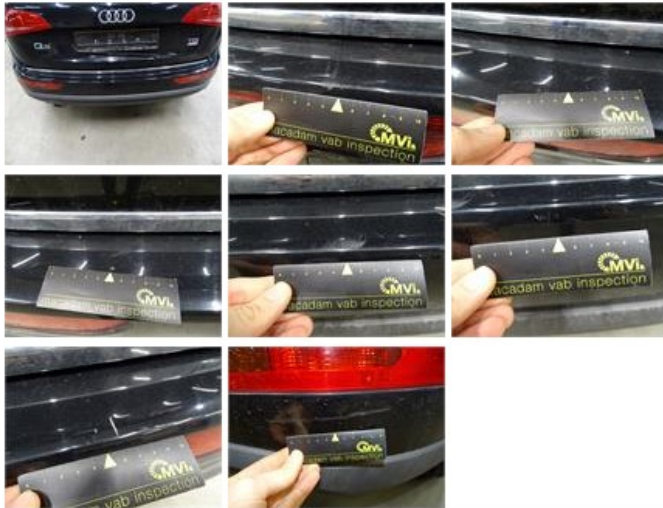
Bumper R, Scratch(es), LI - Repair and paint (complete)	254,16
---	--------

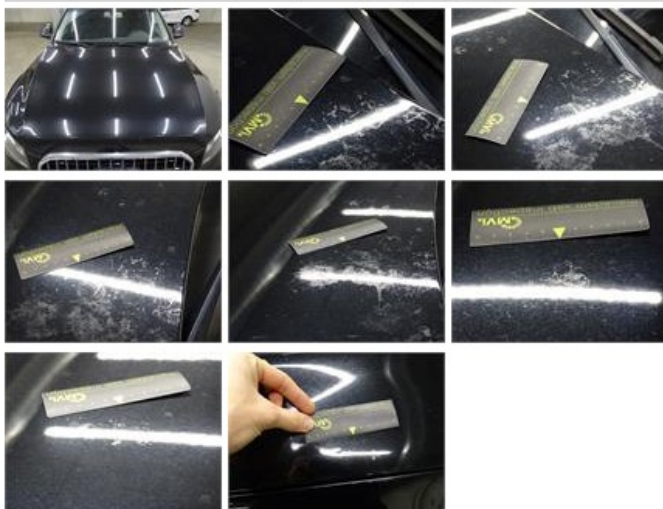
Bonnet, Chemical polution, LI - Repair and paint (complete)	348,09
---	--------
