BMW 1 HATCH: 1TCV999

Limited Technical Inspection

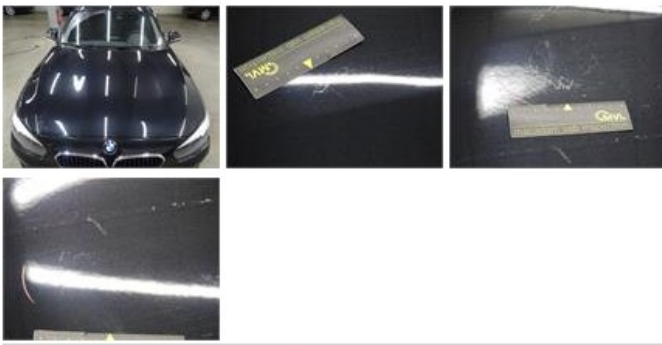
Total cost ex VAT	1617,93
Bonnet, Chemical polution, LI - Repair and paint (complete)	290,08

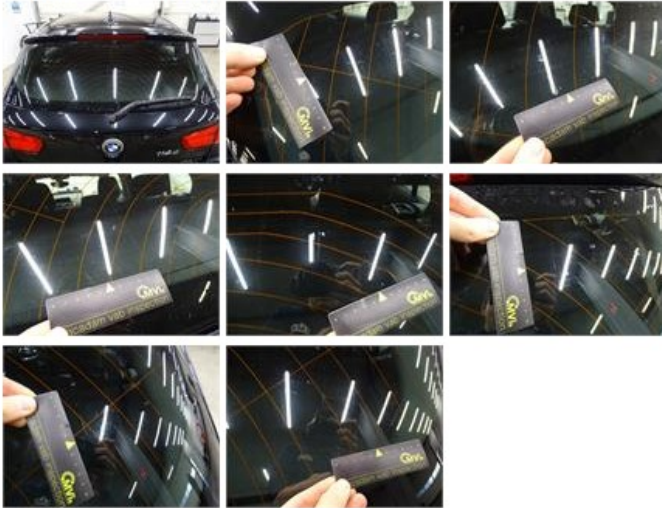
Rear window, Scratch(es), E - Replace 370,00

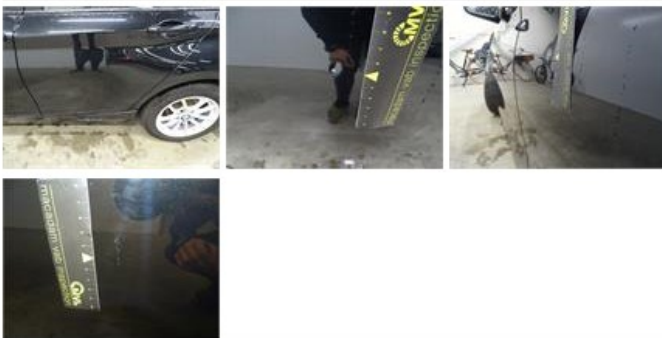
Door R L, Dent(s) and scratch(es), LI - Repair and paint (complete) 318,35
