AUDI A6: 1HZR622

Limited Technical Inspection

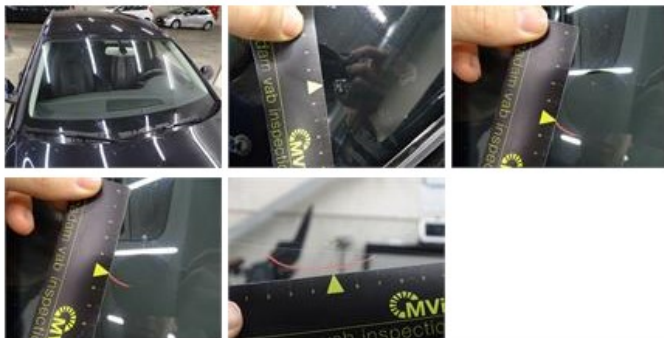
Windscreen, Stone chip(s), E - Replace

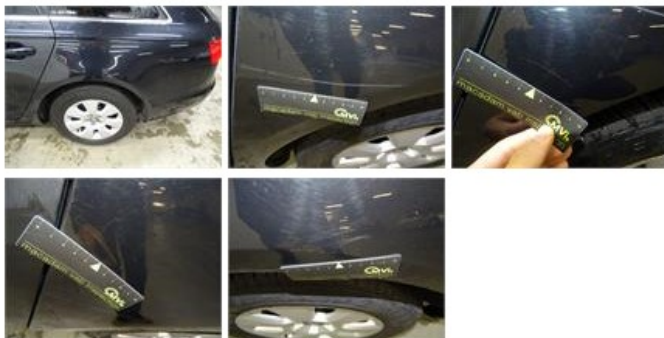
Wing R L, Scratch(es), LI - Repair and paint (complete)

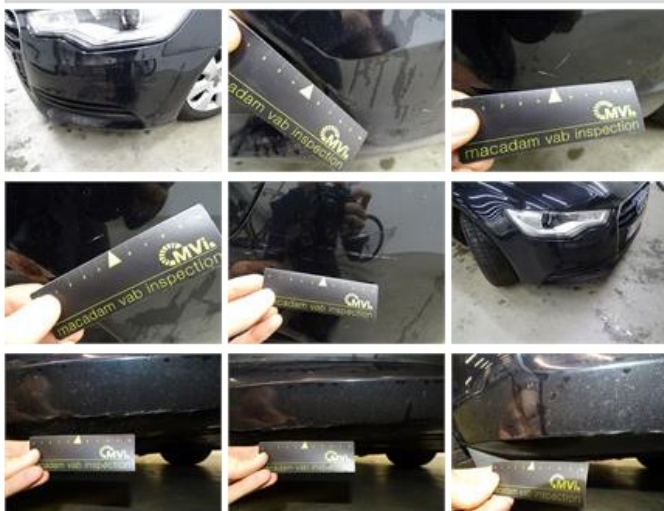
Bumper F, Scratch(es), LI - Repair and paint (complete)

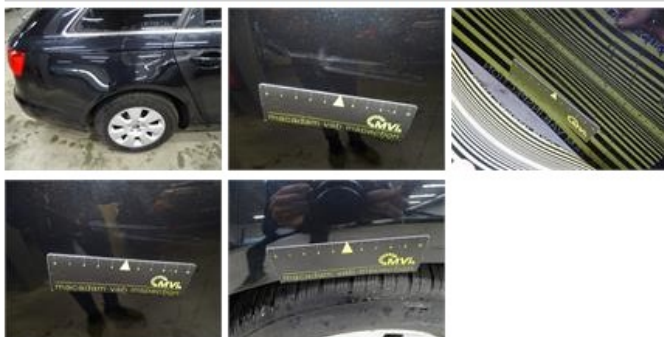
Wing R R, Dent(s) and scratch(es), LI - Repair and paint (complete)

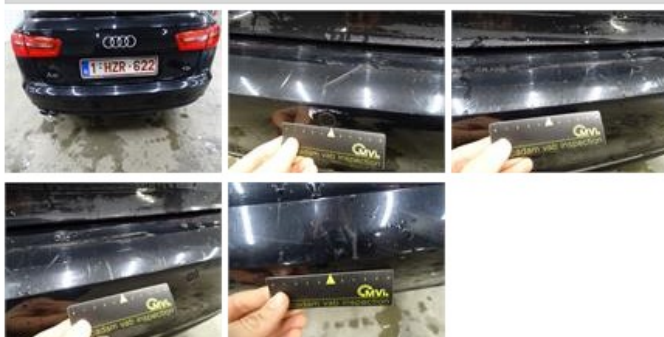
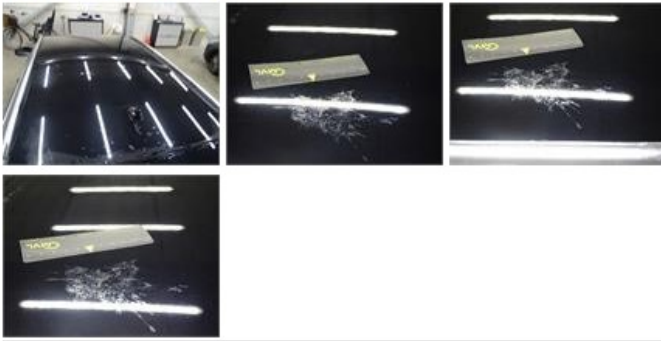
Bumper R, Scratch(es), LI - Repair and paint (complete)
