BMW 2 ACTIVE TOURER: 1LNY960

Limited Technical Inspection

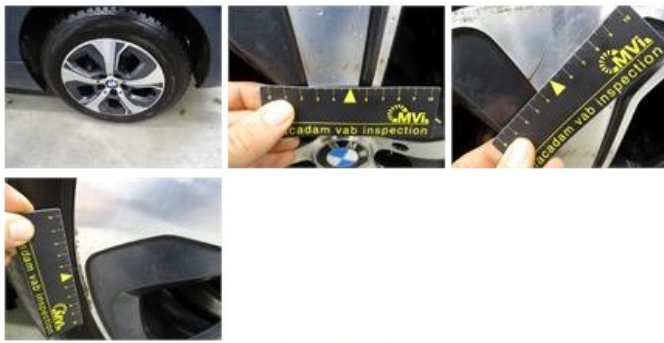
Total cost ex VAT	990,33
Alloy rim R L polished, Scratch(es), LI - Repair and paint (complete)	95,00

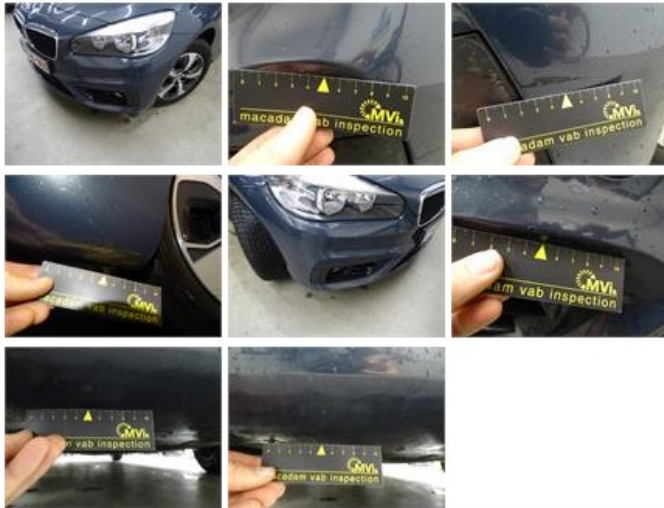
Bumper F, Scratch(es), LI - Repair and paint (complete) 211,80

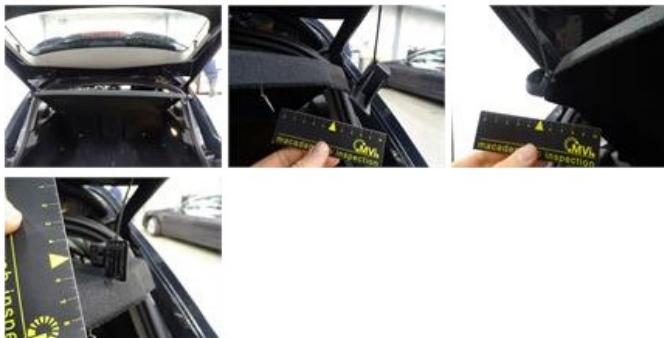
Boot cover, Broken, E - Replace 50,00

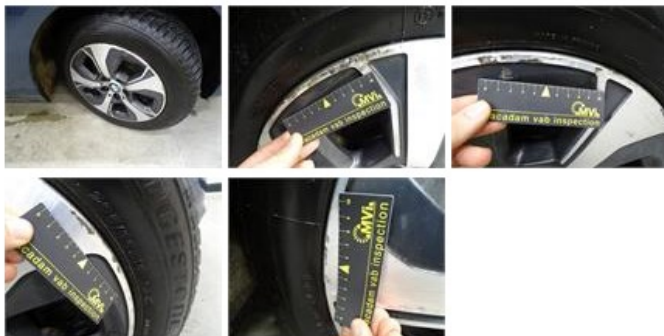
Alloy rim F R polished, Scratch(es), LI - Repair and paint (complete) 95,00

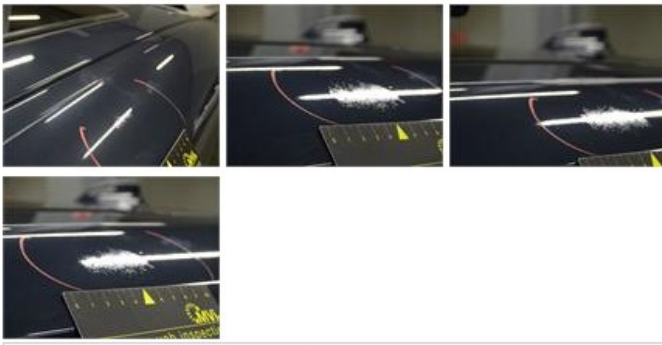
Roof pillar L, Chemical polution, LI - Repair and paint (complete) 220,18

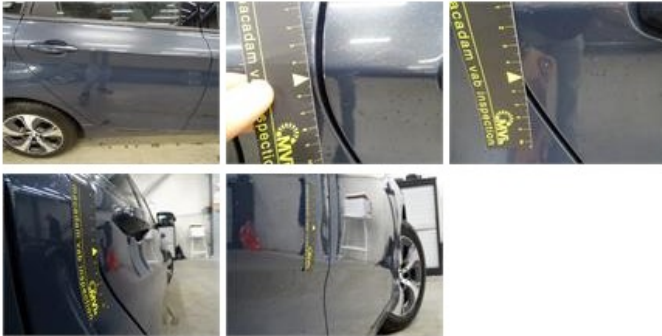
Door R R, Dent(s) and scratch(es), LI - Repair and paint (complete) 318,35
