**BMW 3 BERLINE: 1JJG748**

**Limited Technical Inspection**

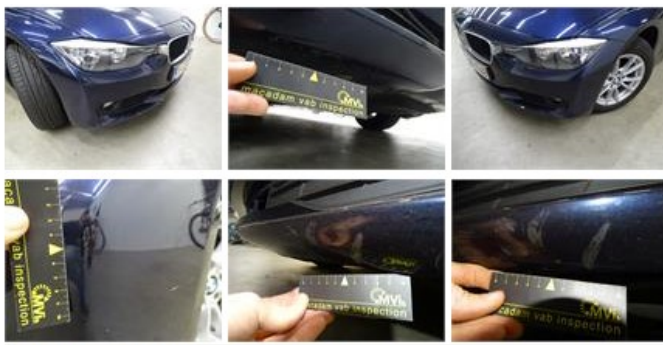
<b>Total cost ex VAT</b>	<b>1325,73</b>
<b>Bumper F, Scratch(es), LI - Repair and paint (complete)</b>	<b>211,80</b>

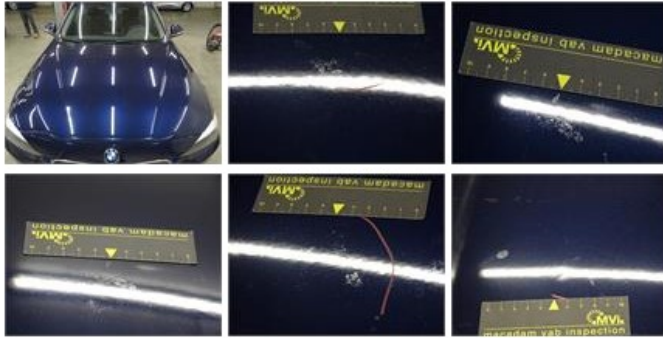
Bonnet, Chemical polution, LI - Repair and paint (complete) 290,08

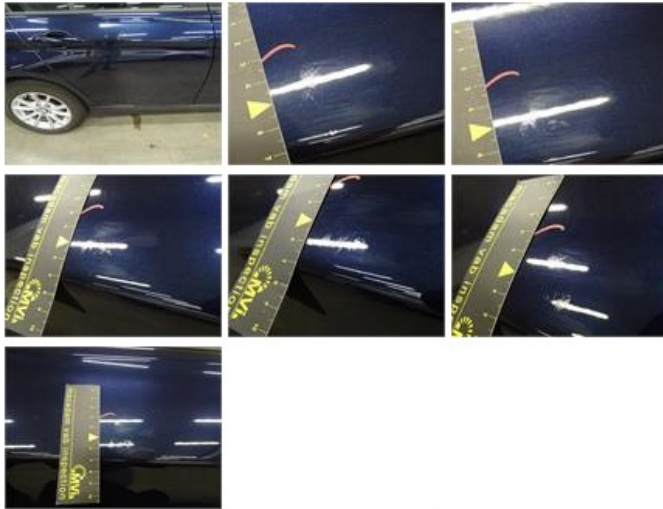
Door R R, Chemical polution, LI - Repair and paint (complete) 318,35

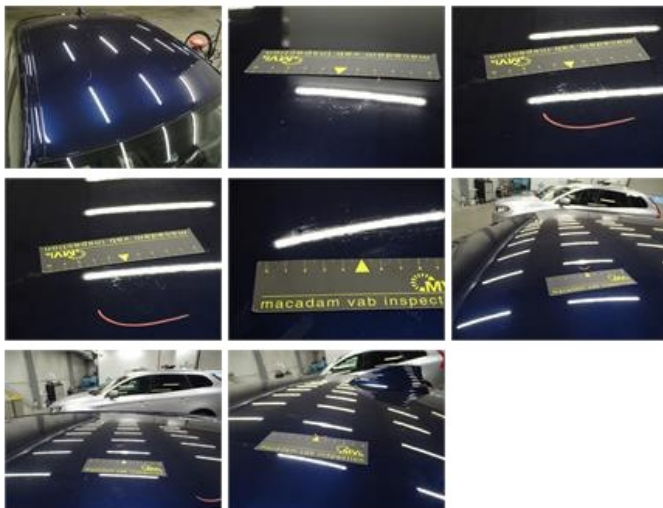
Roof, Chemical polution, LI - Repair and paint (complete) 505,50
