BMW X5: PQ5786			
Vinnumber:	WBAKT010300S42650	Versionname:	2.0 XDRIVE40E (230KW)
First Registrationdate:	17/02/2016	Fiscalpower:	
Expertise Mileage:	94273	Power Kw:	180
Bodytype:		Body color:	Dark Grey
Gearbox:	Automatic	Paint type:	Metalic
Transmission:	4 Weel	Rims summer:	Aluminium
Fueltype:	Hybrid Petrol	Oil level:	OK
Battery functioning:	Yes	Parking lot:	LKW1
Number of doors:	5		
Number of seats:	5		
Number head rests:	5		
Rims summer:	Aluminium		
Category:	Passenger Car		
Oil level:	OK

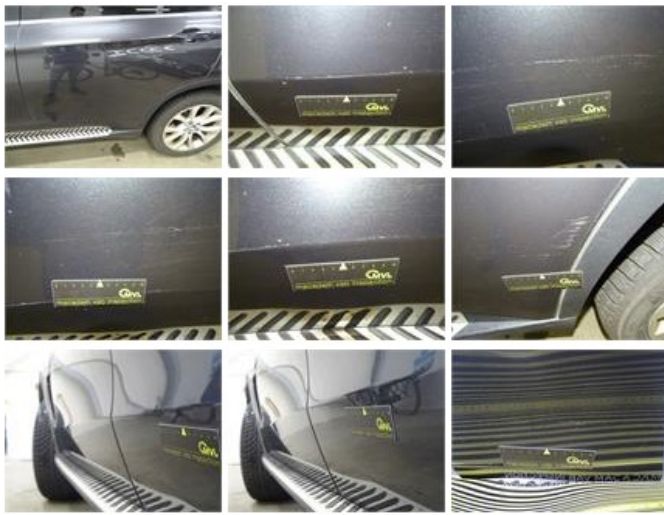
Total cost ex VAT	1886,86
Alloy rim F R, Scratch(es), Acceptable	0,00
<i>No pictures to display</i>	
Door R L, Dent(s) and scratch(es), LI - Repair and paint (complete)	382,02

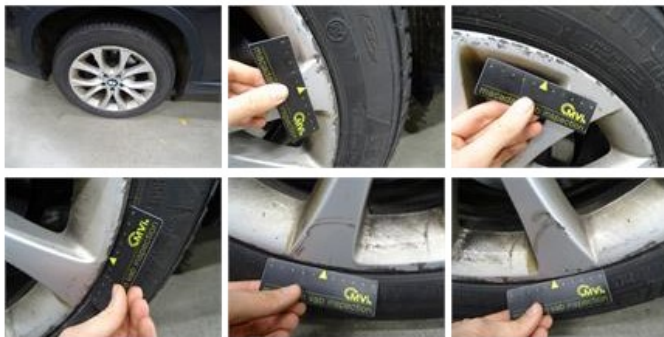
Alloy rim R R, Scratch(es), LI - Repair and paint (complete) 95,00

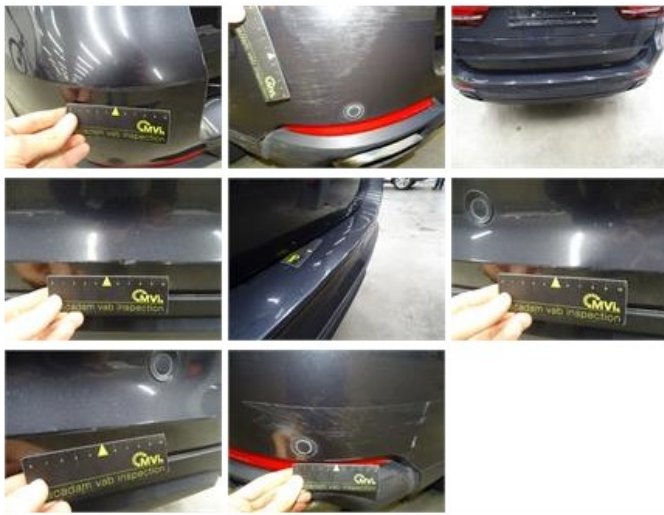
Bumper R, Dent(s) and scratch(es), LI - Repair and paint (complete) 254,16

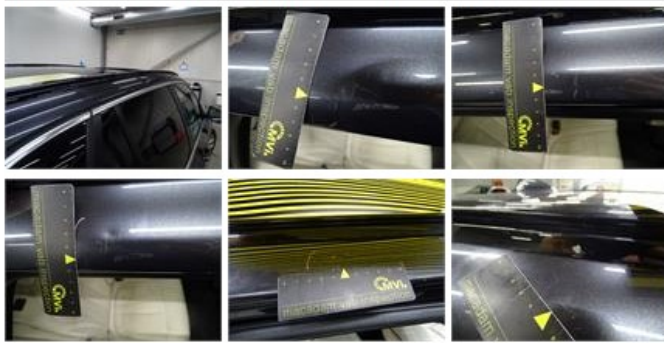
Roof pillar R, Dent(s) and scratch(es), LI - Repair and paint (complete) 264,22

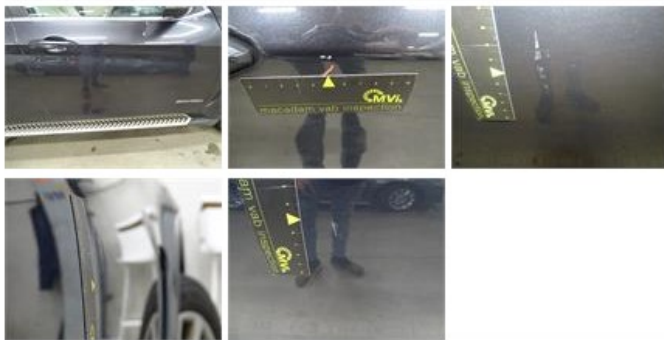
Door F R, Dent(s) and scratch(es), LI - Repair and paint (complete) 382,02

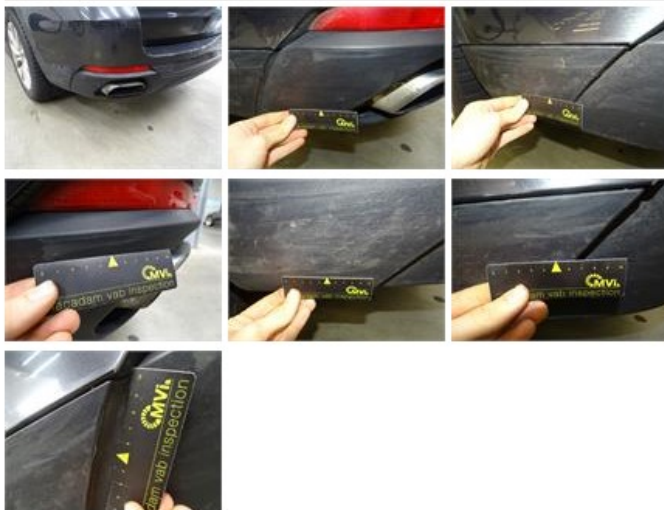
Bumper cover R M, Scratch(es), Smart repair 110,64
