BMW 3 TOURING: 1LKL957

Limited Technical Inspection

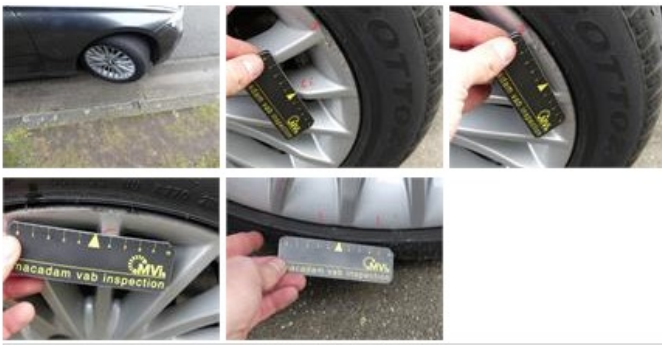
Runflat	Yes
Total cost ex VAT		1575,02
Seat F L compl, Worn, Acceptable		0,00
<i>No pictures to display</i>		
Alloy rim F R, Scratch(es), LI - Repair and paint (complete)		95,00

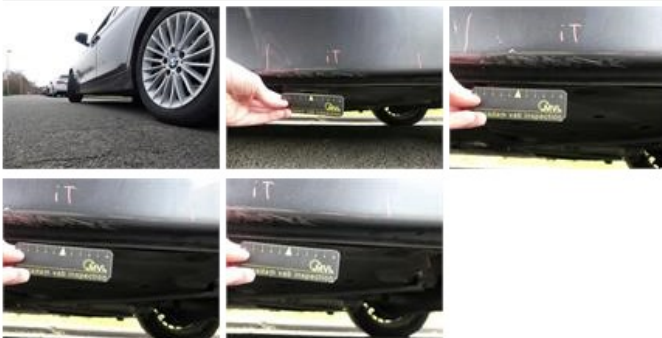
Sill trim L, Scratch(es), It - Spot repair 115,56

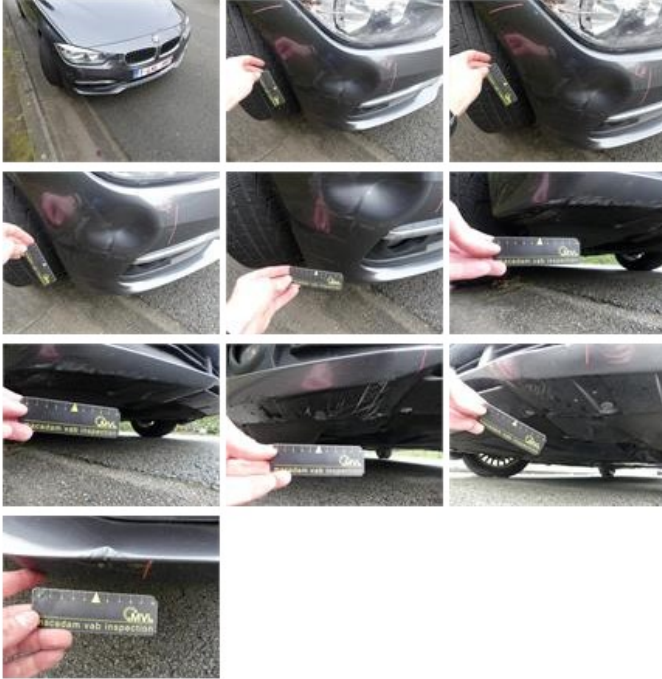
Bumper R, Scratch(es), Acceptable	0,00
<i>No pictures to display</i>	
Rear bulkhead lining, Scratch(es), Acceptable	0,00
<i>No pictures to display</i>	
Internal Boot Lining R, Scratch(es), Acceptable	0,00
<i>No pictures to display</i>	
Outer backrest protection R, Scratch(es), Acceptable	0,00
<i>No pictures to display</i>	
Bumper F, Deformed / Strained, Le - Replace and paint	735,00
