**BMW 4 GRAN COUPE: TY8396**

**Limited Technical Inspection**

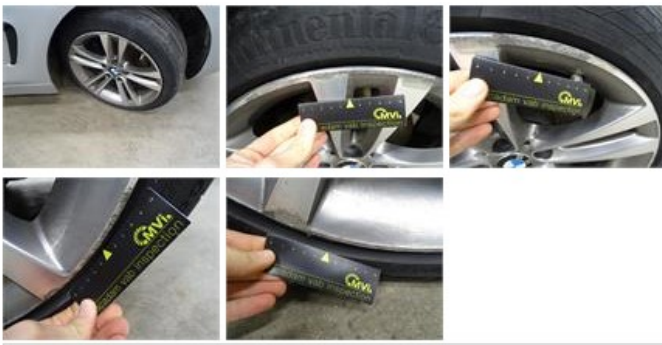
Alloy rim F R polished, Scratch(es), LI - Repair and paint (complete)	<b>95,00</b>
---	--------------

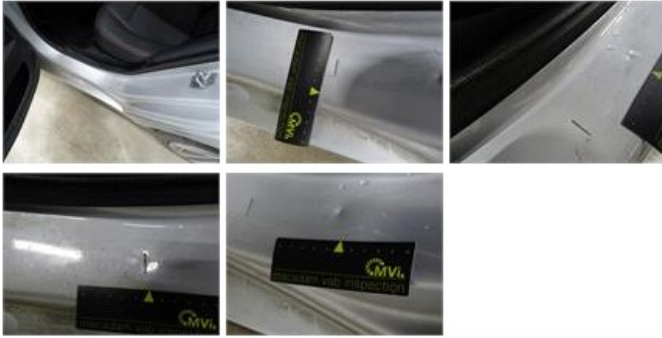
Rocker panel inner R L, Dent(s), LI - Repair and paint (complete) 115,56

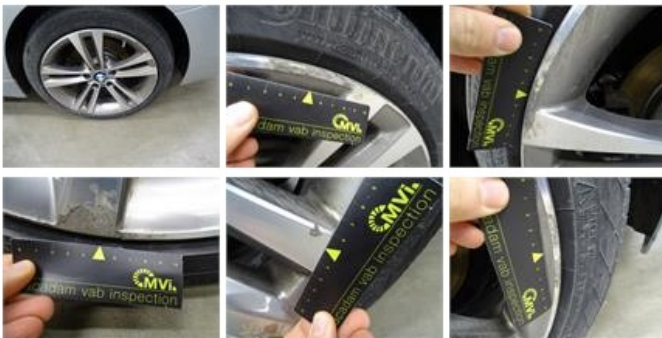
Alloy rim R L polished, Scratch(es), LI - Repair and paint (complete) 95,00

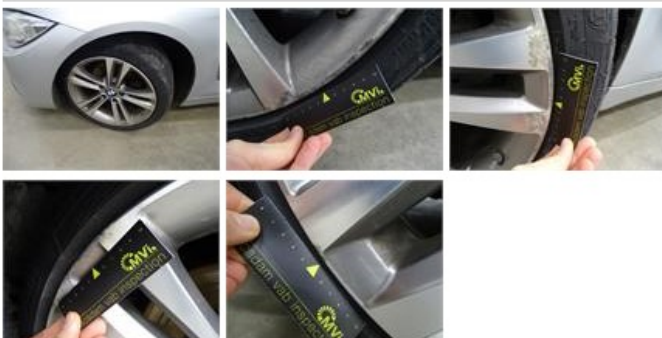
Alloy rim F L polished, Scratch(es), LI - Repair and paint (complete) 95,00

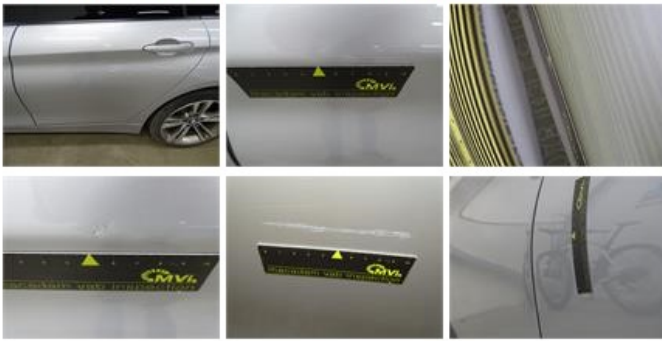
Door R L, Dent(s) and scratch(es), LI - Repair and paint (complete) 382,02

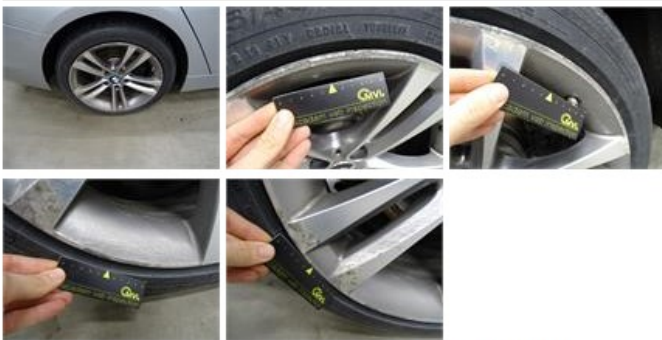
Alloy rim R R polished, Scratch(es), LI - Repair and paint (complete) 95,00

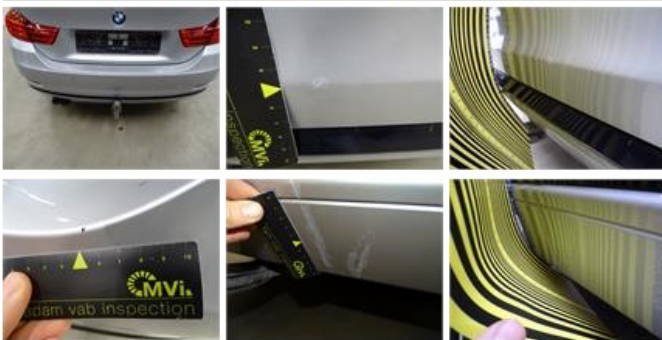
Bumper R, Dent(s) and scratch(es), LI - Repair and paint (complete) 254,16

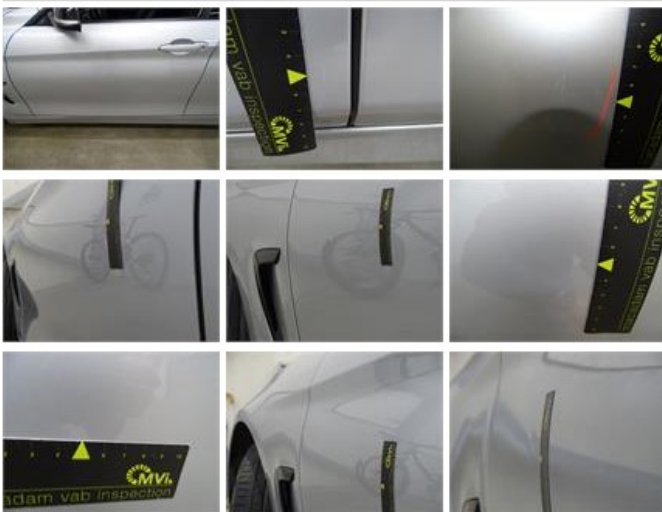
Door F L, Dent(s) and scratch(es), LI - Repair and paint (complete) 382,02
