BMW 5 TOURING: 1KHG869

Limited Technical Inspection

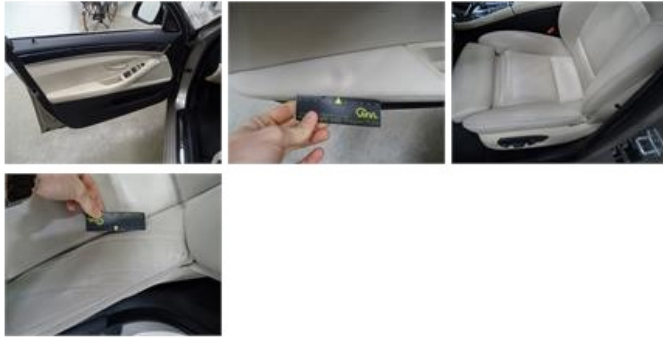
Tailgate, Scratch(es), Acceptable	0,00
<i>No pictures to display</i>	
Roof, Dent(s), Acceptable	0,00
<i>No pictures to display</i>	
Interior, Worn, Acceptable	0,00

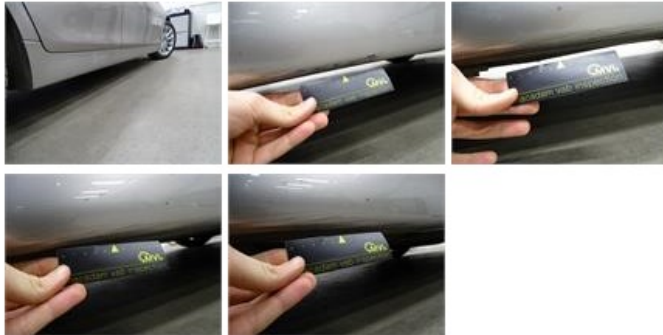
Sill outer R, Scratch(es), LI - Repair and paint (complete)	372,60
---	--------

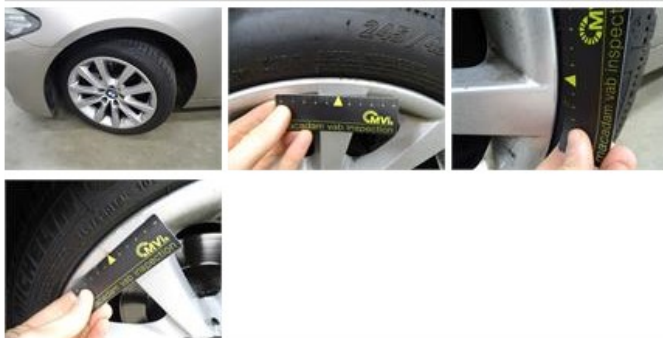
Alloy rim F L, Scratch(es), LI - Repair and paint (complete)	95,00
--	-------

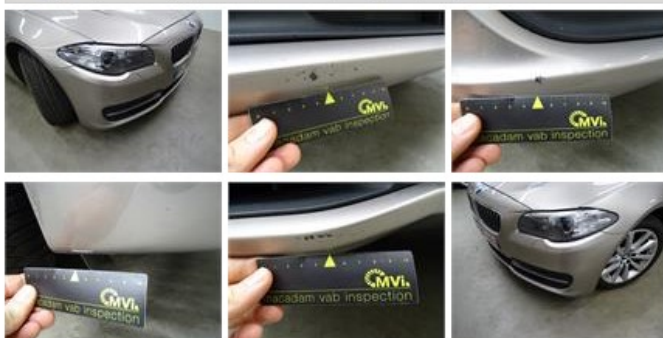
Bumper F, Scratch(es), LI - Repair and paint (complete)	254,16
---	--------
