MERCEDES A: 1PRU561

Limited Technical Inspection

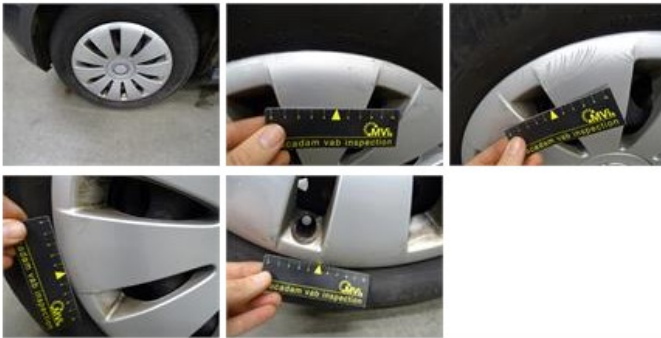
Wheel cover R R, Scratch(es), E - Replace

30,00

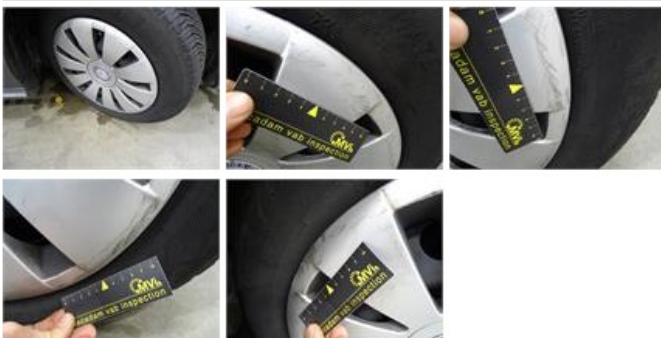
Wheel cover F R, Scratch(es), E - Replace

30,00

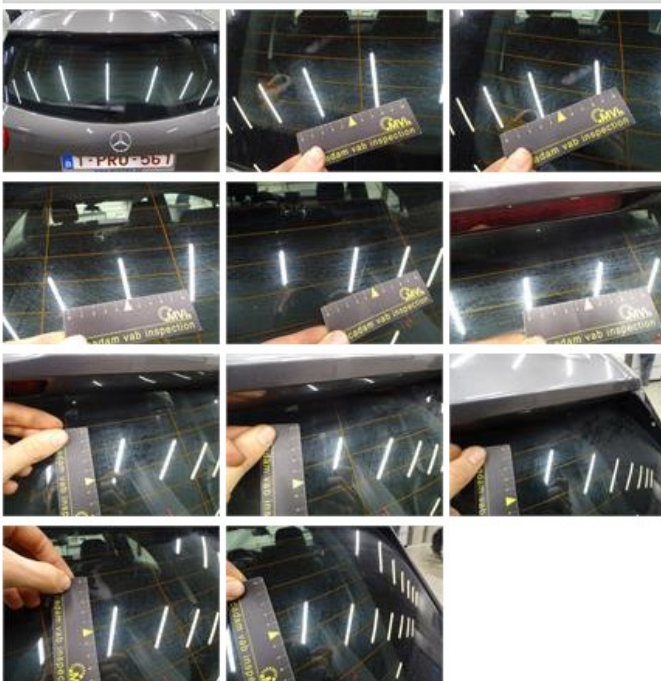
Rear window, Scratch(es), E - Replace

370,00

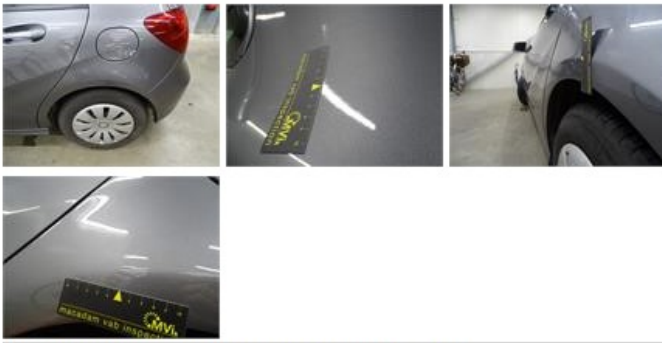
Wing R L, Bad repair, Acceptable

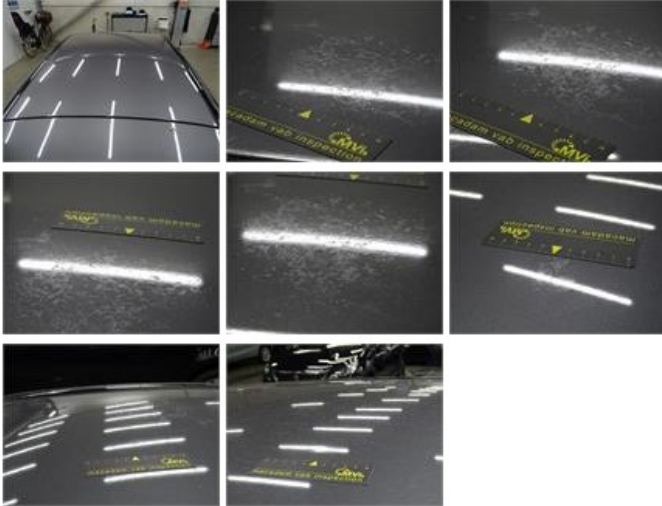
Roof, Chemical pollution, LI - Repair and paint (complete) 481,50
