**LU Mercedes cla: ZS9984**

**Limited Technical Inspection**

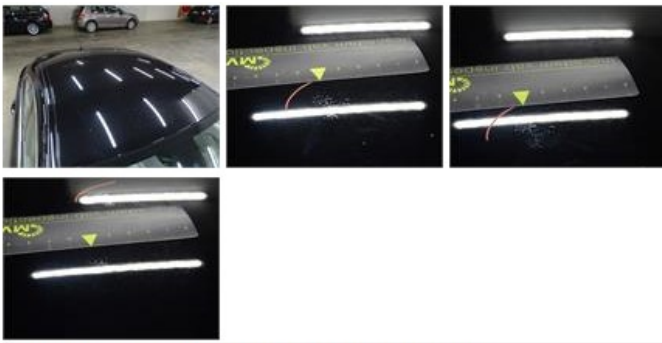
Total cost ex VAT	<b>1403,20</b>
Roof, Chemical polution, LI - Repair and paint (complete)	<b>481,50</b>

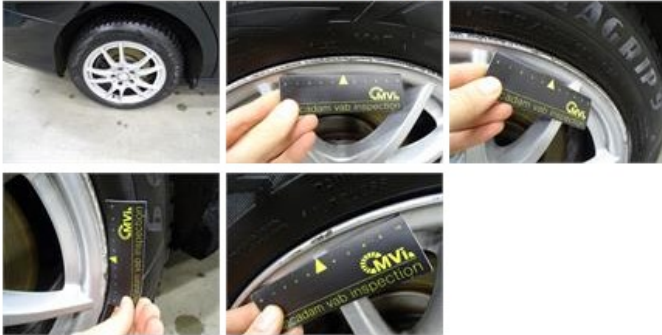
Alloy rim R R, Scratch(es), LI - Repair and paint (complete) 95,00

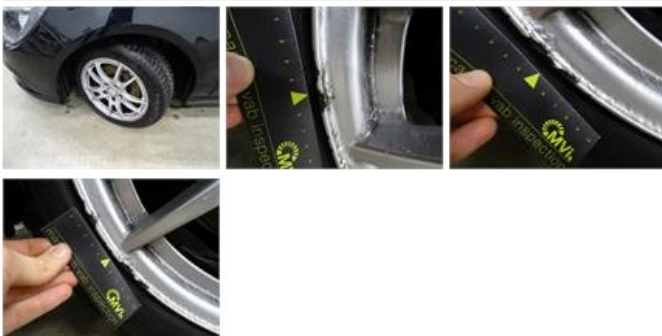
Alloy rim F L, Scratch(es), LI - Repair and paint (complete) 95,00

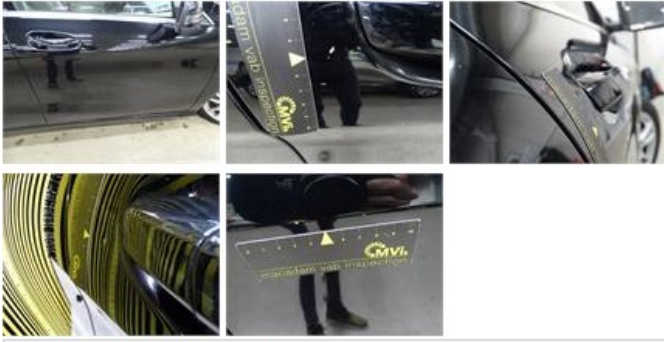
Door F R, Dent(s) and scratch(es), LI - Repair and paint (complete) 318,35
