**MINI : 1KFR243**

**Limited Technical Inspection**

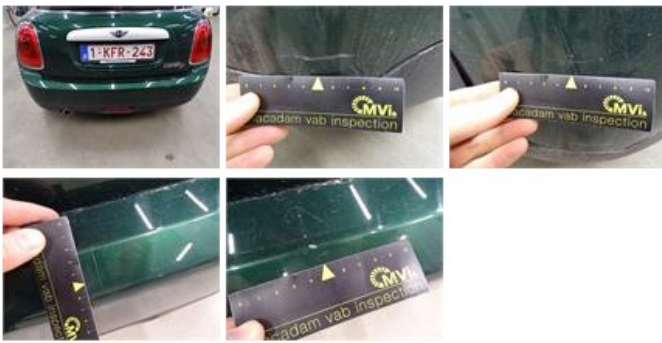
Bumper R, Scratch(es), LI - Repair and paint (complete) 211,80

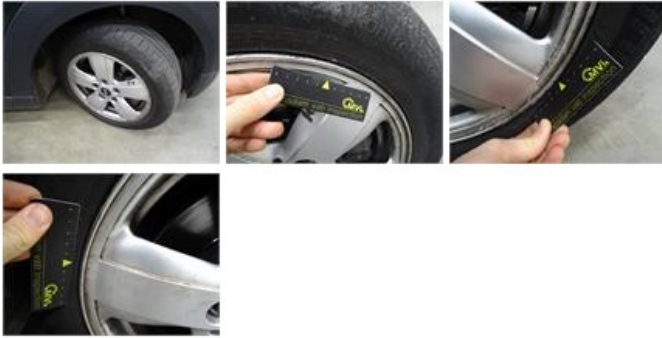
Alloy rim F R, Scratch(es), LI - Repair and paint (complete)

95,00
