NISSAN QASHQAI: 1JGT900

Limited Technical Inspection

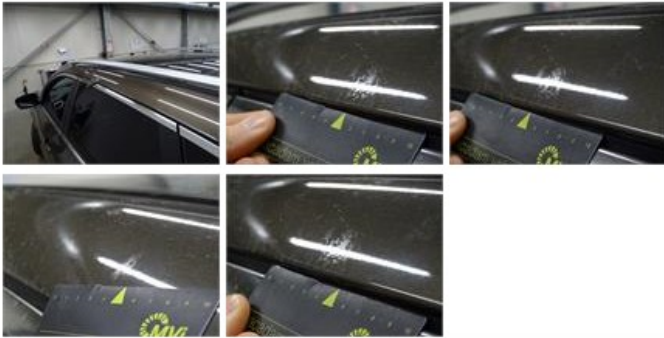
Door R R, Scratch(es), Acceptable	0,00
<i>No pictures to display</i>	
Alloy rim R R, Scratch(es), Acceptable	0,00
<i>No pictures to display</i>	
Door F L, Scratch(es), Acceptable	0,00
<i>No pictures to display</i>	
Wing F R, Scratch(es), 67 - Polish	0,00
<i>No pictures to display</i>	
Roof pillar L, Chemical polution, LI - Repair and paint (complete)	220,18

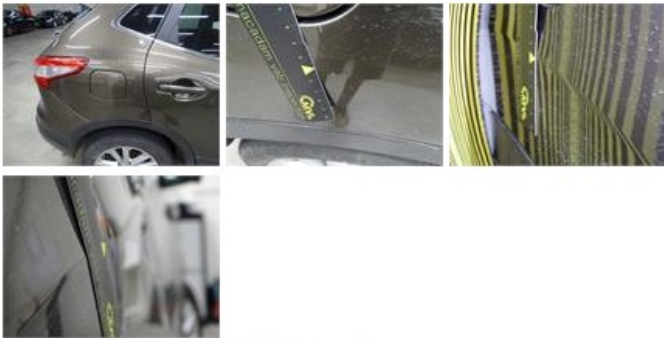
Roof pillar R, Dent(s), Acceptable	0,00
<i>No pictures to display</i>	
Wing R R, Dent(s) and scratch(es), LI - Repair and paint (complete)	308,20

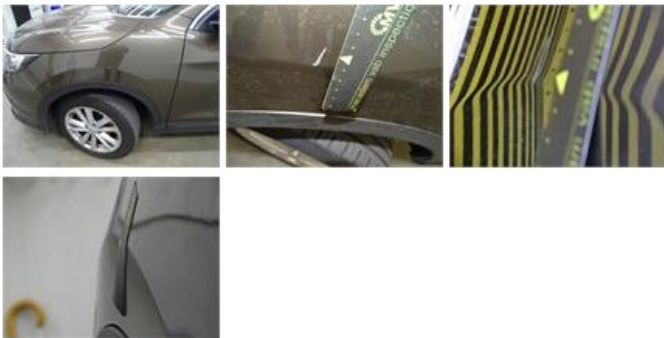
Tailgate, Dent(s) and scratch(es), Acceptable	0,00
<i>No pictures to display</i>	
Door R L, Scratch(es), 67 - Polish	0,00
<i>No pictures to display</i>	
Wing F L, Dent(s) and scratch(es), LI - Repair and paint (complete)	220,18
