RENAULT CLIO: 1LLV800

| Vinnumber: | VF15R0J0A53968387 | Versionname: | 1.5 ENERGY DCI 90E EXPRESSION |

Limited Technical Inspection

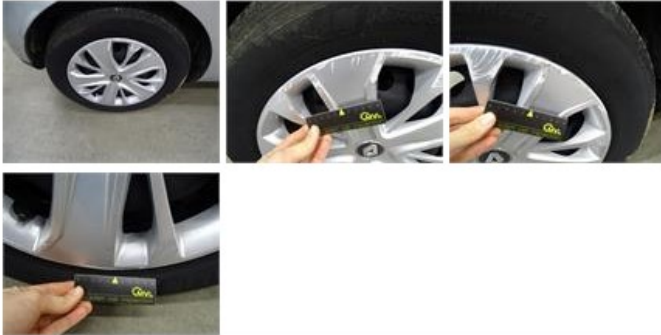
Wheel cover R R, Scratch(es), E - Replace 24,00

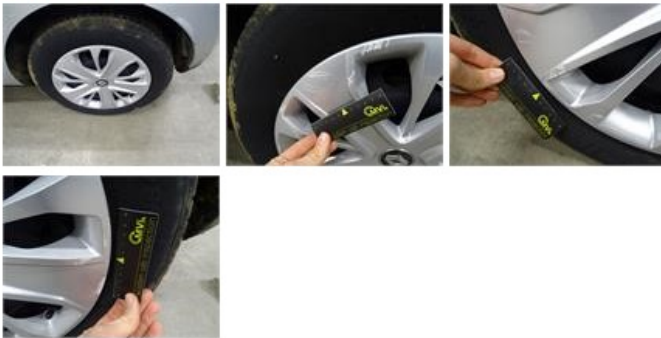
Wheel cover R L, Scratch(es), E - Replace 24,00

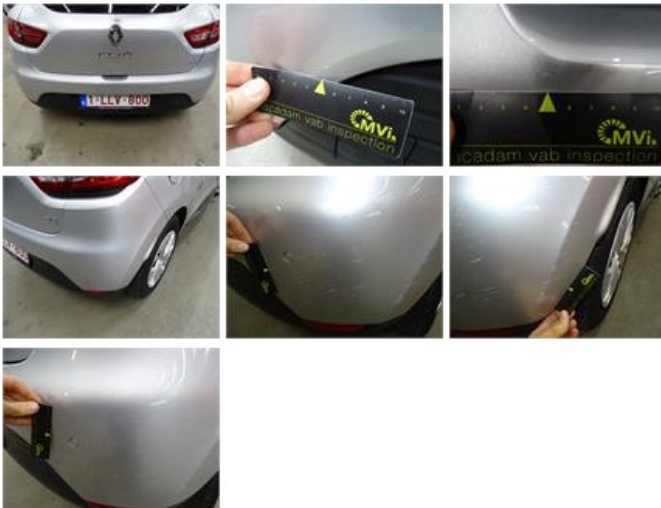
Bumper R, Scratch(es), LI - Repair and paint (complete) 169,44

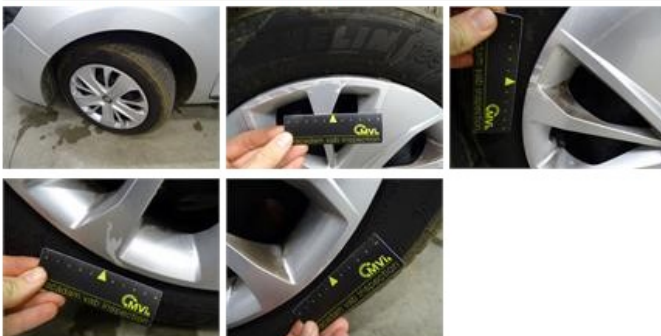
Wheel cover F L, Scratch(es), E - Replace 24,00

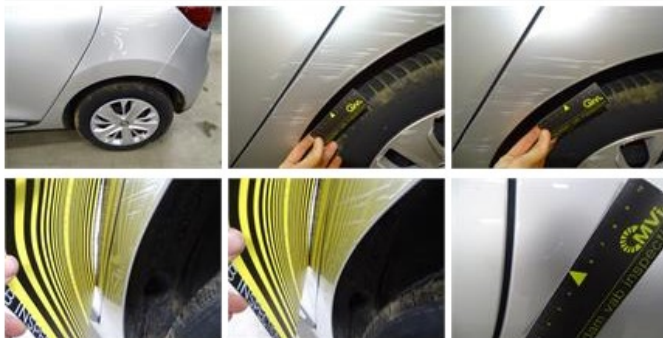
Wing R L, Dent(s) and scratch(es), LI - Repair and paint (complete)

246,56

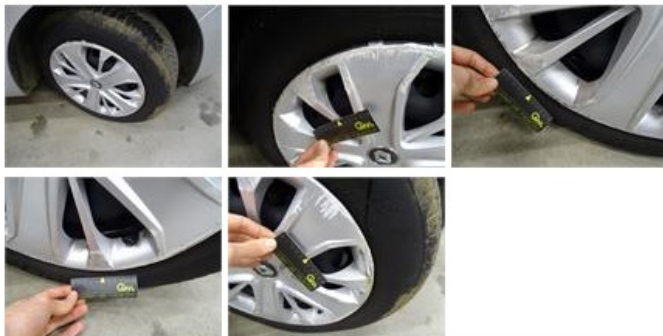
Wheel cover F R, Scratch(es), E - Replace

24,00

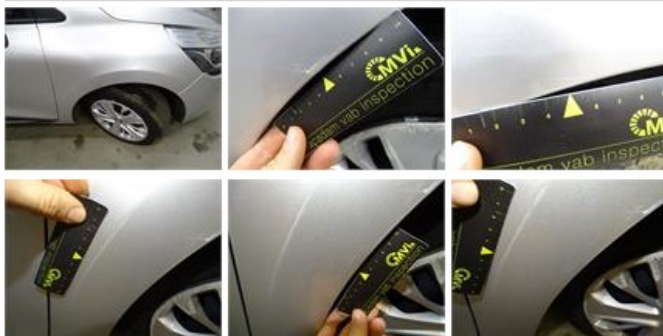
Wing F R, Scratch(es), LI - Repair and paint (complete)

176,14
