VOLVO V40 CROSS COUNTRY: 1LEH296

Limited Technical Inspection

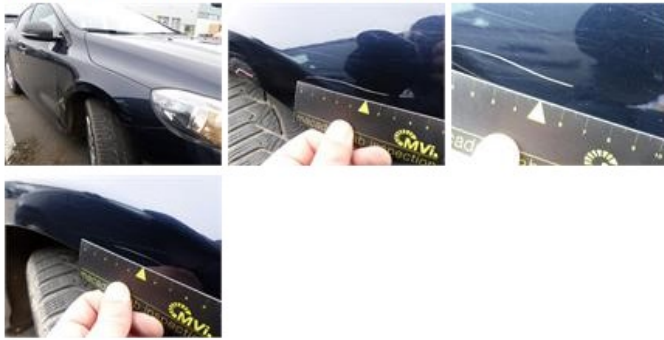
Wing F R, Scratch(es), LI - Repair and paint (complete)

220,18

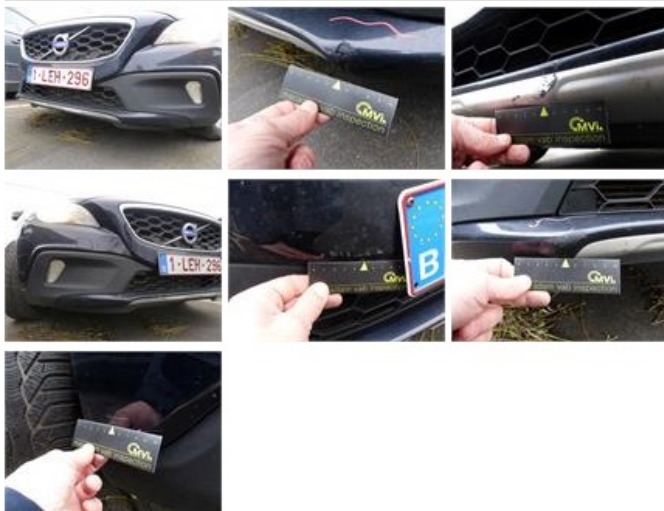
Bumper F, Dent(s) and scratch(es), LI - Repair and paint (complete)

211,80
