VOLVO V60: 1PAY145

| Vinnumber: | YV1FW74C1H1330803 | Versionname: | 2.0 D2 KINETIC |

Limited Technical Inspection

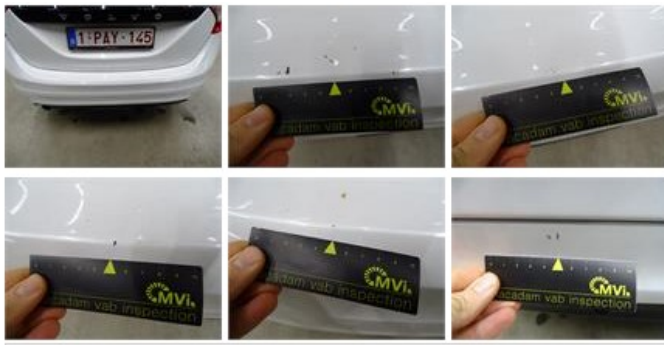
| Bumper R, Scratch(es), LI - Repair and paint (complete) | 211,80 |

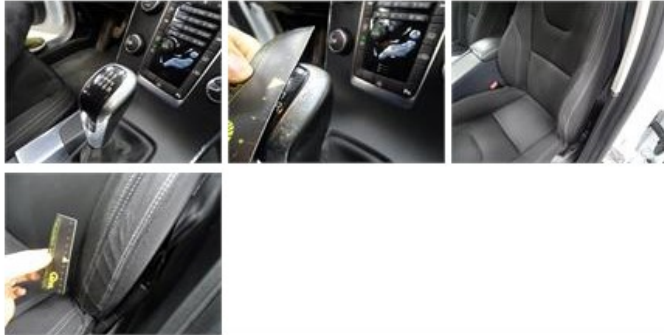
Interior, Worn, Acceptable

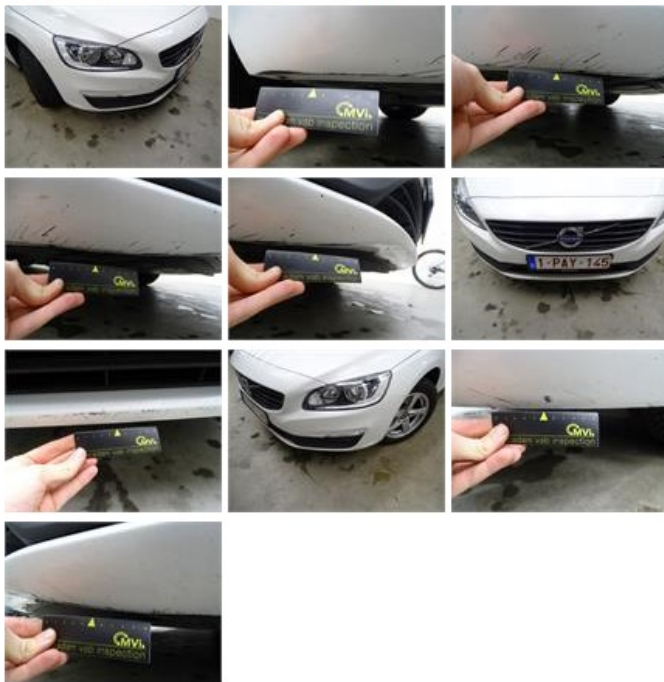
Bumper F, Scratch(es), LI - Repair and paint (complete)

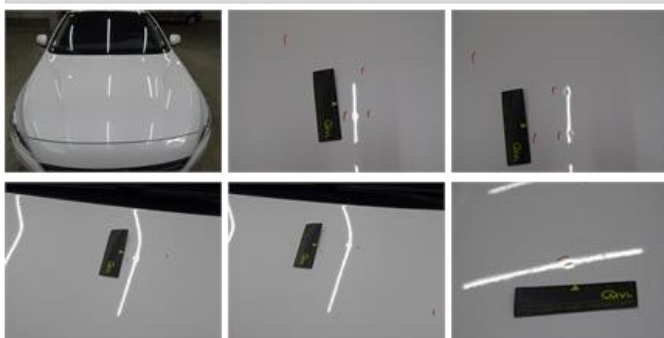
Bonnet, Hail damage, PDR - Hail

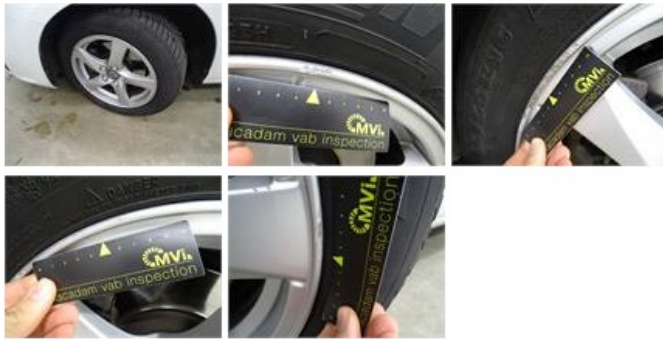
Alloy rim F L, Scratch(es), LI - Repair and paint (complete)

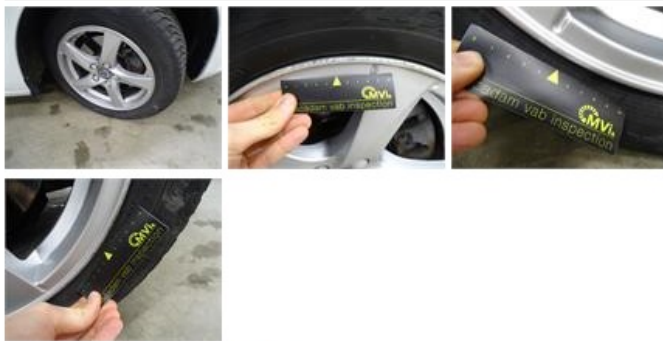
Alloy rim F R, Scratch(es), LI - Repair and paint (complete)

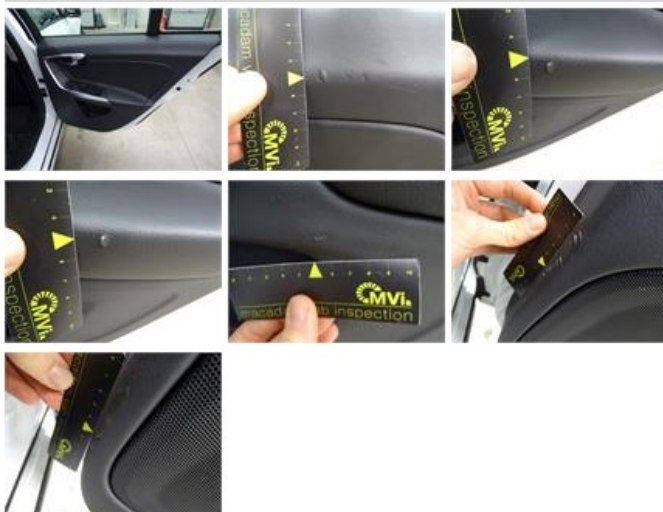
Door panel R R, Tear, Smart repair
