**VOLVO XC60: 1HZK992**

**Limited Technical Inspection**

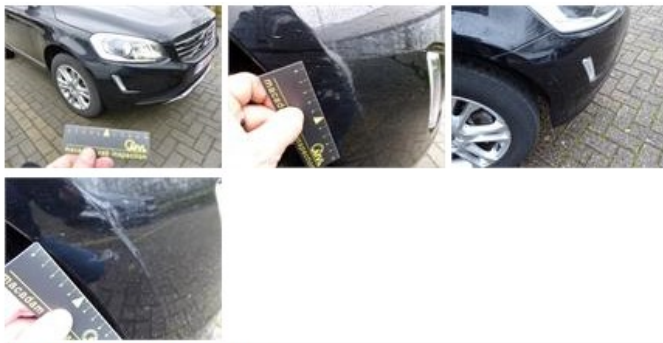
Total cost ex VAT	<b>231,12</b>
Bumper F R, Scratch(es), It - Spot repair	<b>115,56</b>

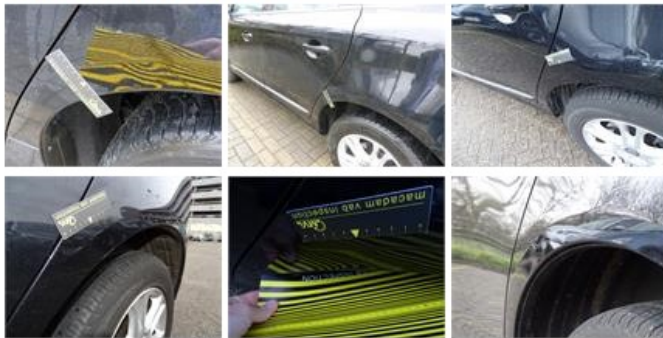
Wing R R, Dent(s), Acceptable	0,00
<i>No pictures to display</i>	
Alloy rim F R, Scratch(es), Acceptable	0,00
<i>No pictures to display</i>	
Alloy rim F L, Scratch(es), Acceptable	0,00
<i>No pictures to display</i>	
Seat cover R R, Stain, Cleaning	0,00
<i>No pictures to display</i>	
Seat cover R L, Worn, P - Check	0,00
<i>No pictures to display</i>	
Wing F L, Scratch(es), Acceptable	0,00
<i>No pictures to display</i>	
Seat cover F L, Worn, P - Check	0,00
<i>No pictures to display</i>	
Door panel F L, Hole, Acceptable	0,00
<i>No pictures to display</i>	
Wing R L, Dent(s), It - Spot repair	115,56
