MERCEDES A: 1PPH033

Limited Technical Inspection

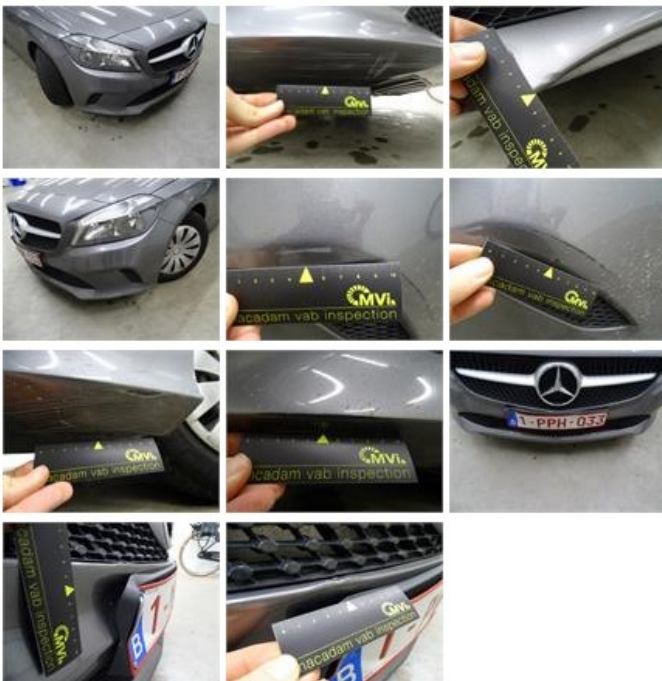
Bumper F, Dent(s) and scratch(es), LI - Repair and paint (complete)

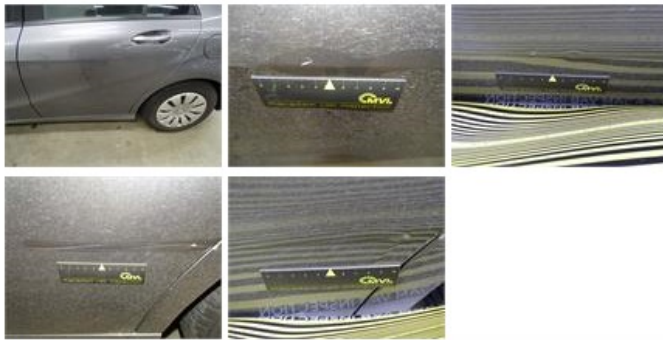
Door R L, Dent(s) and scratch(es), LI - Repair and paint (complete) 342,35

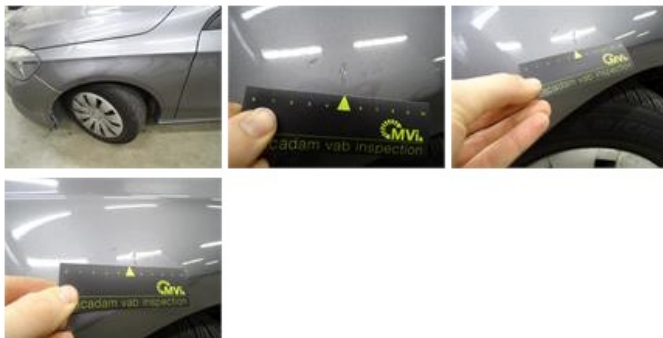
Wing F L, Dent(s) and scratch(es), LI - Repair and paint (complete) 220,18

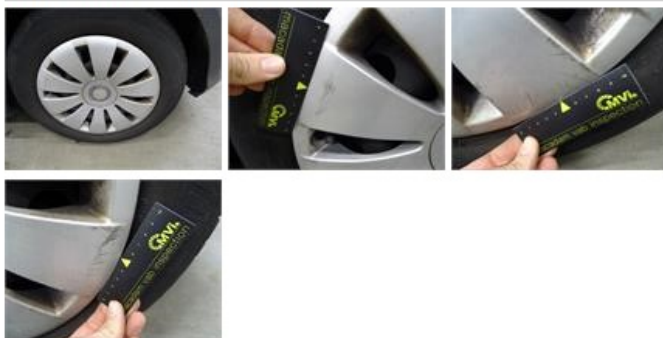
Wheel cover R L, Scratch(es), E - Replace 30,00

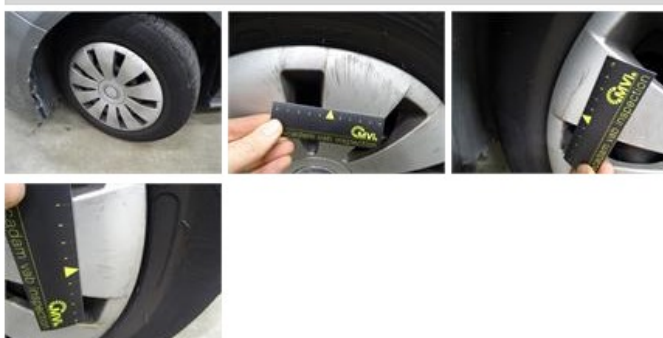
Wheel cover F L, Scratch(es), E - Replace 30,00
