**BMW 2 ACTIVE TOURER: 1KUK797**

**Limited Technical Inspection**

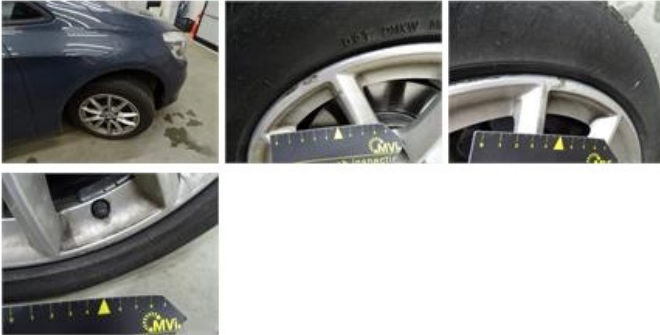
Alloy rim F R, Scratch(es), LI - Repair and paint (complete) 95,00
