BMW 3: 1FLQ787

Limited Technical Inspection

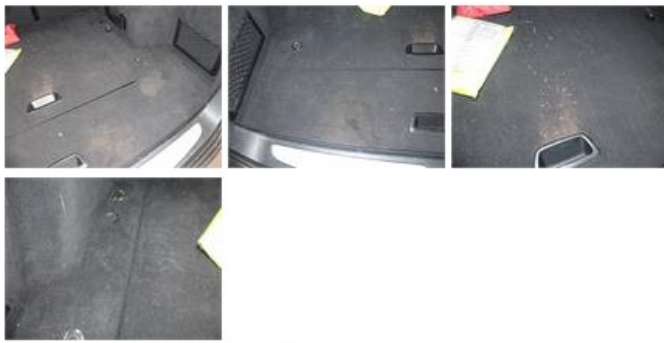
Interior, Dirty, Cleaning	24,00
---------------------------	--------------

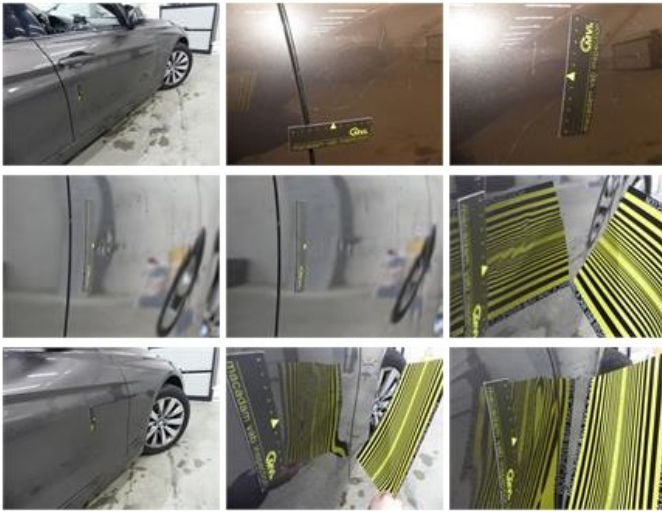
Door F R, Scratch(es), LI - Repair and paint (complete)

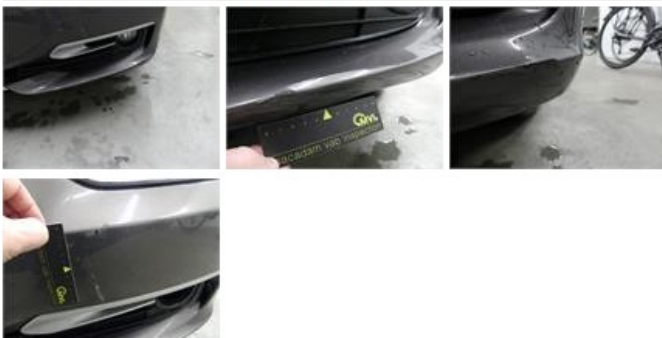
Bumper F, Deformed / Strained, Le - Replace and paint

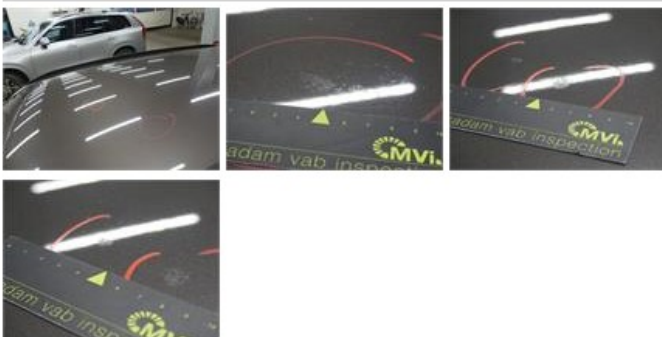
Roof, Chemical polution, LI - Repair and paint (complete)
