**BMW 5 TOURING: 1KXK012**

**Limited Technical Inspection**

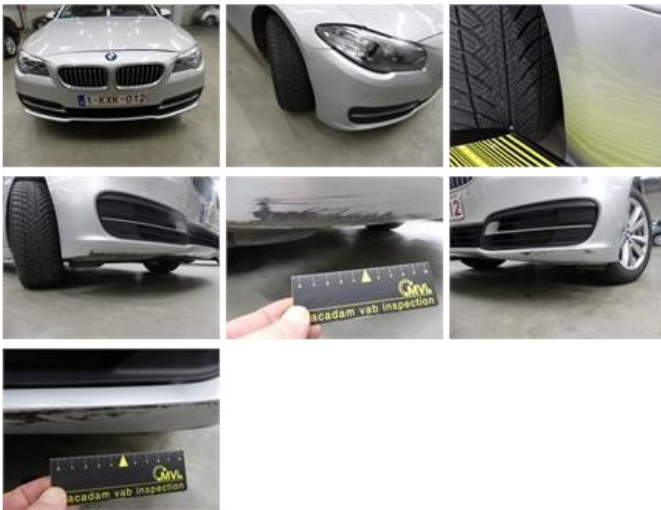
Bumper F, Dent(s) and scratch(es), LI - Repair and paint (complete) 302,16

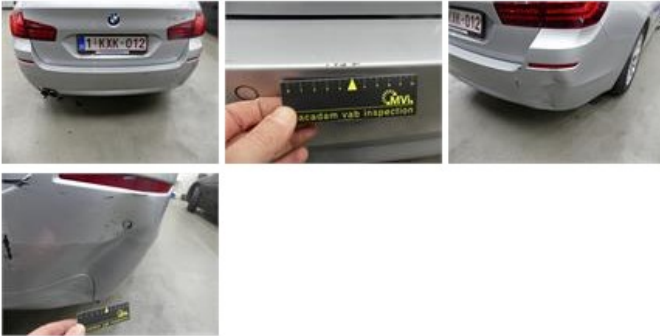
Bumper R, Dent(s) and scratch(es), Le - Replace and paint

766,80
