BMW 3 TOURING: 1JGL667

Limited Technical Inspection

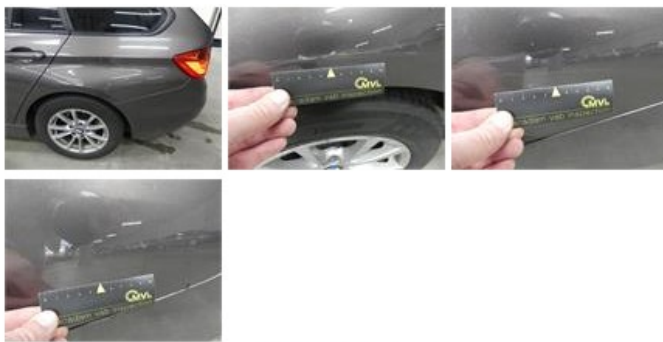
Wing R L, Scratch(es), 67 - Polish 0,00

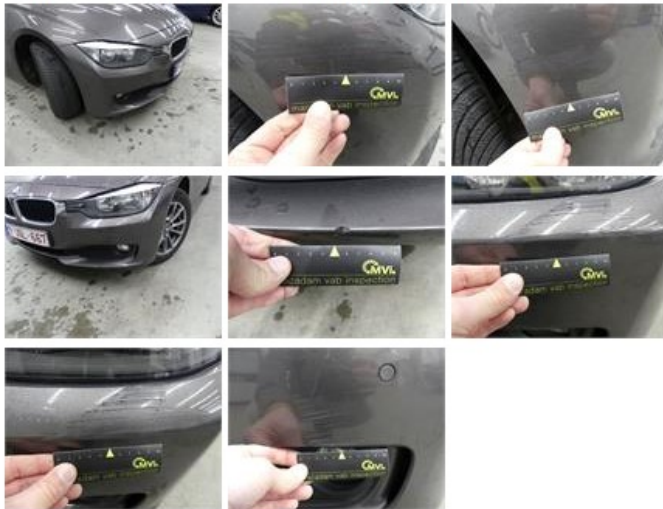
Bumper F, Scratch(es), LI - Repair and paint (complete) 211,80

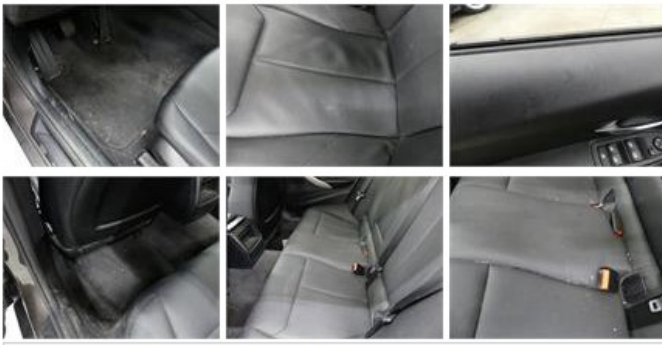
Interior, Dirty, Cleaning 0,00
