**MERCEDES A: 1LBU572**

**Limited Technical Inspection**

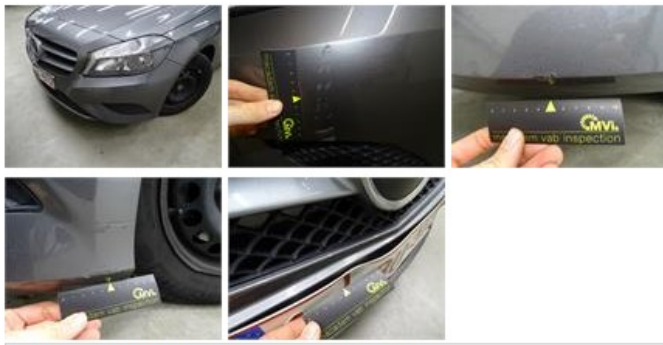
Total cost ex VAT	<b>1992,03</b>
Bumper F, Dent(s) and scratch(es), LI - Repair and paint (complete)	<b>211,80</b>

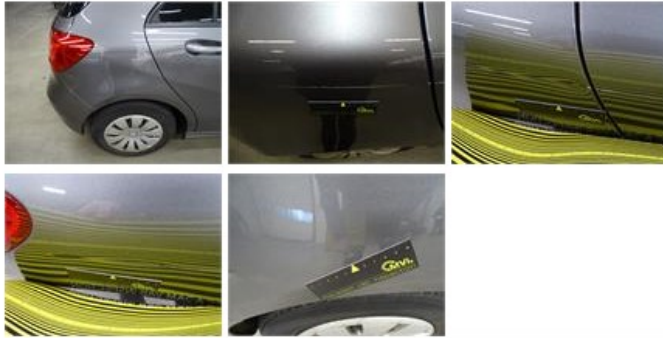
Wing R R, Dent(s) and scratch(es), LI - Repair and paint (complete) 356,20

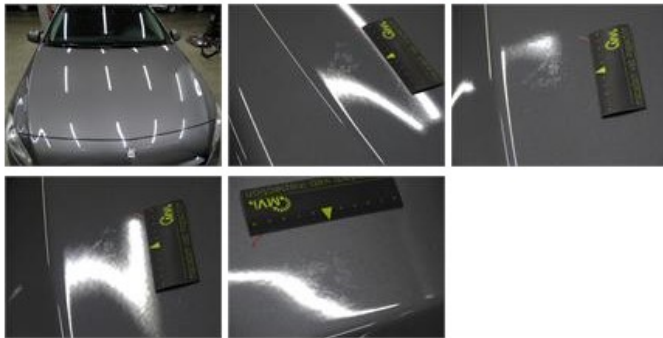
Bonnet, Chemical polution, LI - Repair and paint (complete) 290,08

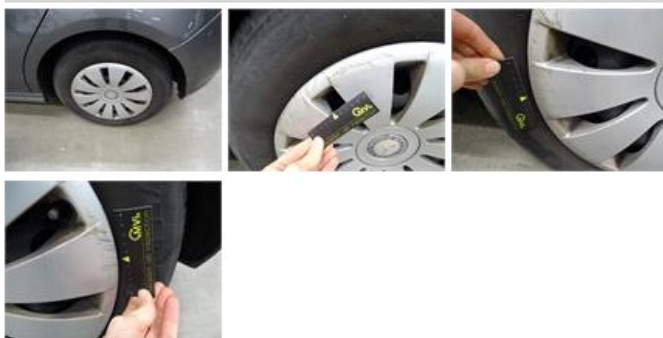
Wheel cover R L, Scratch(es), E - Replace 30,00

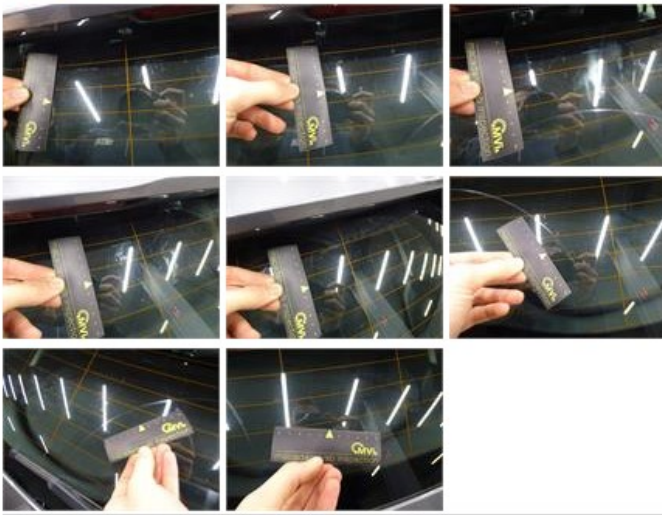
Rear window, Scratch(es), E - Replace 370,00

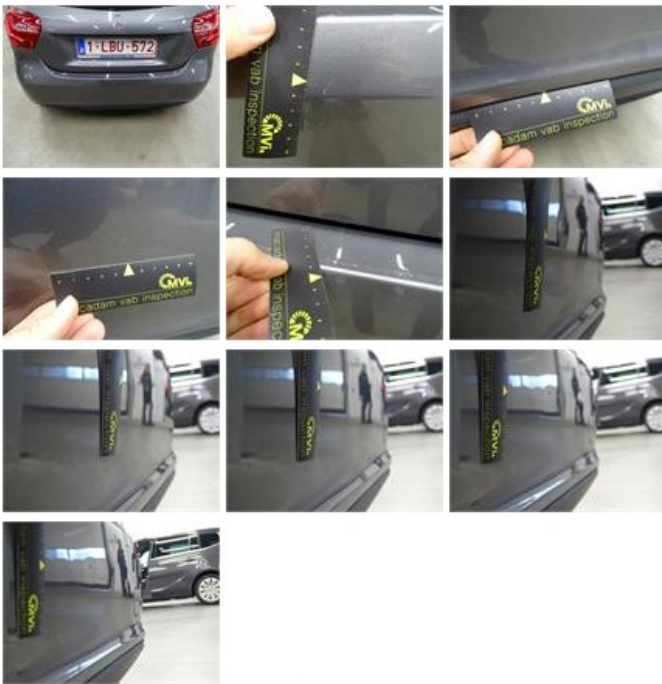
Bumper R, Dent(s) and scratch(es), LI - Repair and paint (complete) 211,80

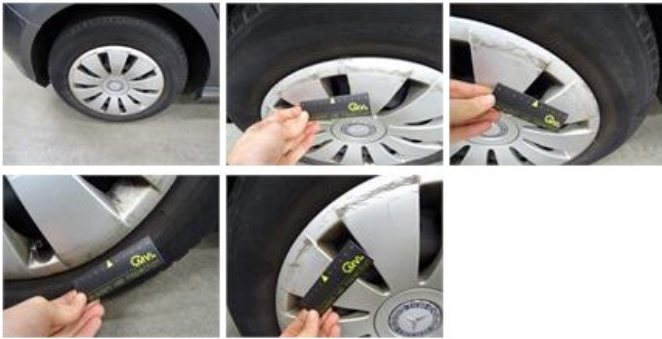
Wheel cover R R, Scratch(es), E - Replace 30,00
